Environment Monitoring For an Asbestos Plant in Kymore

Capacity Building and Training

Environics Trust
28-Dec-21

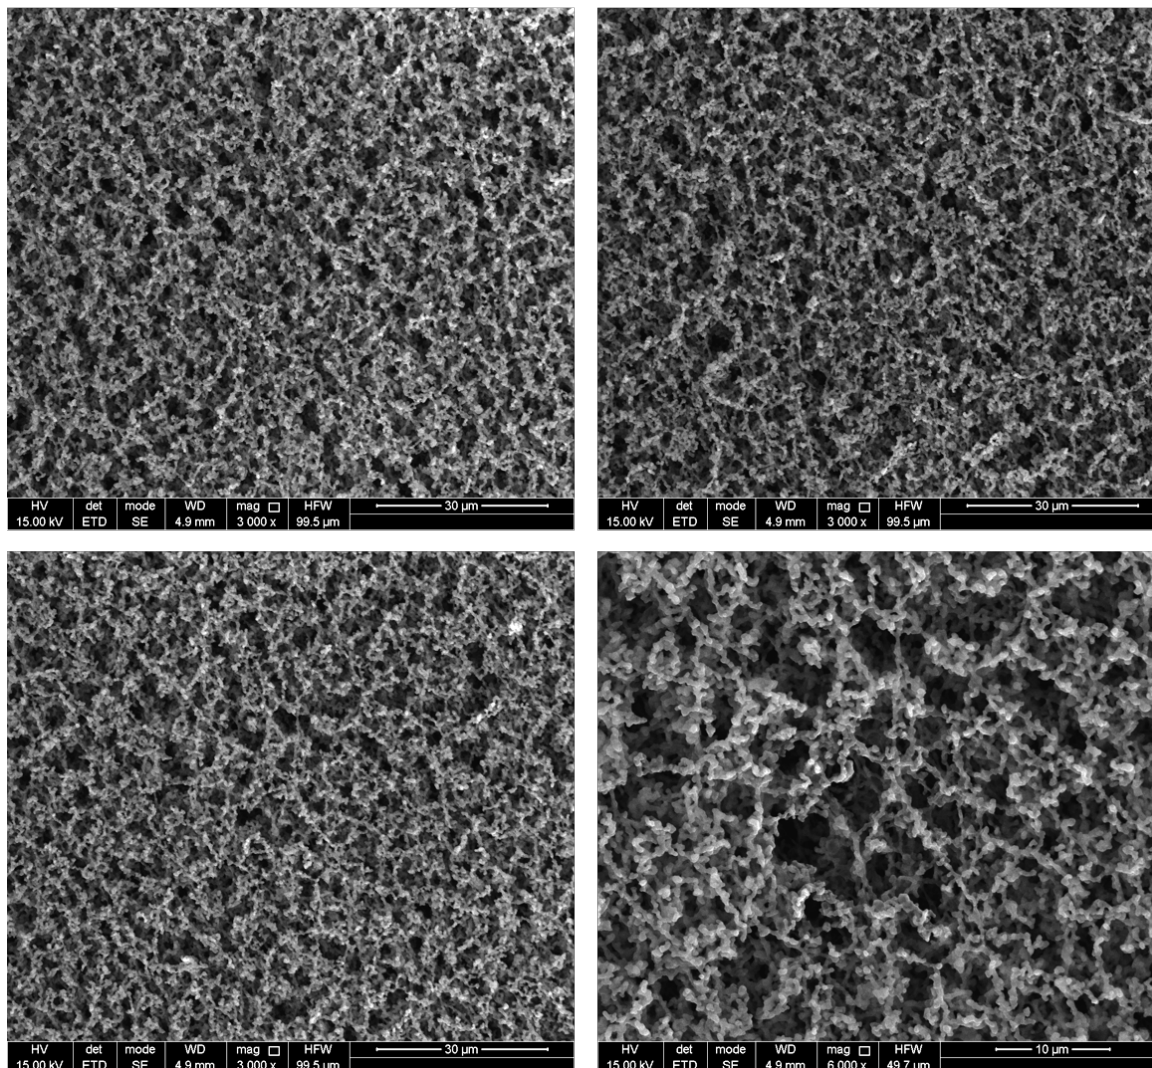
Figure 1. SEM-images with secondary electron detector of the sample “21-WB001 | 18.02.2020N-1”. The images show the network of the pvc filter using different magnifications. No fibre structures or other particles were observed in this sample.

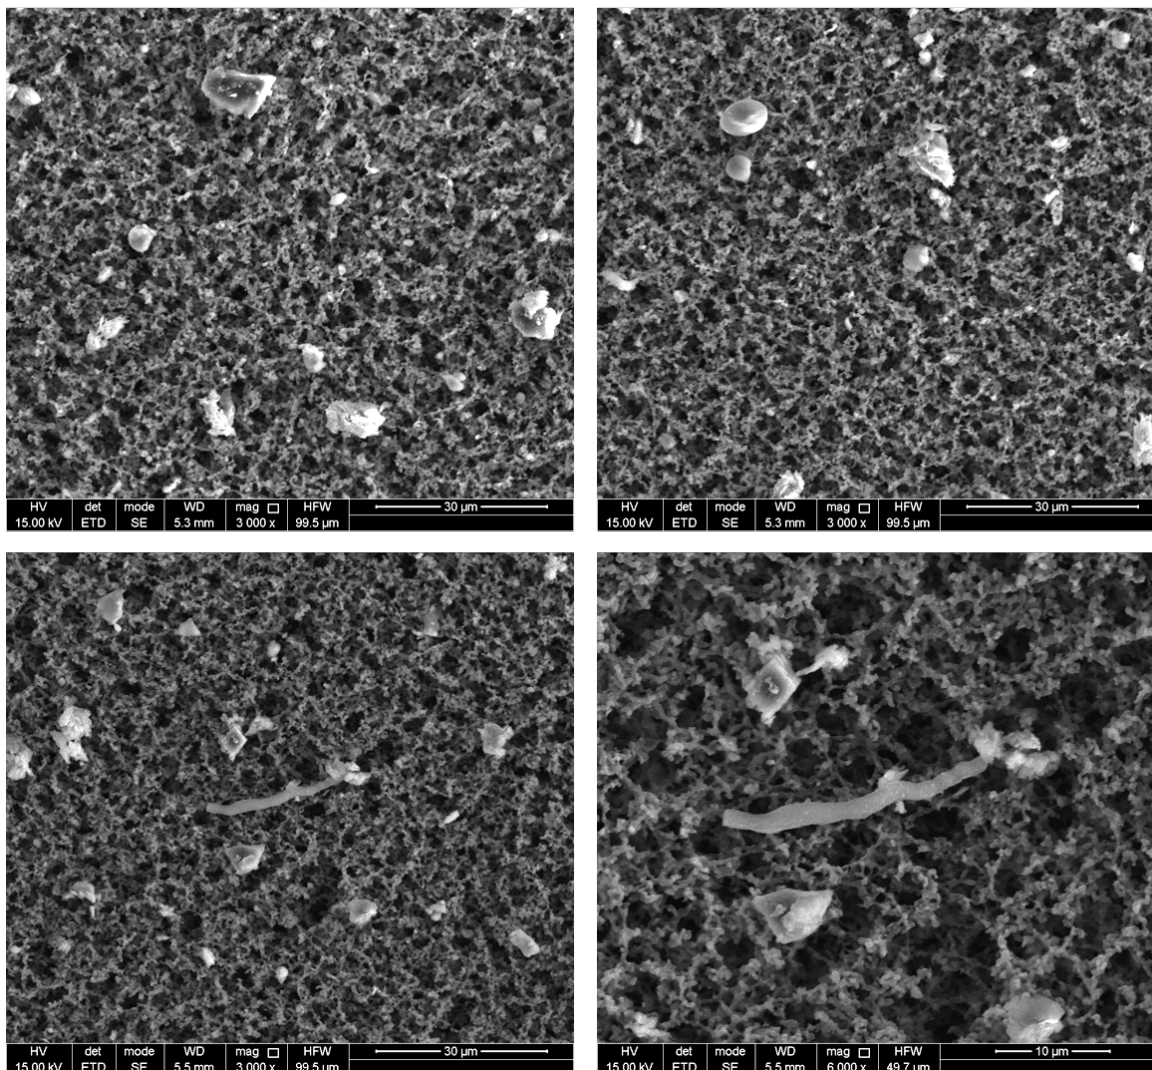
Figure 2. SEM-images with secondary electron detector of the sample “21-WB002 | 18.02.20200-1”. The images show the network of the pvc filter using different magnifications with several multiple particles on the surface. One single fibre structure was observed in this sample but it has no asbestos appearance. The chemical characterization confirms it is not an asbestos fibre (see Figure 2a).

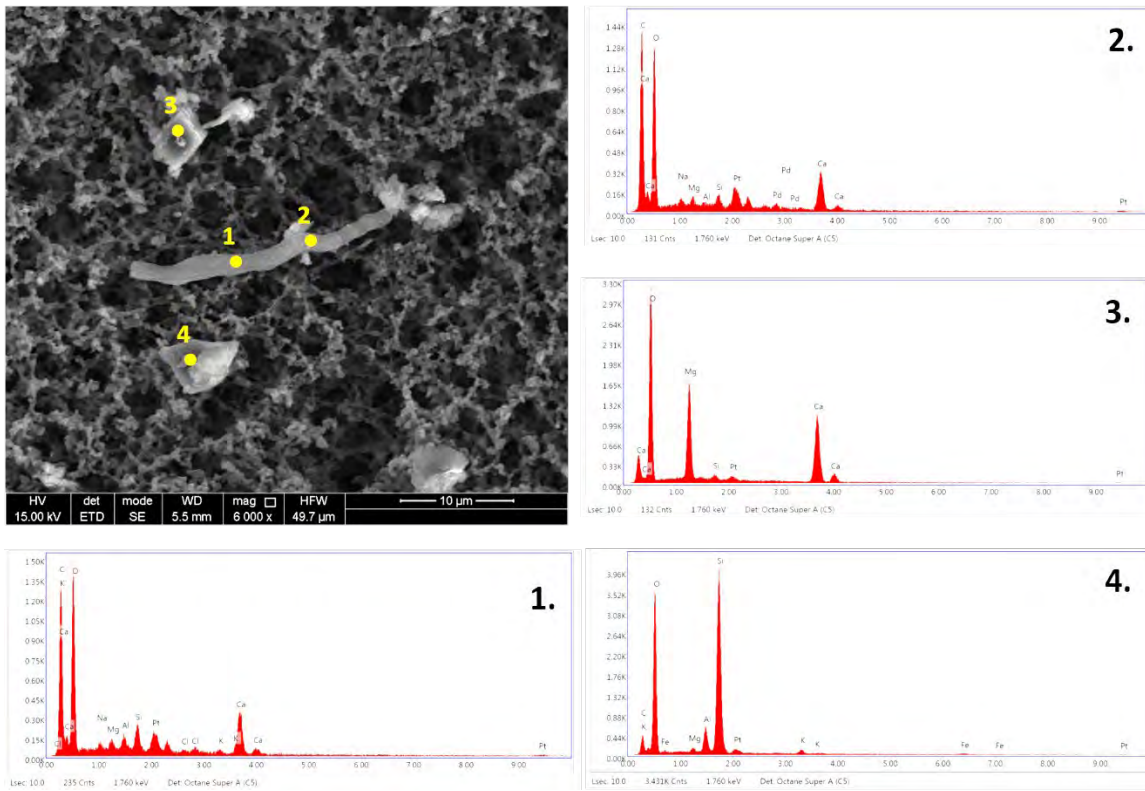
Figure 2a. EDX characterization of the particles identified in sample “21-WB002 | 18.02.2020-1”. The chemical composition of the fibre structure (spots “1” and “2”) consists of mainly carbon, oxygen and calcium.

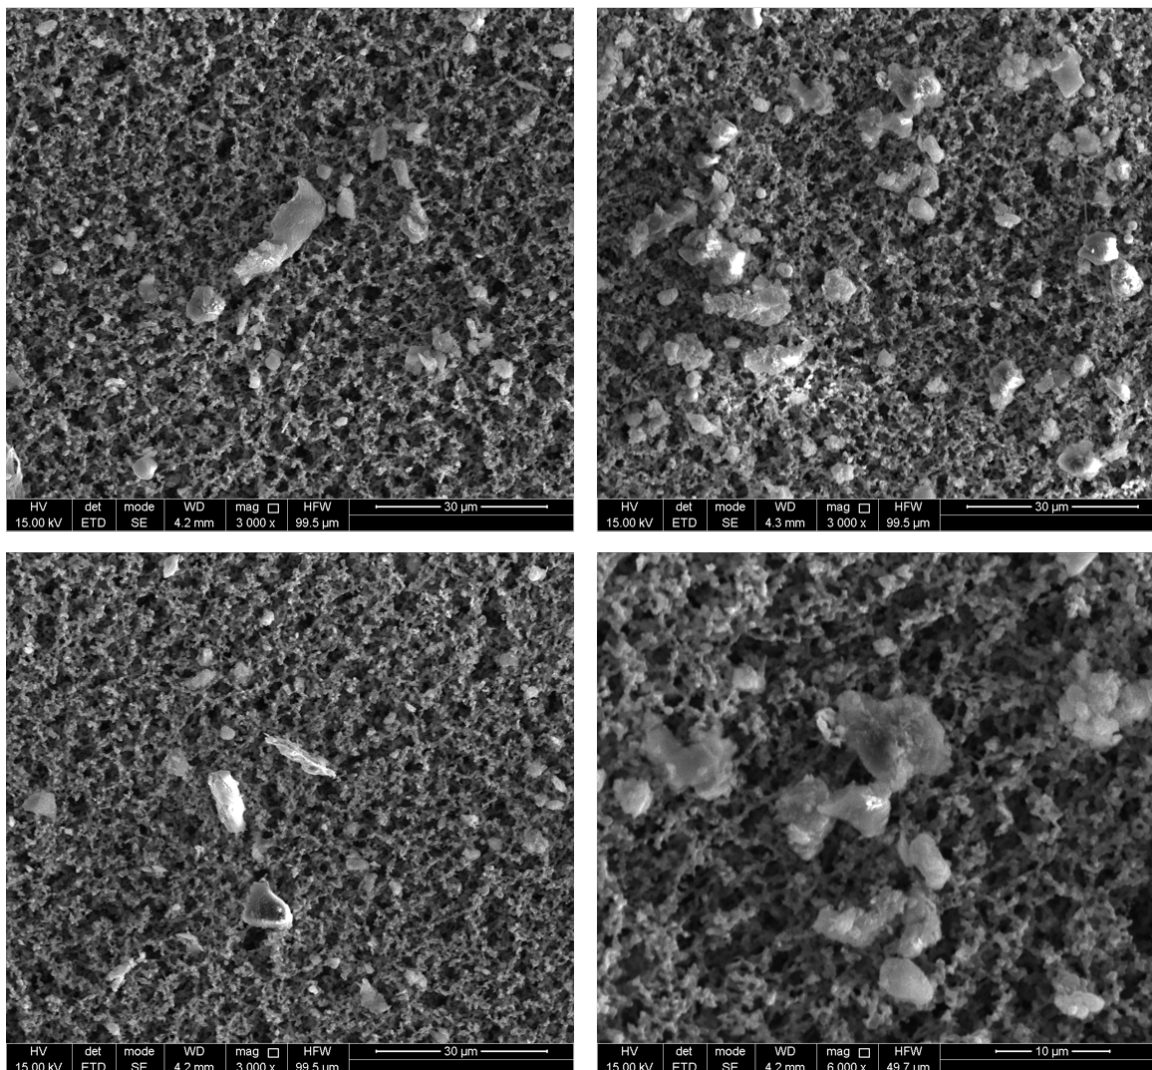
Figure 3. SEM-images with secondary electron detector of the sample “21-WB003 | 18.02.20200-2”. The images show the network of the pvc filter using different magnifications with several multiple particles on the surface. No fibre structures were observed. The chemical characterization of the particles is shown in Figure 3a.

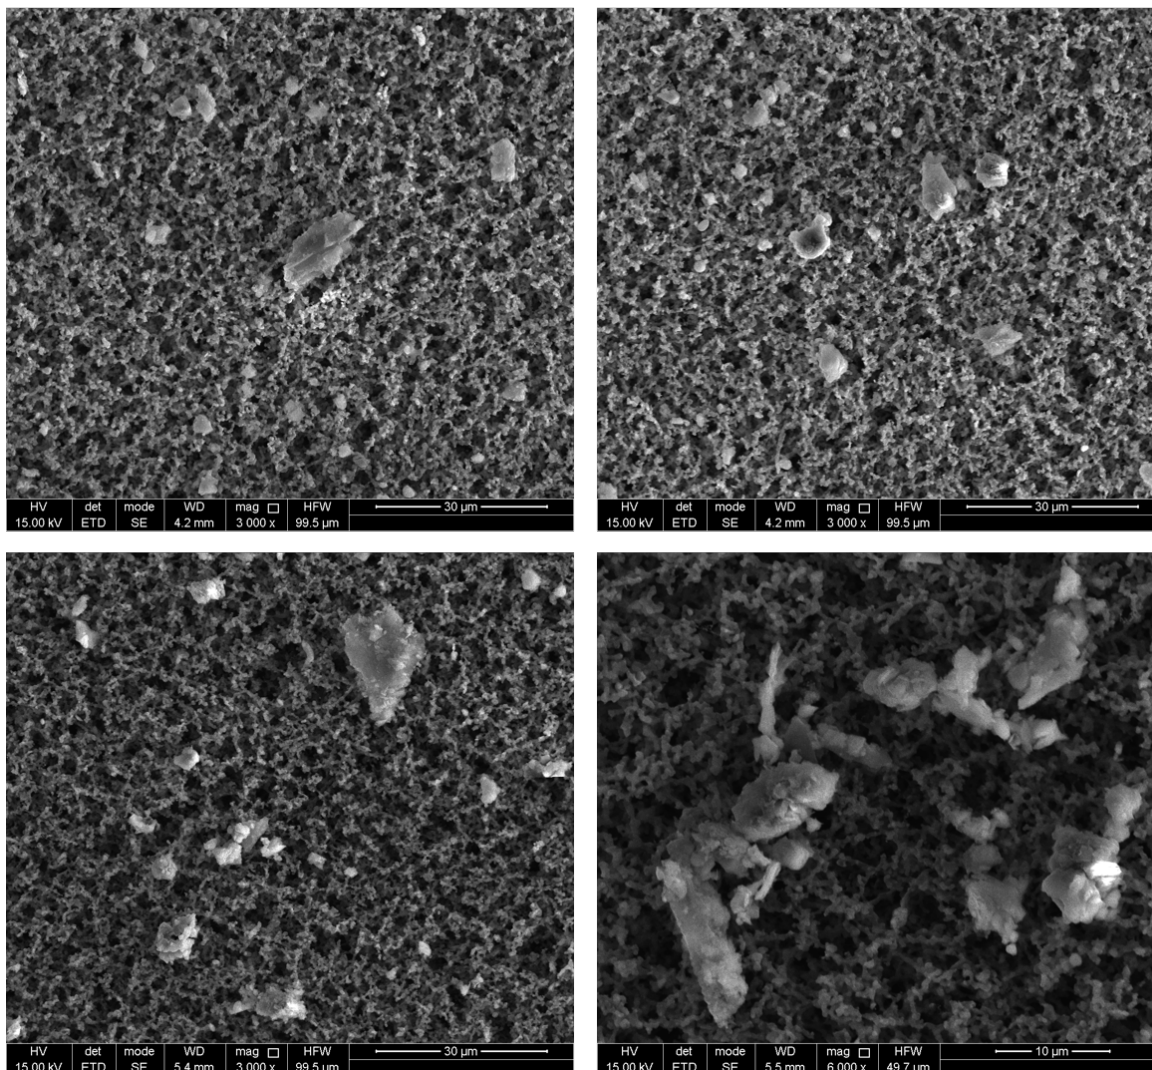
Figure 4. SEM-images with secondary electron detector of the sample “21-WB004 | 19.02.2020O-1”. The images show the network of the pvc filter using different magnifications with several multiple particles on the surface. No fibre structures were observed. The chemical characterization of the particles is shown in Figure 4a.

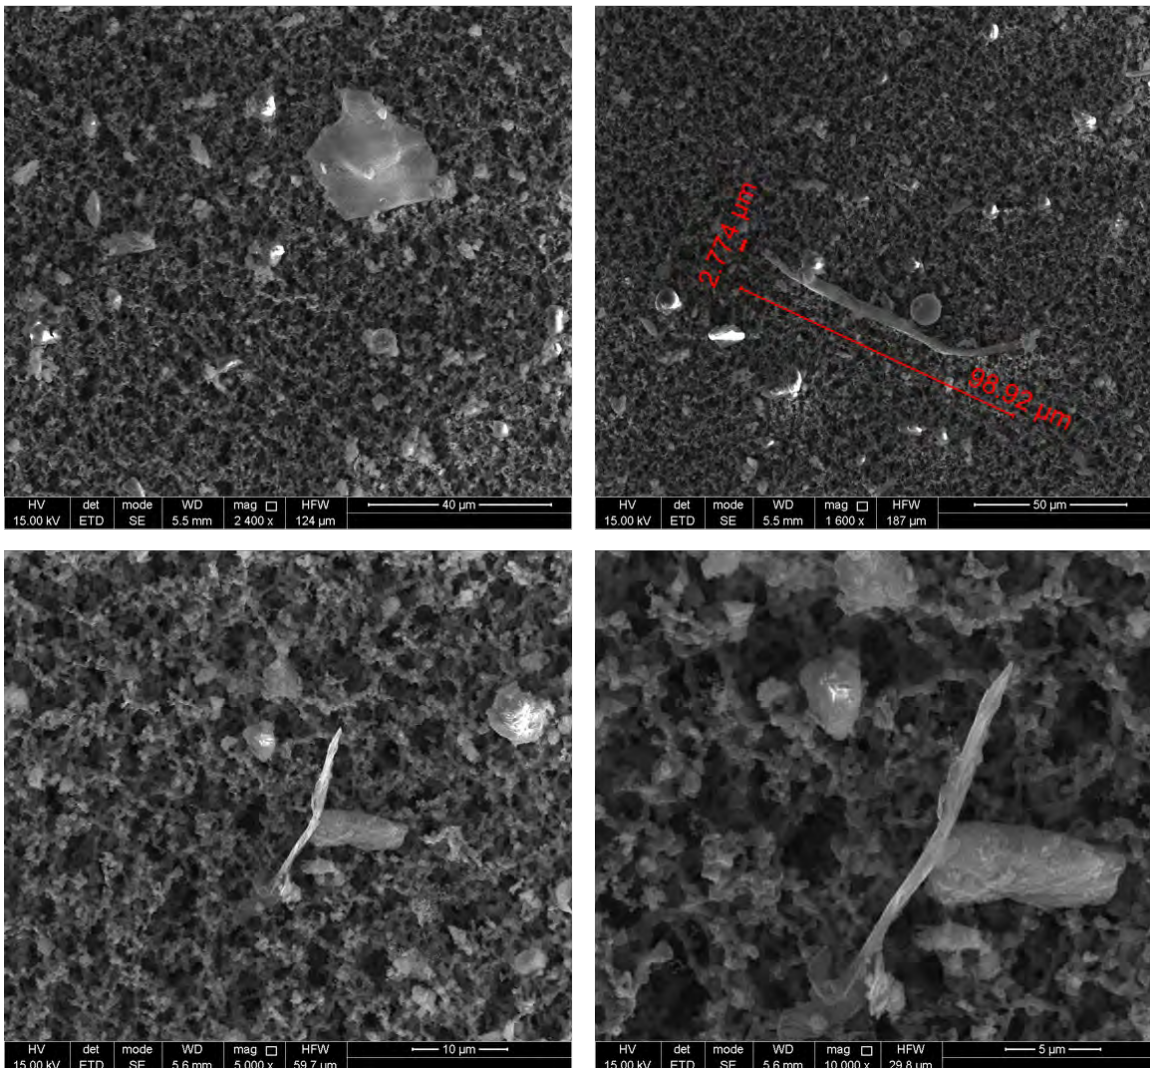
Figure 5. SEM-images with secondary electron detector of the sample “21-WB005 | 19.02.2020O-4”. The images show the network of the pvc filter using different magnifications with several multiple particles on the surface. Two single fibre structures were observed in this sample but the fibres have no asbestos appearance. The chemical characterization confirms that they are not asbestos fibres (see Figure 5a).

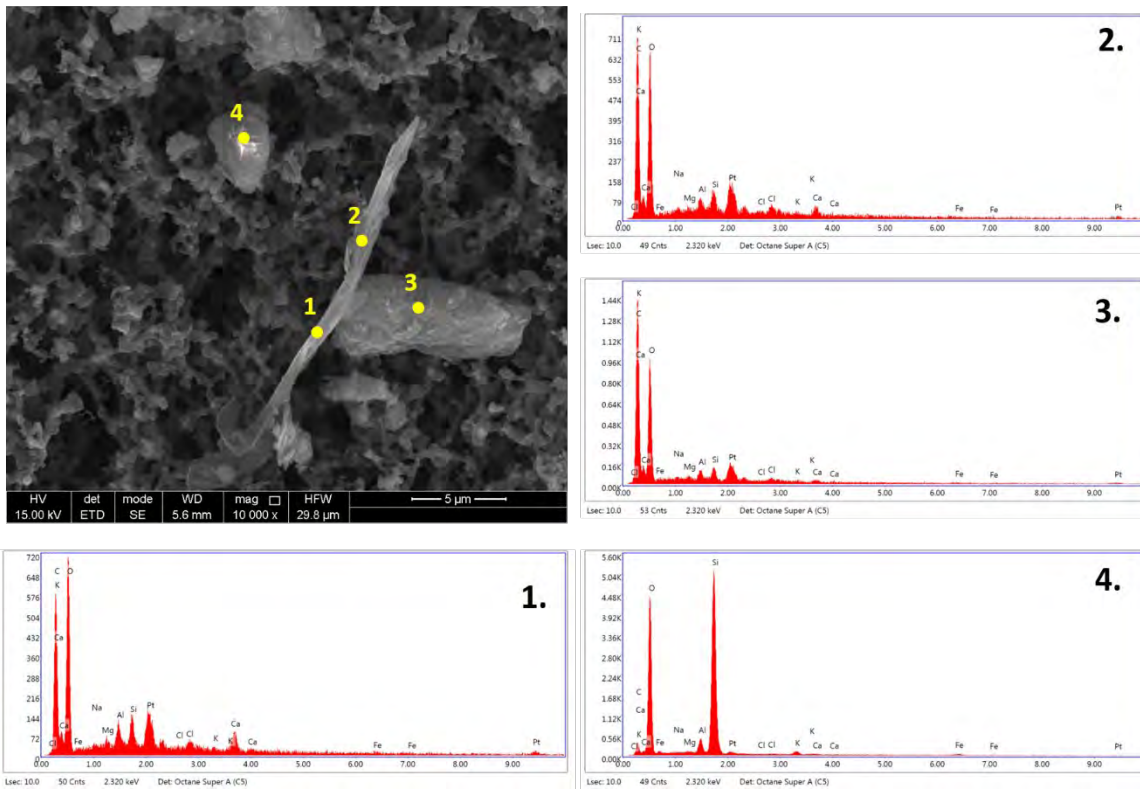
Figure 5a. EDX characterization of the particles identified in sample “21-WB005 | 19.02.20200-4”. The chemical composition of the fibre structure (spots “1” and “2”) consists of mainly carbon and oxygen.

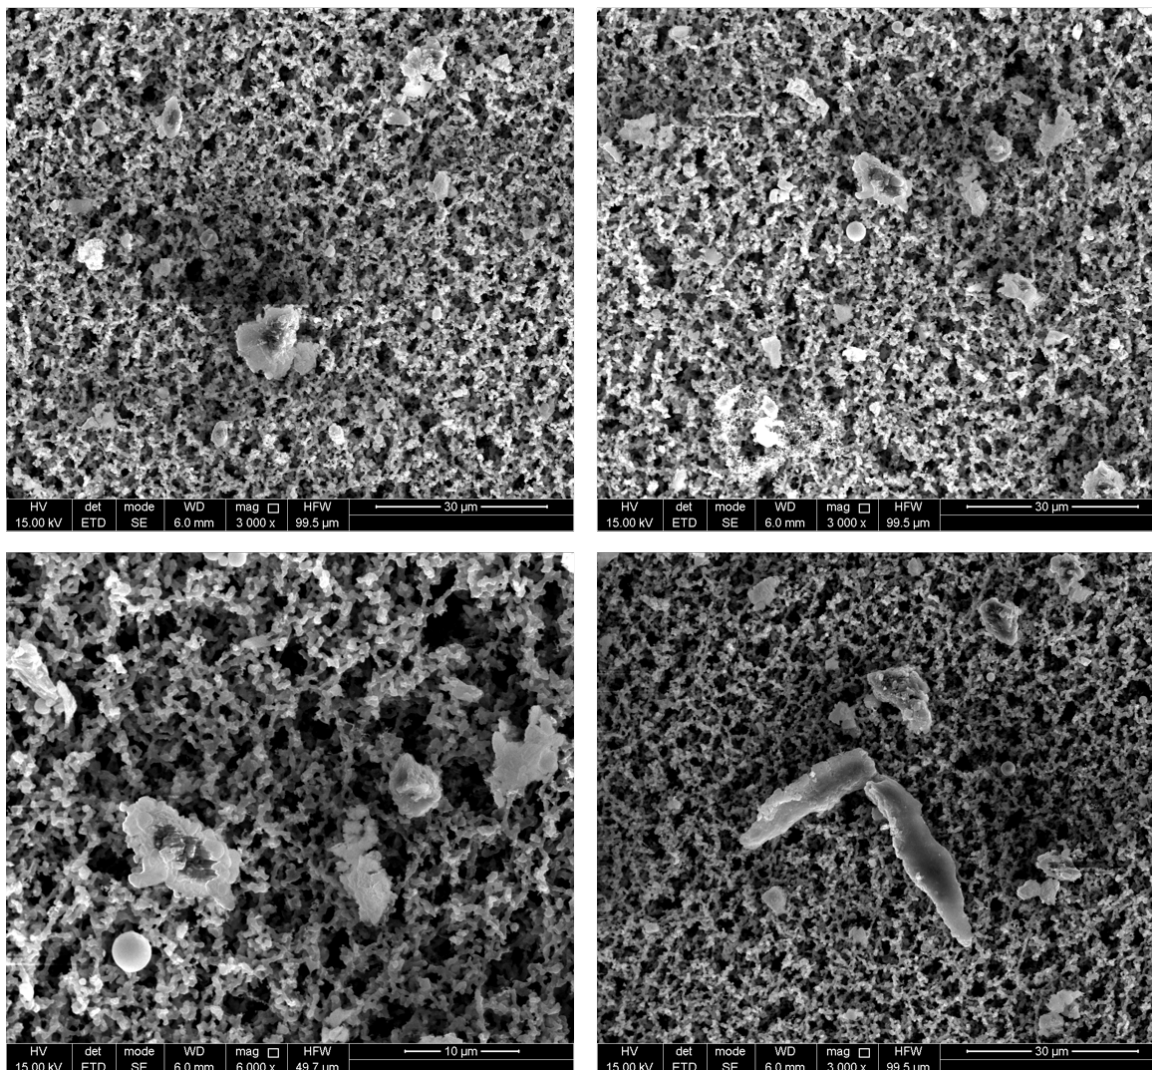
Figure 6. SEM-images with secondary electron detector of the sample “21-WB006 | 19.02.2020O-5”. The images show the network of the pvc filter using different magnifications with several multiple particles on the surface. The chemical characterization of the particles is shown in Figure 6a.

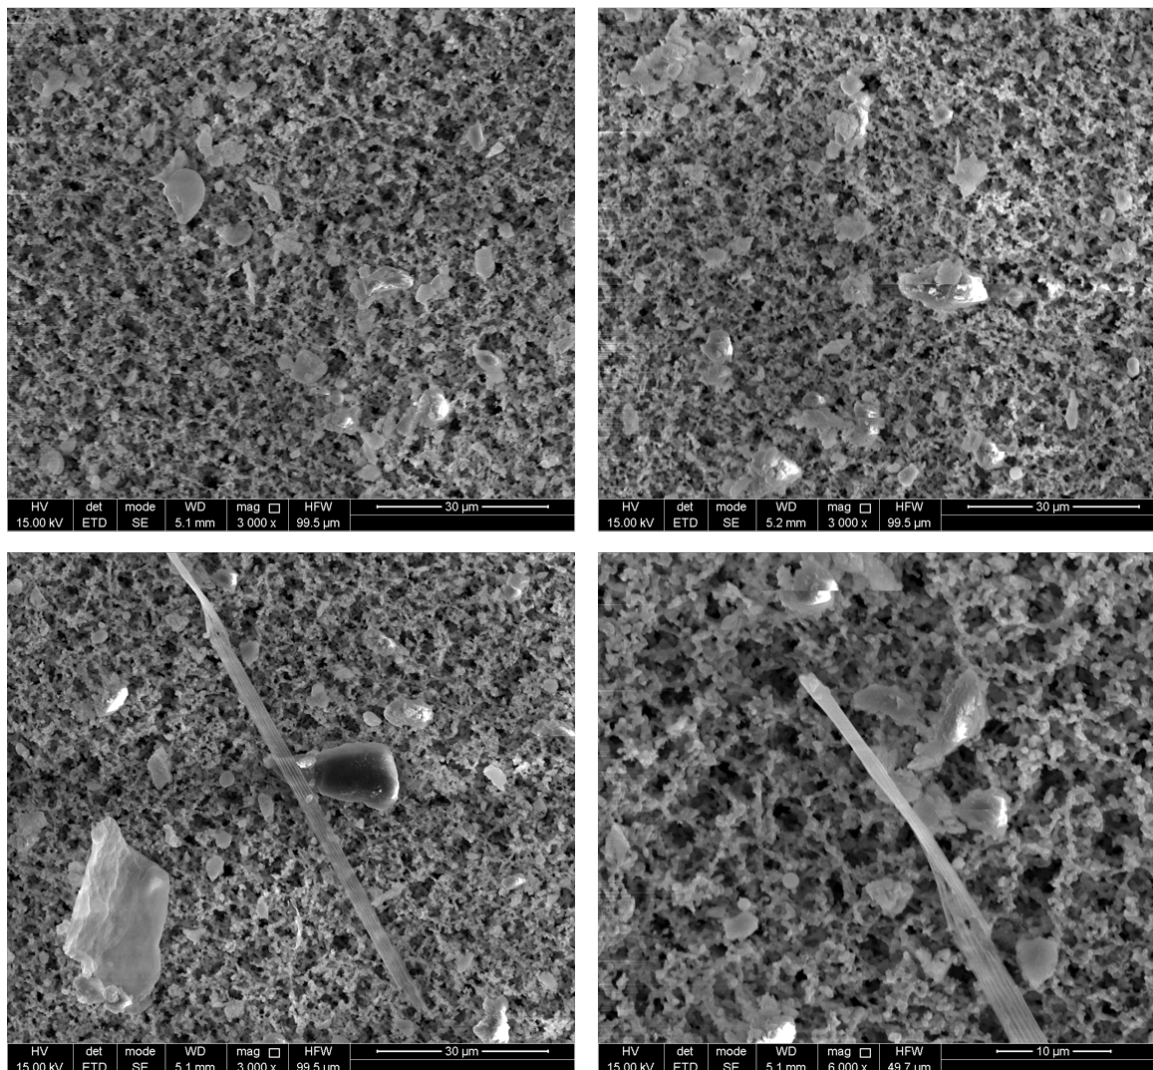
Figure 7. SEM-images with secondary electron detector of the sample “21-WB007 | 19.02.2020O-3”. The images show the network of the pvc filter using different magnifications with several multiple particles on the surface. Two single fibre structures were observed in this sample but the fibres have no asbestos appearance. The chemical characterization confirms that they are not asbestos fibres (see Figure 7a).

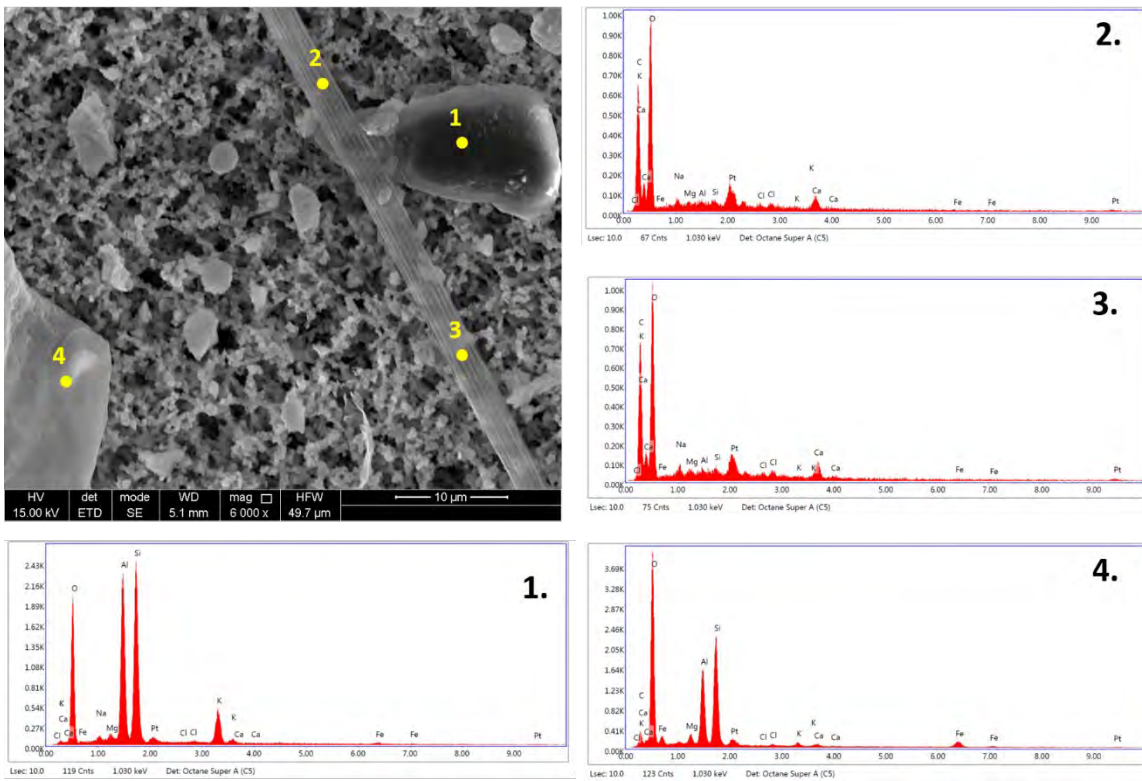
Figure 7a. EDX characterization of the particles identified in sample “21-WB007 | 19.02.20200-3”. The chemical composition of the fibre structure (spots “2” and “3”) consists of mainly carbon and oxygen.

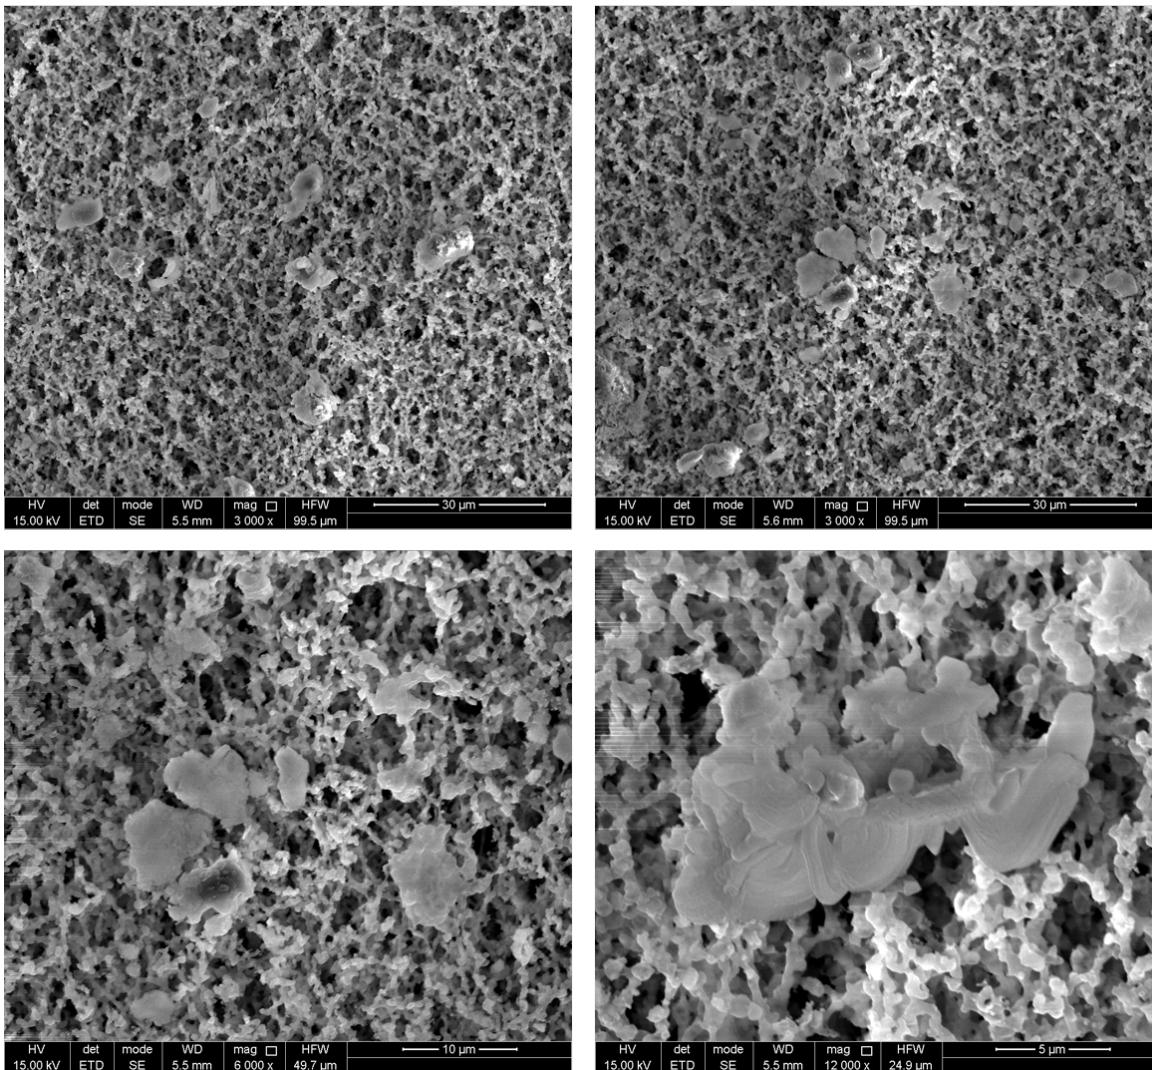
Figure 8. SEM-images with secondary electron detector of the sample “21-WB008 | 19.02.2020N-1”. The images show the network of the pvc filter using different magnifications with several multiple particles on the surface. The chemical characterization of the particles is shown in Figure 8a.

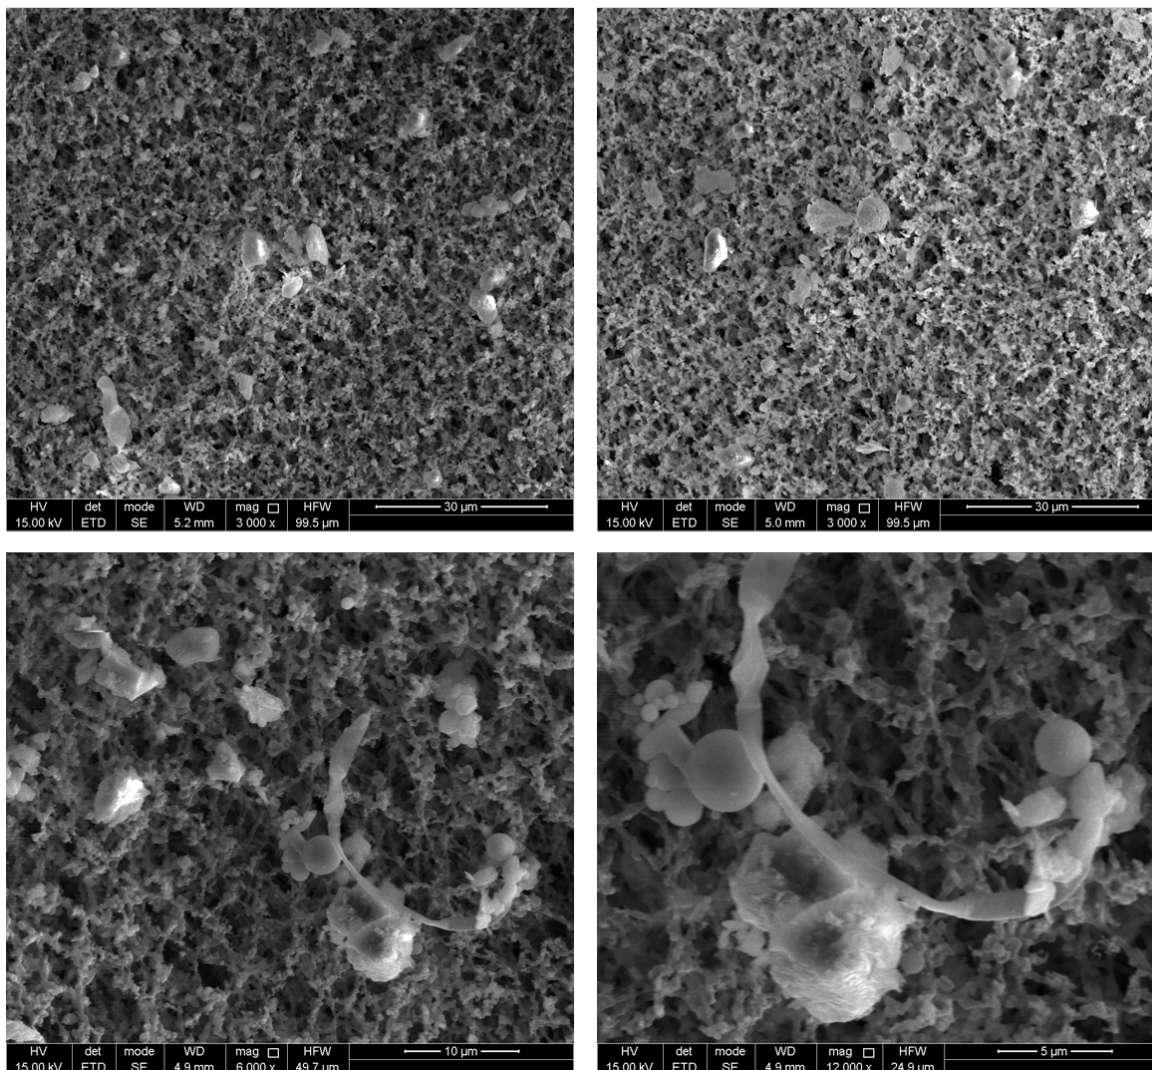
Figure 9. SEM-images with secondary electron detector of the sample “21-WB009 | 19.02.2020N-2”. The images show the network of the pvc filter using different magnifications with several multiple particles on the surface. One single fibre structure was observed in this sample but the fibre has no asbestos appearance. The chemical characterization confirms that it is not an asbestos fibre (see Figure 9a).

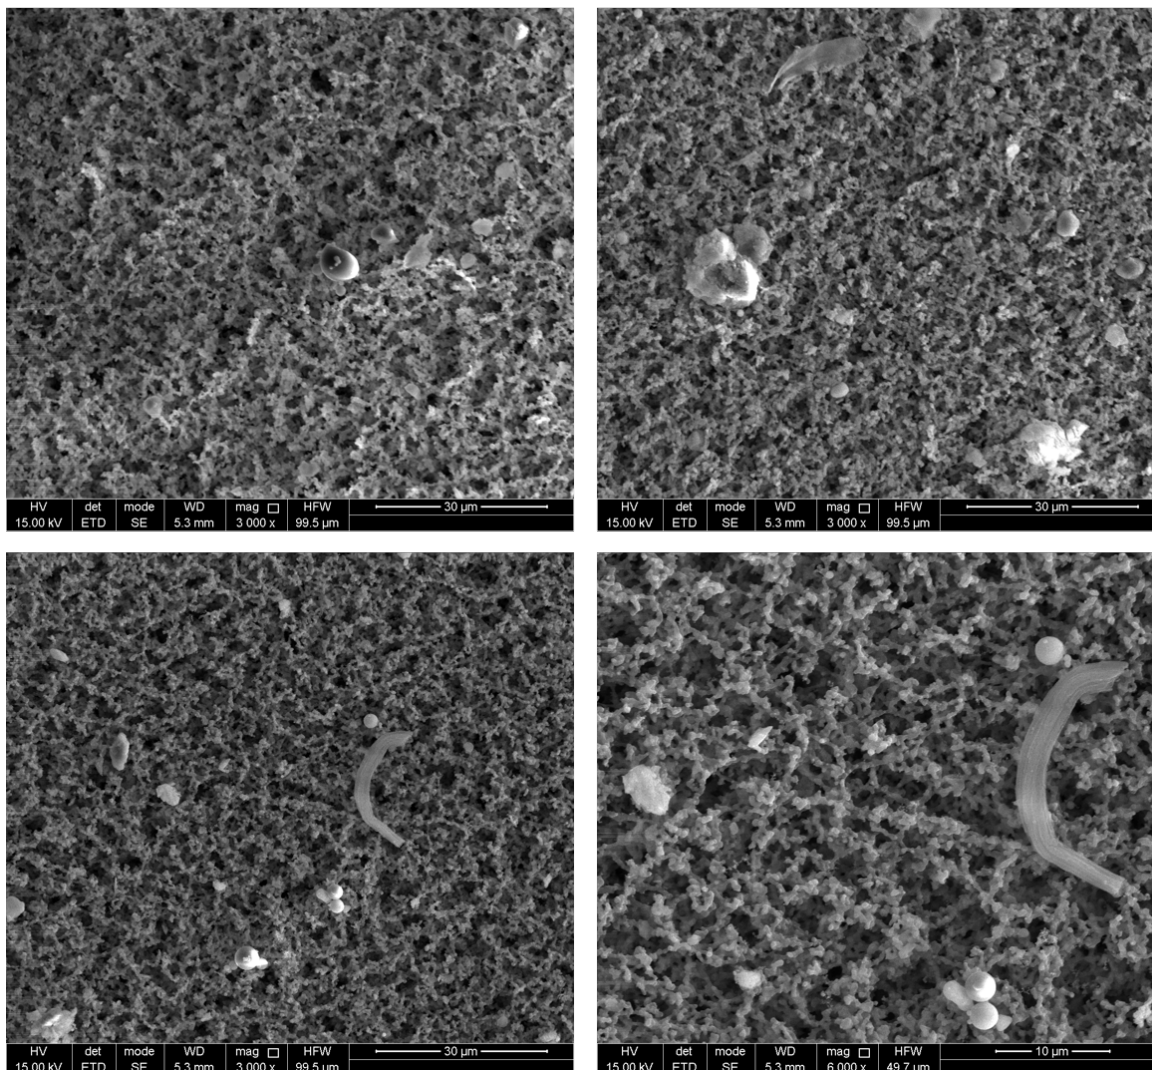
Figure 10. SEM-images with secondary electron detector of the sample “21-WB010 | 20.02.20200-1”. The images show the network of the pvc filter using different magnifications with several multiple particles on the surface. One single fibre structure was observed in this sample but the fibre has no asbestos appearance. The chemical characterization confirms that it is not an asbestos fibre (see Figure 10a).

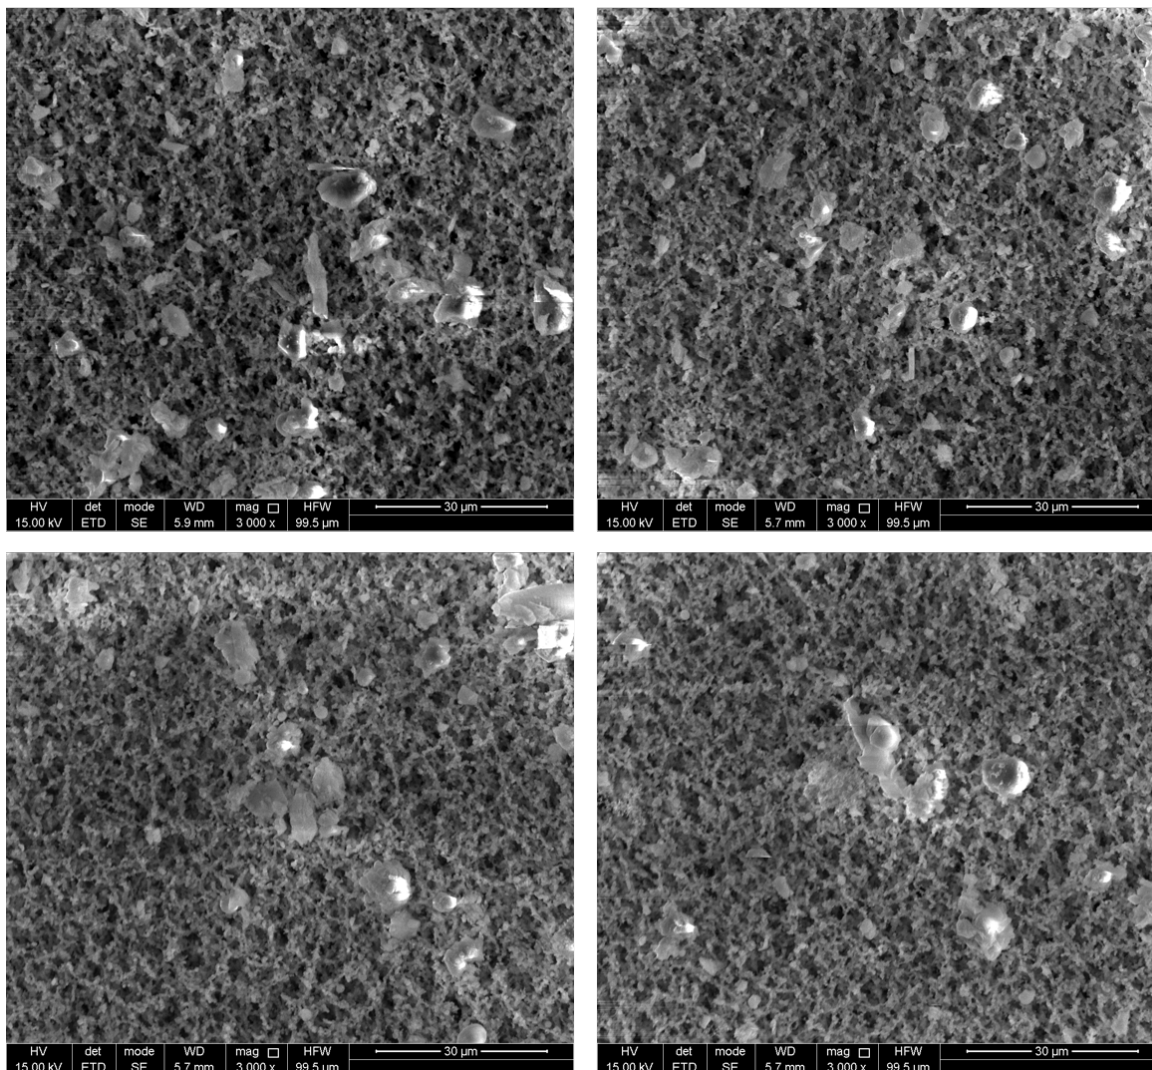
Figure 11. SEM-images with secondary electron detector of the sample “21-WB011 | 20.02.2020O-2”. The images show the network of the pvc filter using different magnifications with several multiple particles on the surface. The chemical characterization of the particles is shown in Figure 11a.

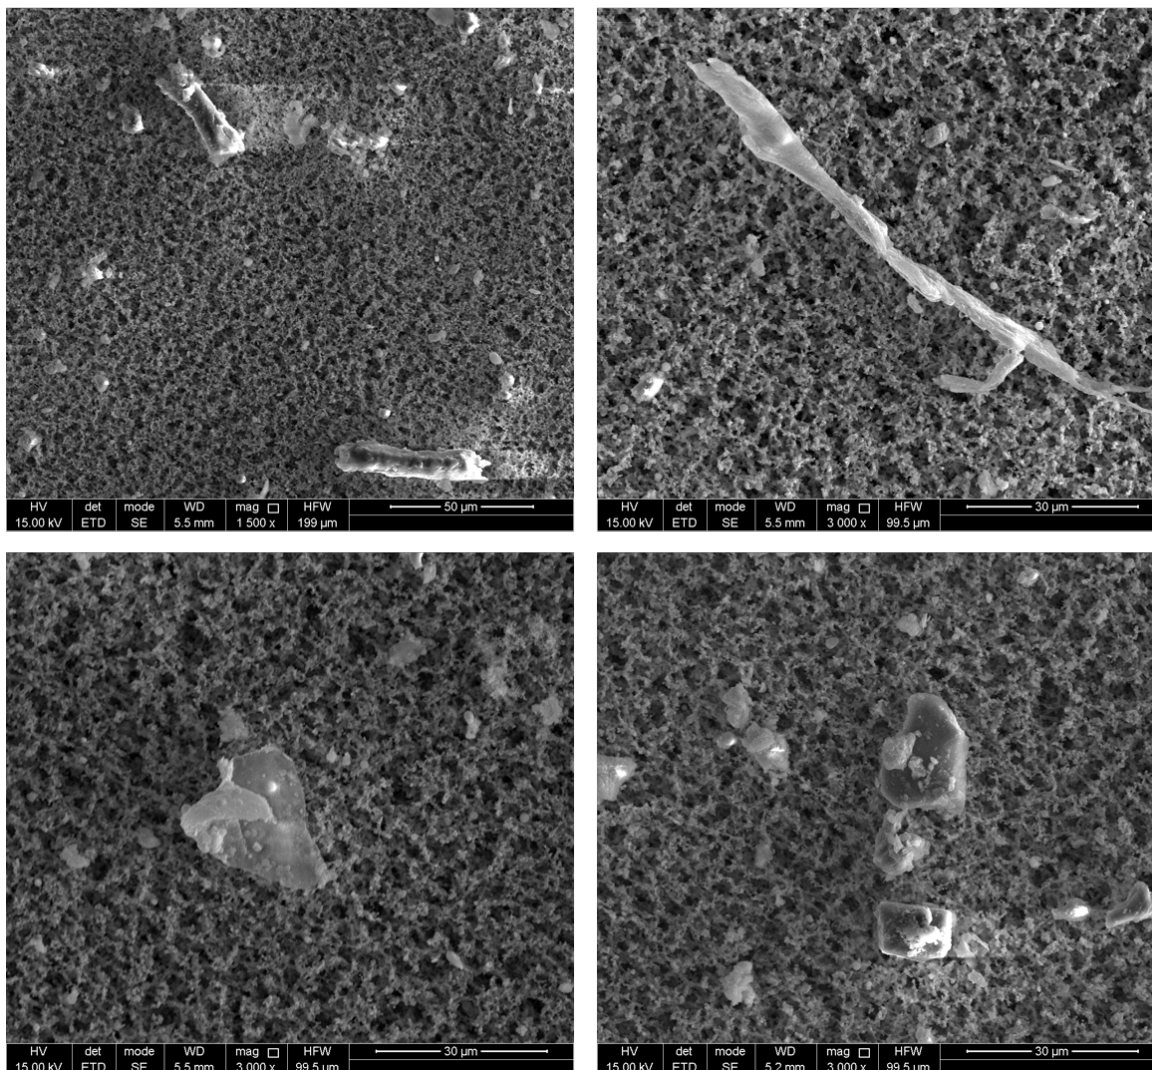
Figure 12. SEM-images with secondary electron detector of the sample “21-WB012 | 20.02.20200-3”. The images show the network of the pvc filter using different magnifications with several multiple particles on the surface. One single fibre structure was observed in this sample but the fibre has no asbestos appearance. The chemical characterization confirms that it is not an asbestos fibre (see Figure 12a).

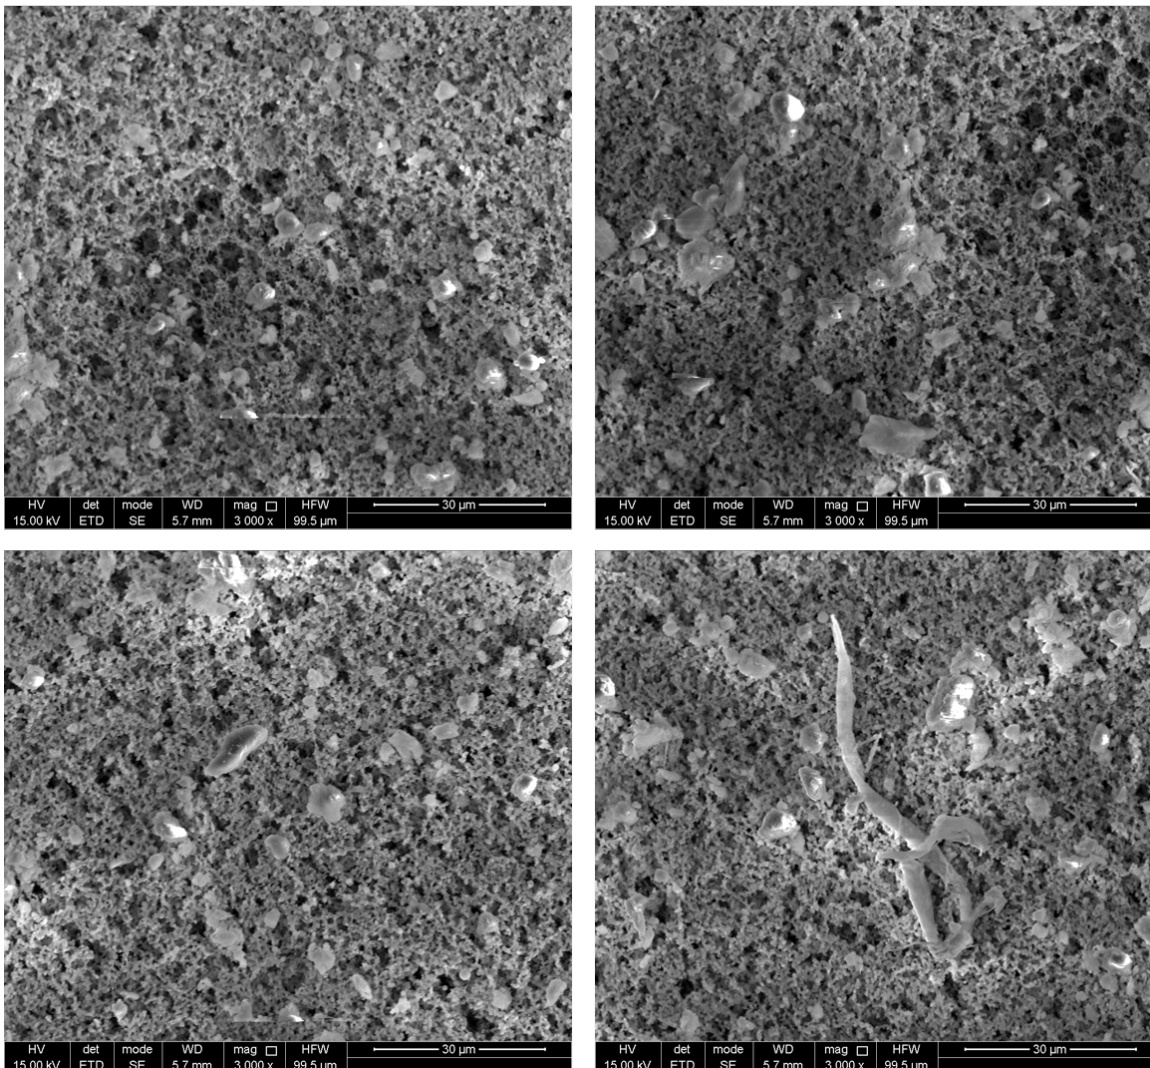
Figure 13. SEM-images with secondary electron detector of the sample “21-WB013 | 20.02.2020O-4”. The images show the network of the pvc filter using different magnifications with several multiple particles on the surface. One single fibre structure was observed in this sample but the fibre has no asbestos appearance. The chemical characterization of the particles is shown in Figure 13a.

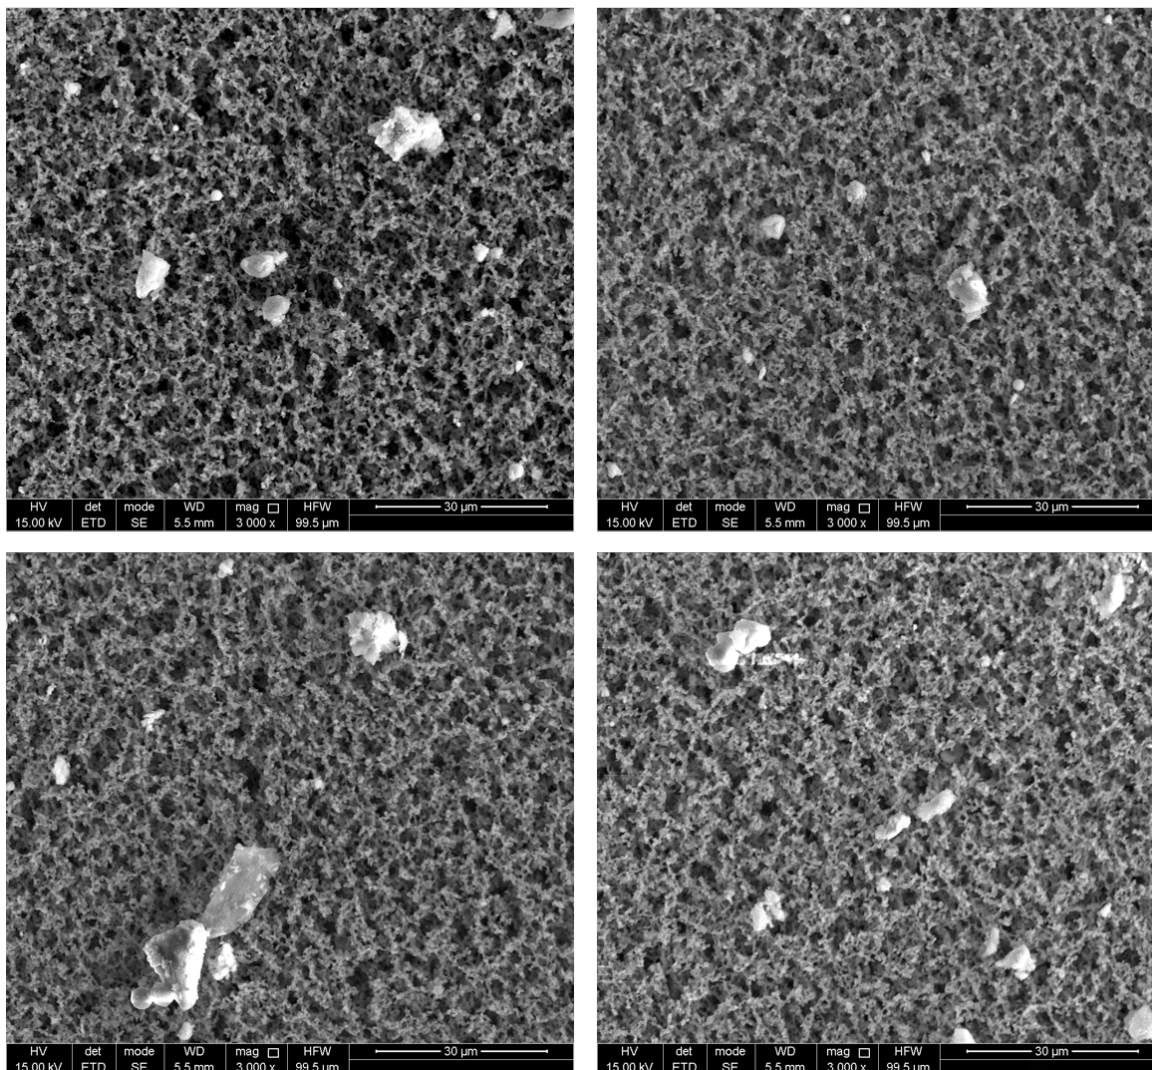
Figure 14. SEM-images with secondary electron detector of the sample “21-WB014 | 20.02.2020O-5”. The images show the network of the pvc filter using different magnifications with several multiple particles on the surface. The chemical characterization of the particles is shown in Figure 14a.

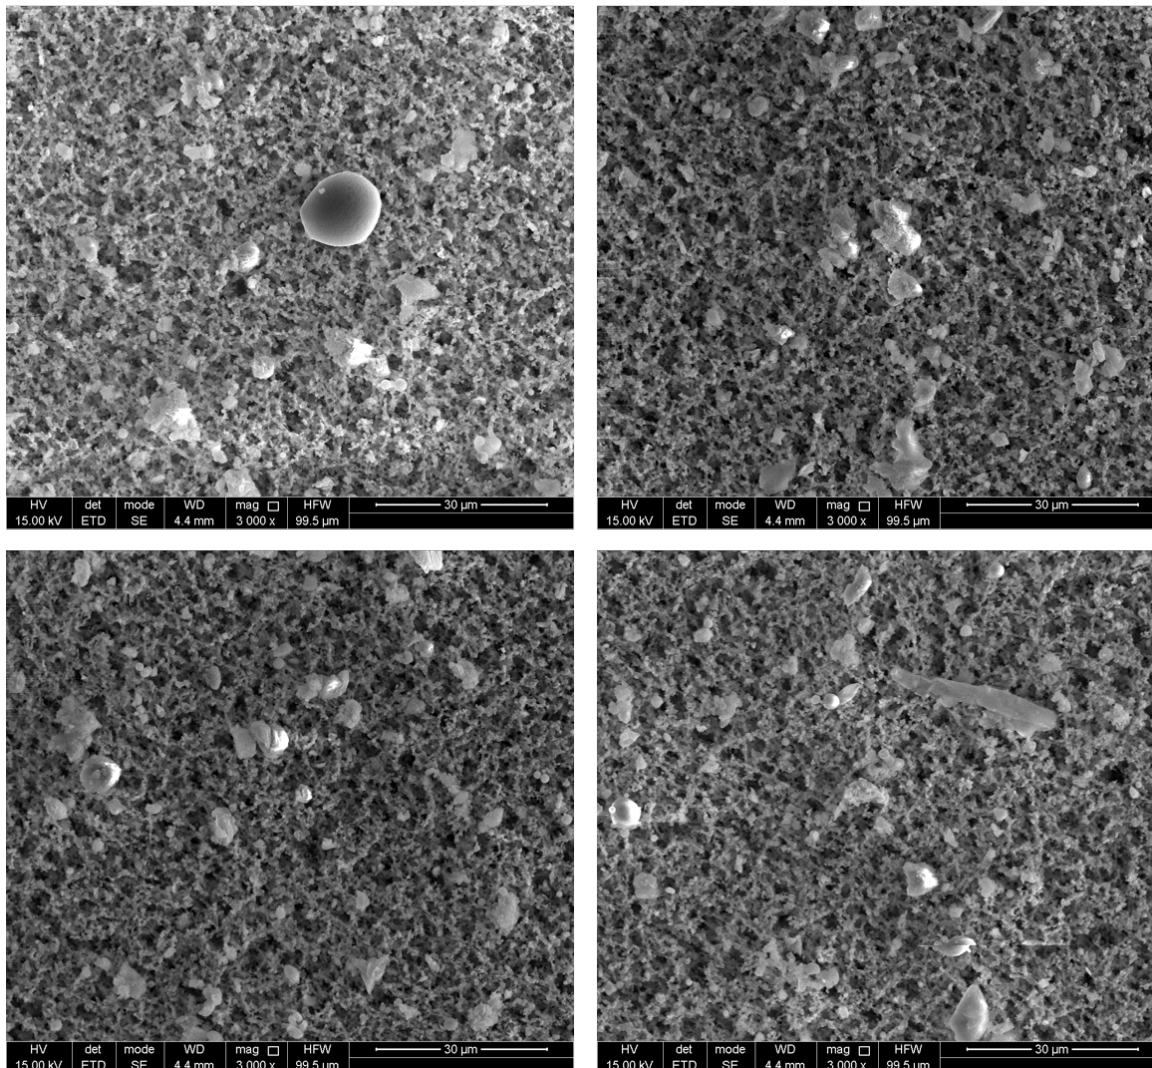
Figure 15. SEM-images with secondary electron detector of the sample “21-WB015 | 20.02.2020N-1”. The images show the network of the pvc filter using different magnifications with several multiple particles on the surface. The chemical characterization of the particles is shown in Figure 15a.
