Environment Monitoring For an Asbestos Plant in Kymore

Capacity Building and Training

Environics Trust
28-Dec-21

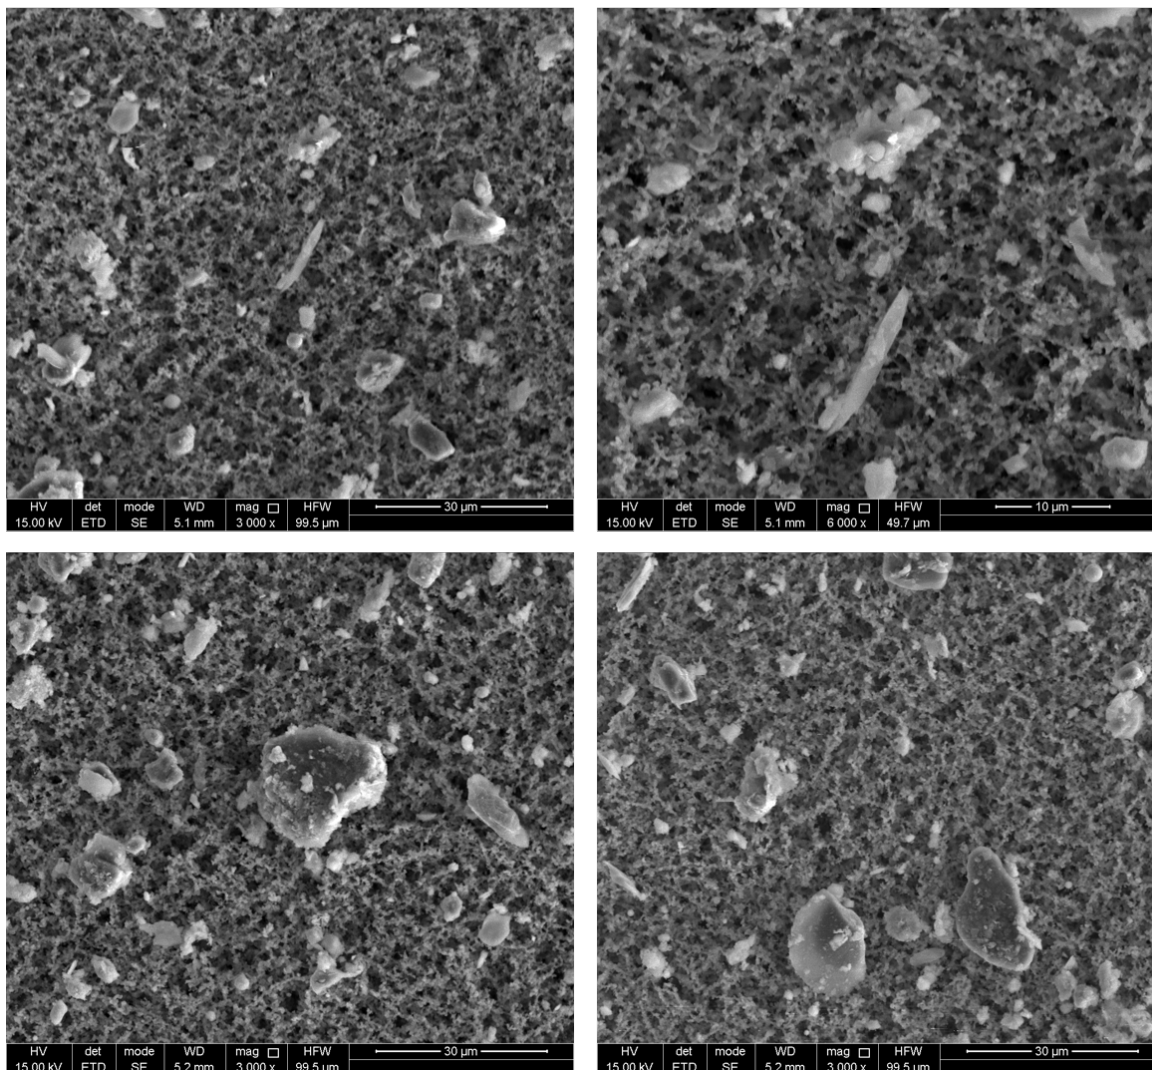
Figure 16. SEM-images with secondary electron detector of the sample “21-WB016 | 20.02.2020N-2”. The images show the network of the pvc filter using different magnifications with several multiple particles on the surface. The chemical characterization of the particles is shown in Figure 16a.

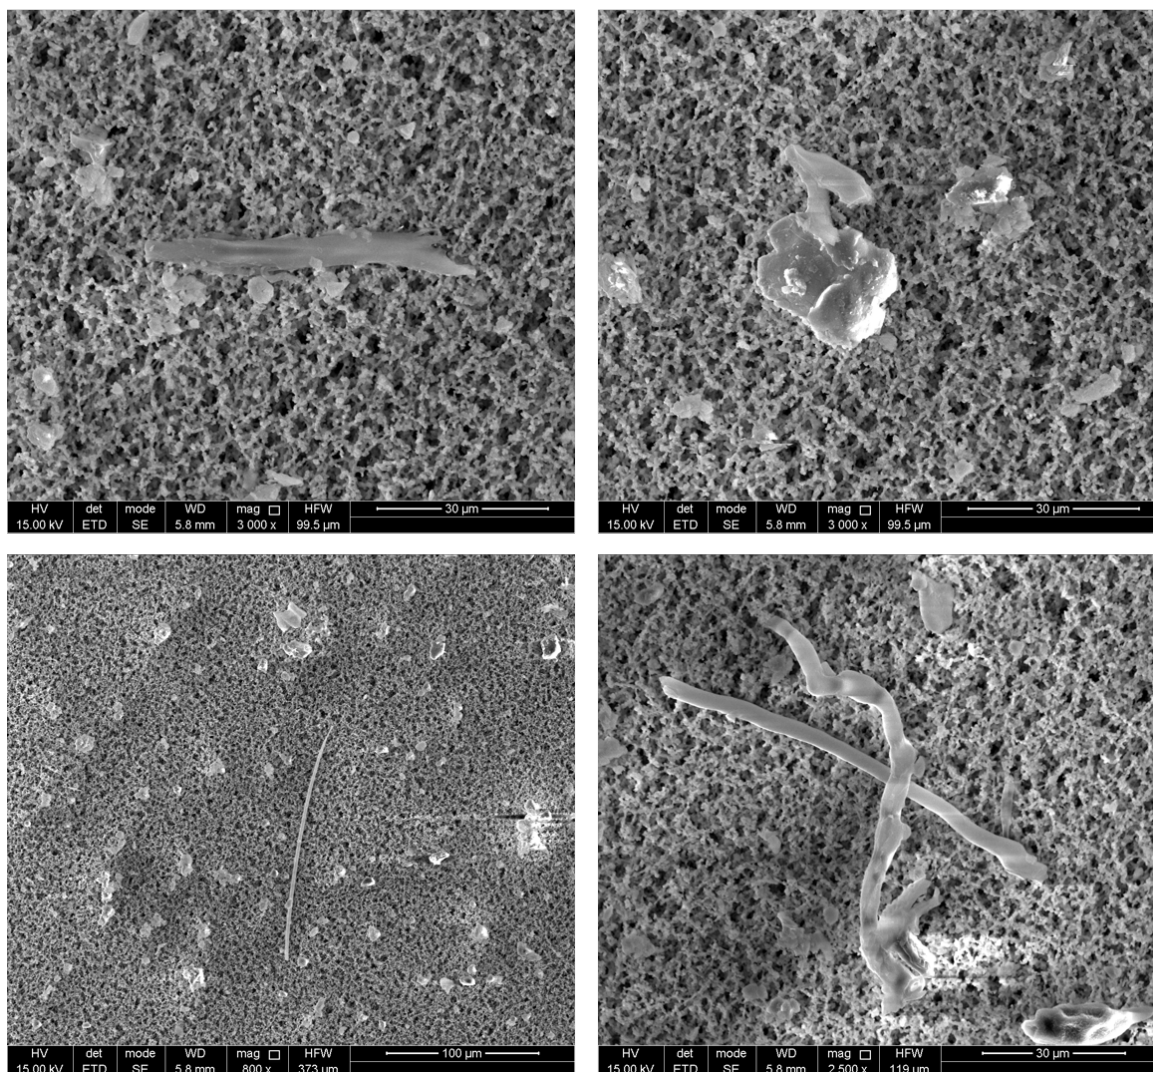
Figure 17. SEM-images with secondary electron detector of the sample “21-WB017 | 21.02.2020O-1”. The images show the network of the pvc filter using different magnifications with several multiple particles on the surface. Four single fibre structures were observed in this sample but the fibres have no asbestos appearance. The chemical characterization of the particles is shown in Figure 17a.

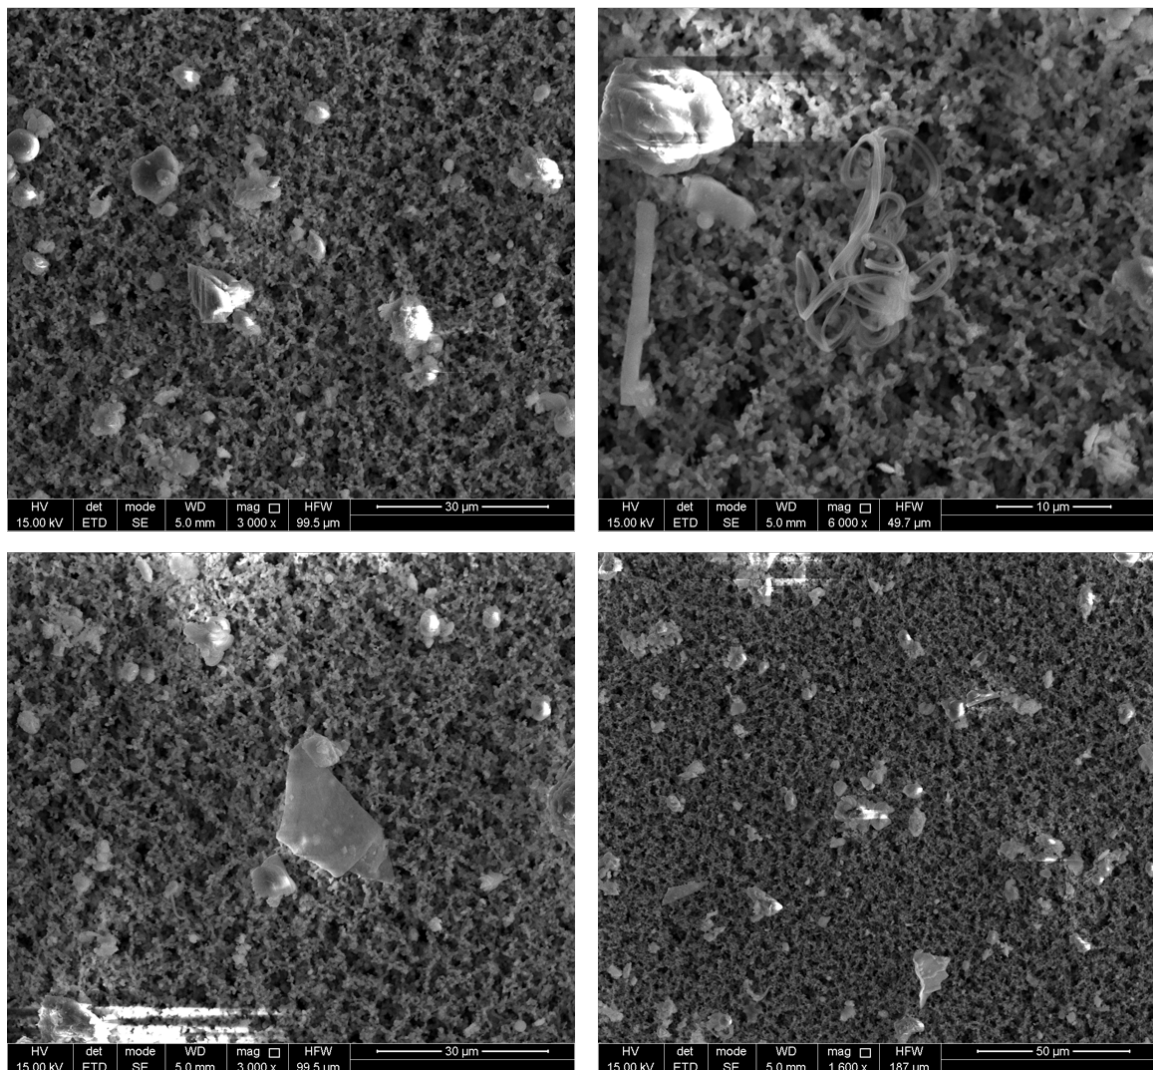
Figure 18. SEM-images with secondary electron detector of the sample “21-WB018 | 21.02.2020O-2”. The images show the network of the pvc filter using different magnifications with several multiple particles on the surface. One single fibre structure was observed in this sample but the fibre has no asbestos appearance. The chemical characterization of the particles is shown in Figure 18a.

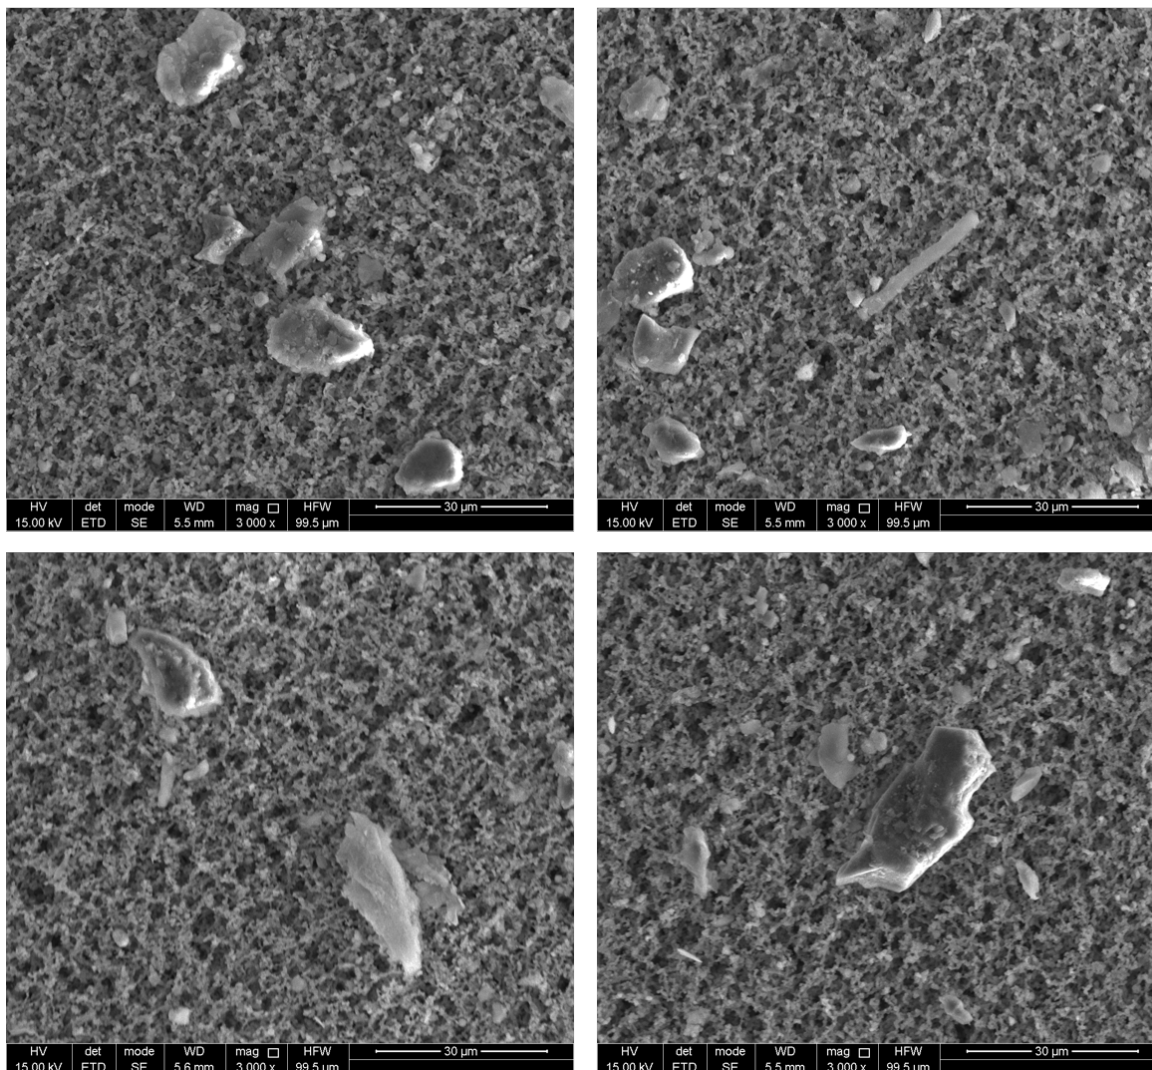
Figure 19. SEM-images with secondary electron detector of the sample “21-WB019 | 21.02.20200-3”. The images show the network of the pvc filter using different magnifications with several multiple particles on the surface. One single fibre structure was observed in this sample but the fibre has no asbestos appearance. The chemical characterization of the particles is shown in Figure 19a.

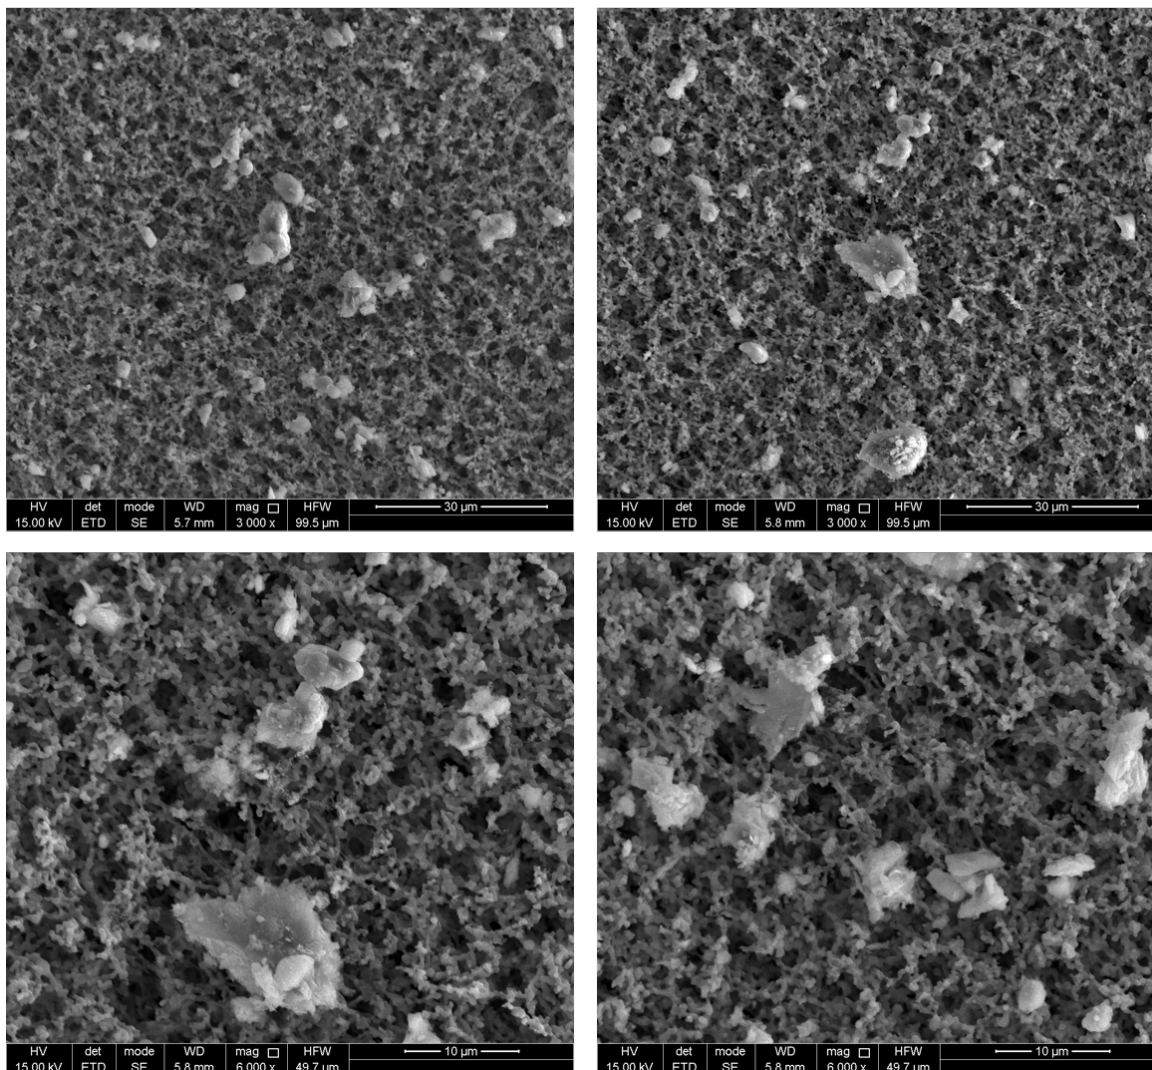
Figure 20. SEM-images with secondary electron detector of the sample “21-WB020 | 21.02.2020O-4”. The images show the network of the pvc filter using different magnifications with several multiple particles on the surface. The chemical characterization of the particles is shown in Figure 20a.

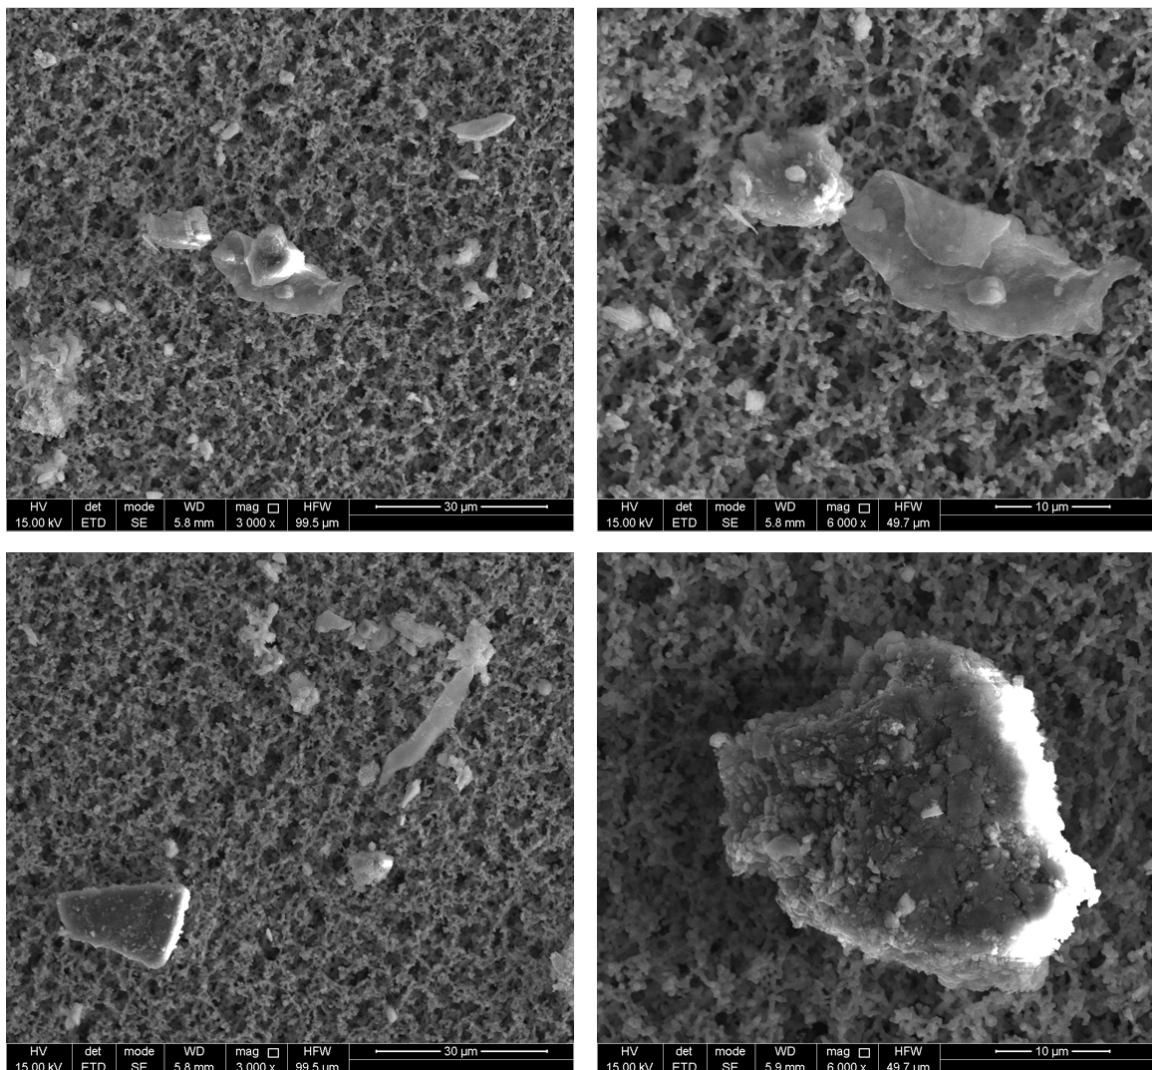
Figure 21. SEM-images with secondary electron detector of the sample “21-WB021 | 21.02.2020O-5”. The images show the network of the pvc filter using different magnifications with several multiple particles on the surface. One single fibre structure was observed in this sample but the fibre has no asbestos appearance. The chemical characterization of the particles is shown in Figure 21a.

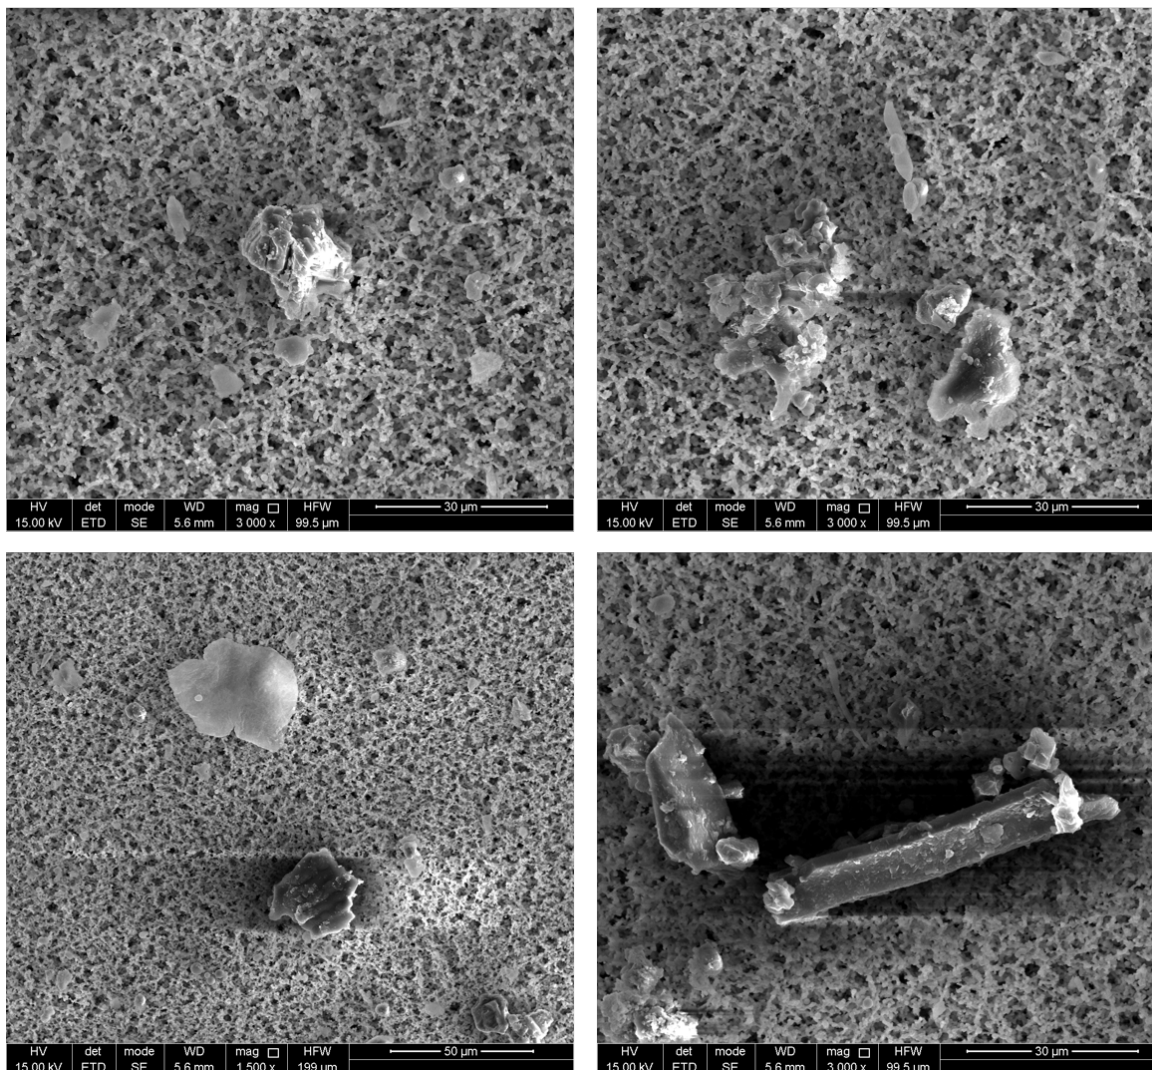
Figure 22. SEM-images with secondary electron detector of the sample “21-WB022 | 21.02.2020N-1”. The images show the network of the pvc filter using different magnifications with several multiple particles on the surface. One single fibre structure was observed in this sample but the fibre has no asbestos appearance. The chemical characterization of the particles is shown in Figure 22a.

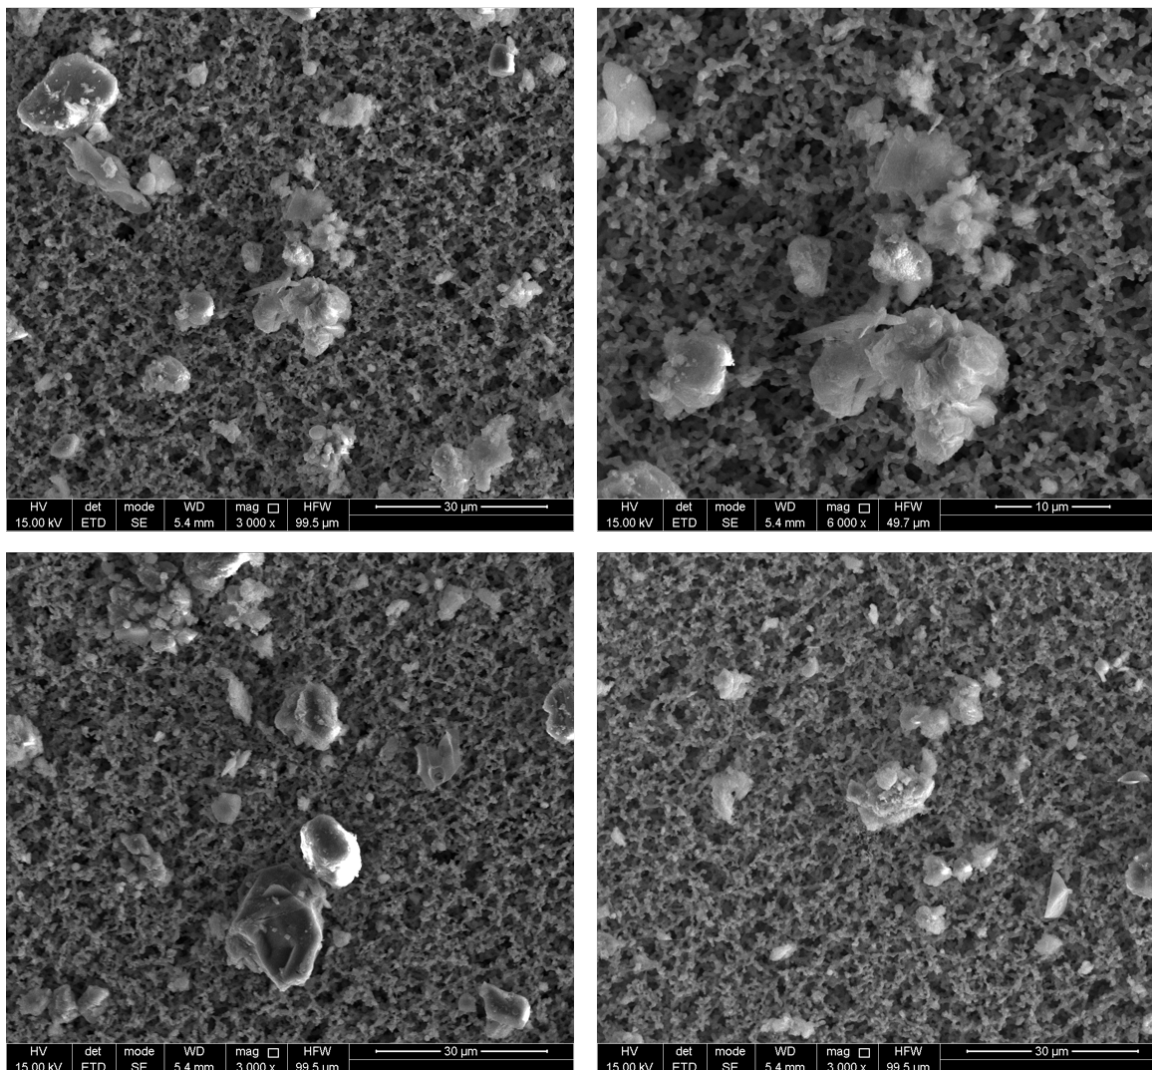
Figure 23. SEM-images with secondary electron detector of the sample “21-WB023 | 21.02.2020N-2”. The images show the network of the pvc filter using different magnifications with several multiple particles on the surface. The chemical characterization of the particles is shown in Figure 23a.

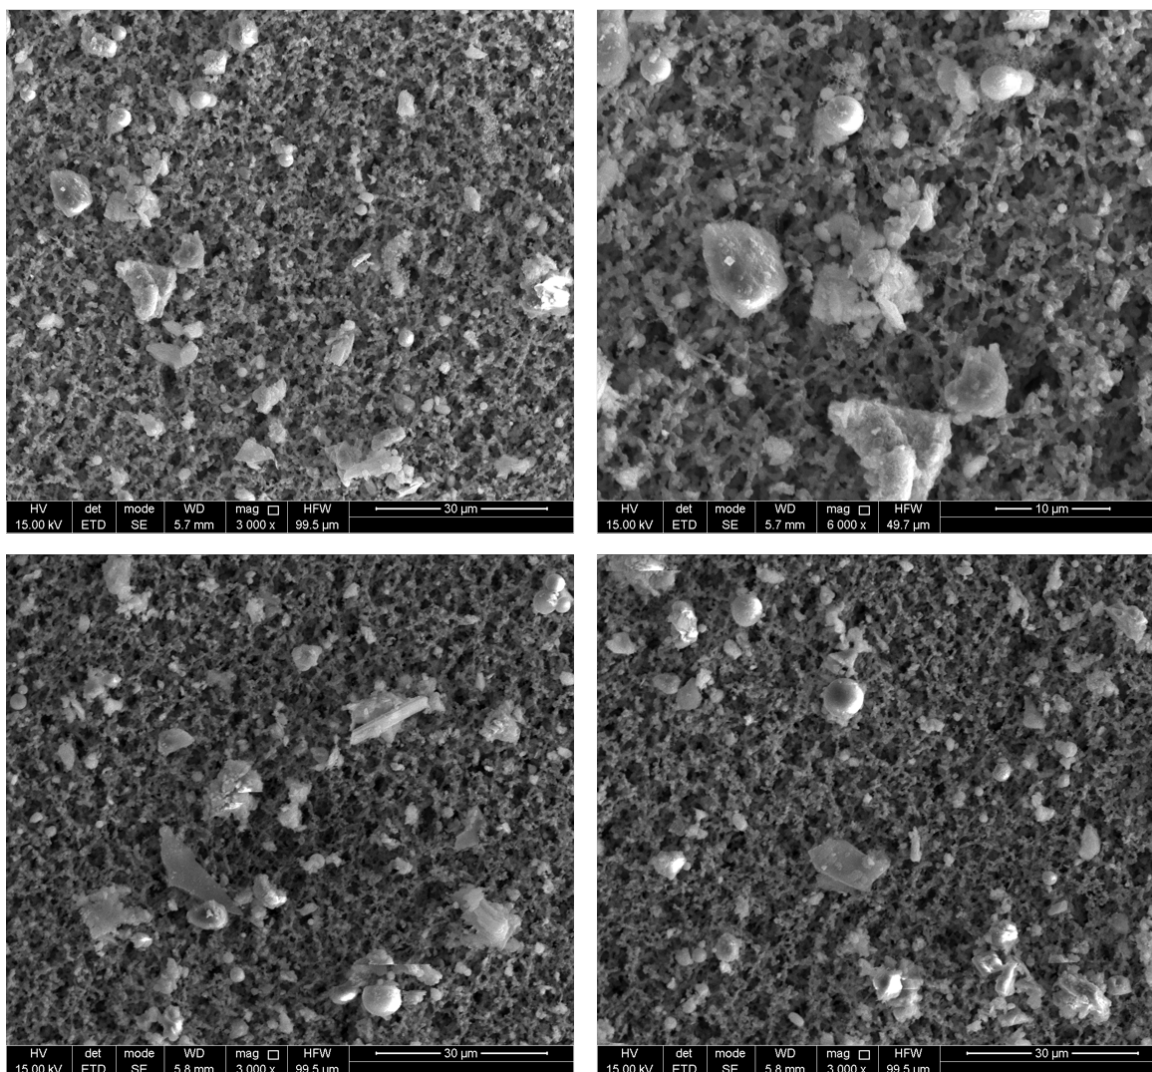
Figure 24. SEM-images with secondary electron detector of the sample “18-02-2020 Portable Day Sampling (N-1)”. The images show the network of the pvc filter using different magnifications with several multiple particles on the surface. The chemical characterization of the particles is shown in Figure 24a.

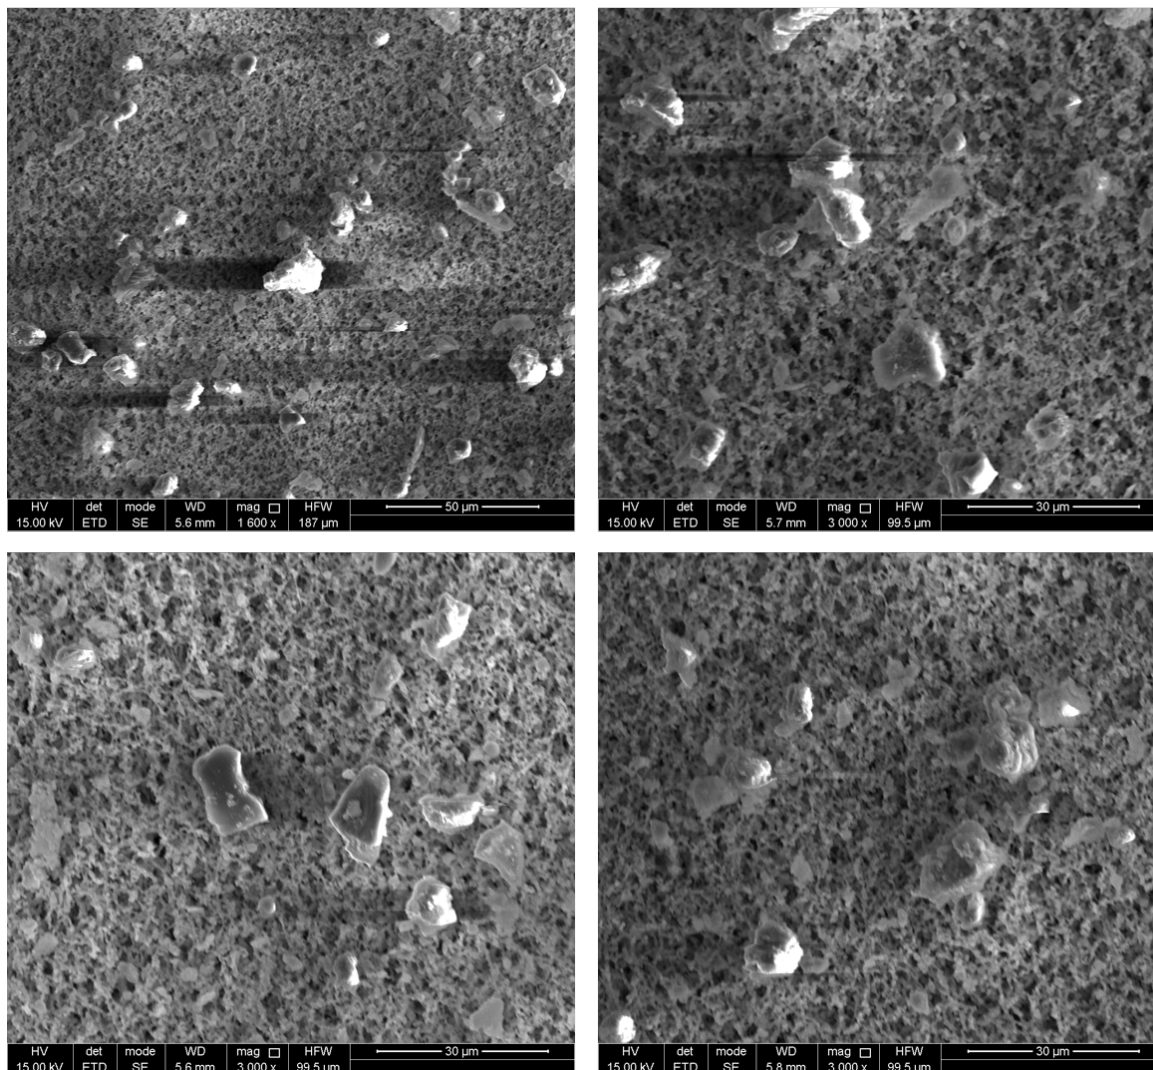
Figure 25. SEM-images with secondary electron detector of the sample “22-02-2020 01”. The images show the network of the pvc filter using different magnifications with several multiple particles on the surface. The chemical characterization of the particles is shown in Figure 25a.

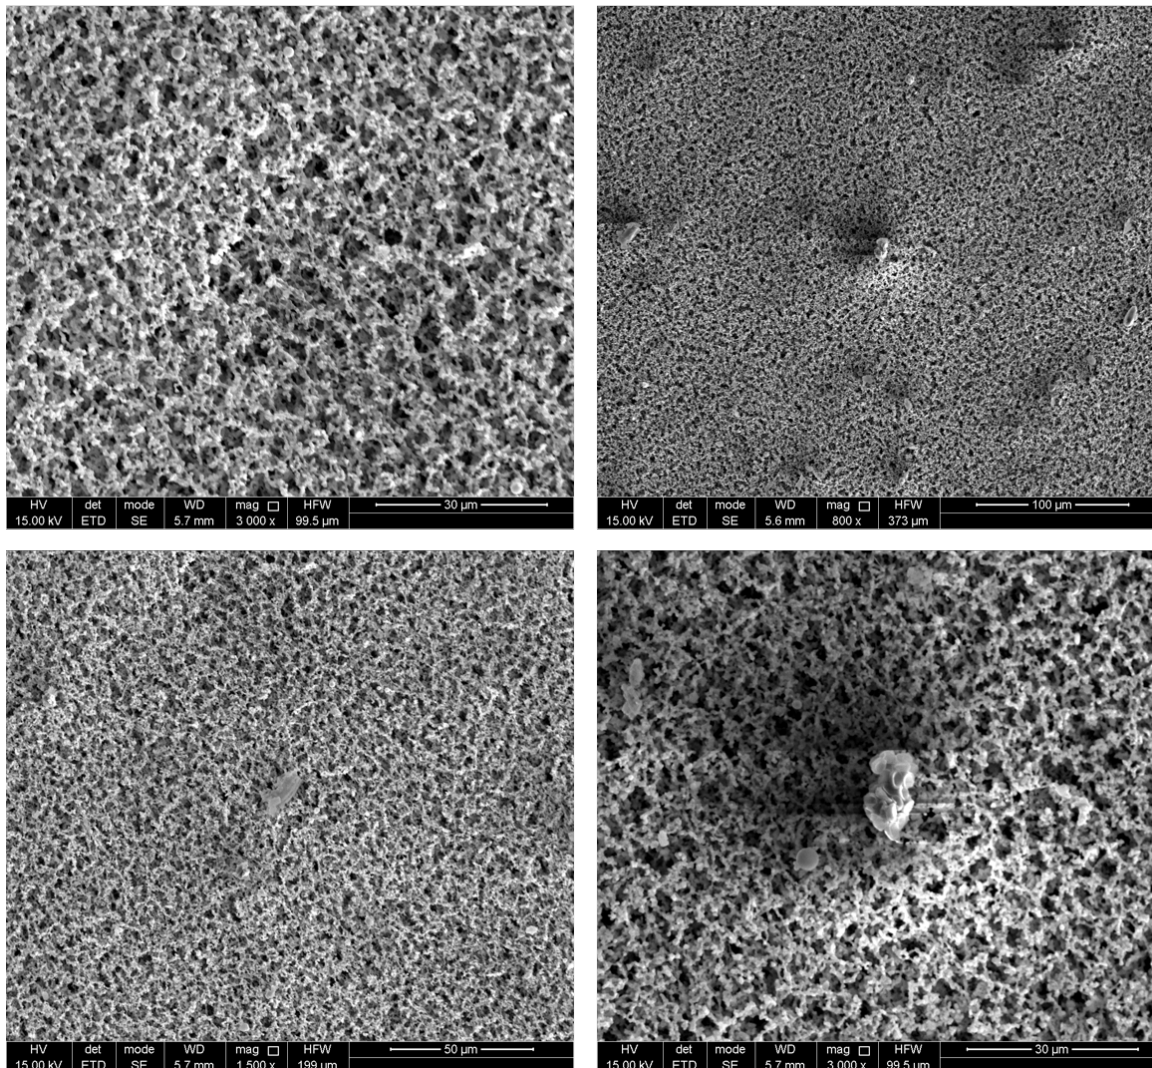
Figure 26. SEM-images with secondary electron detector of the sample “22-02-2020 03”. The images show the network of the pvc filter using different magnifications with several multiple particles on the surface. The chemical characterization of the particles is shown in Figure 26a.

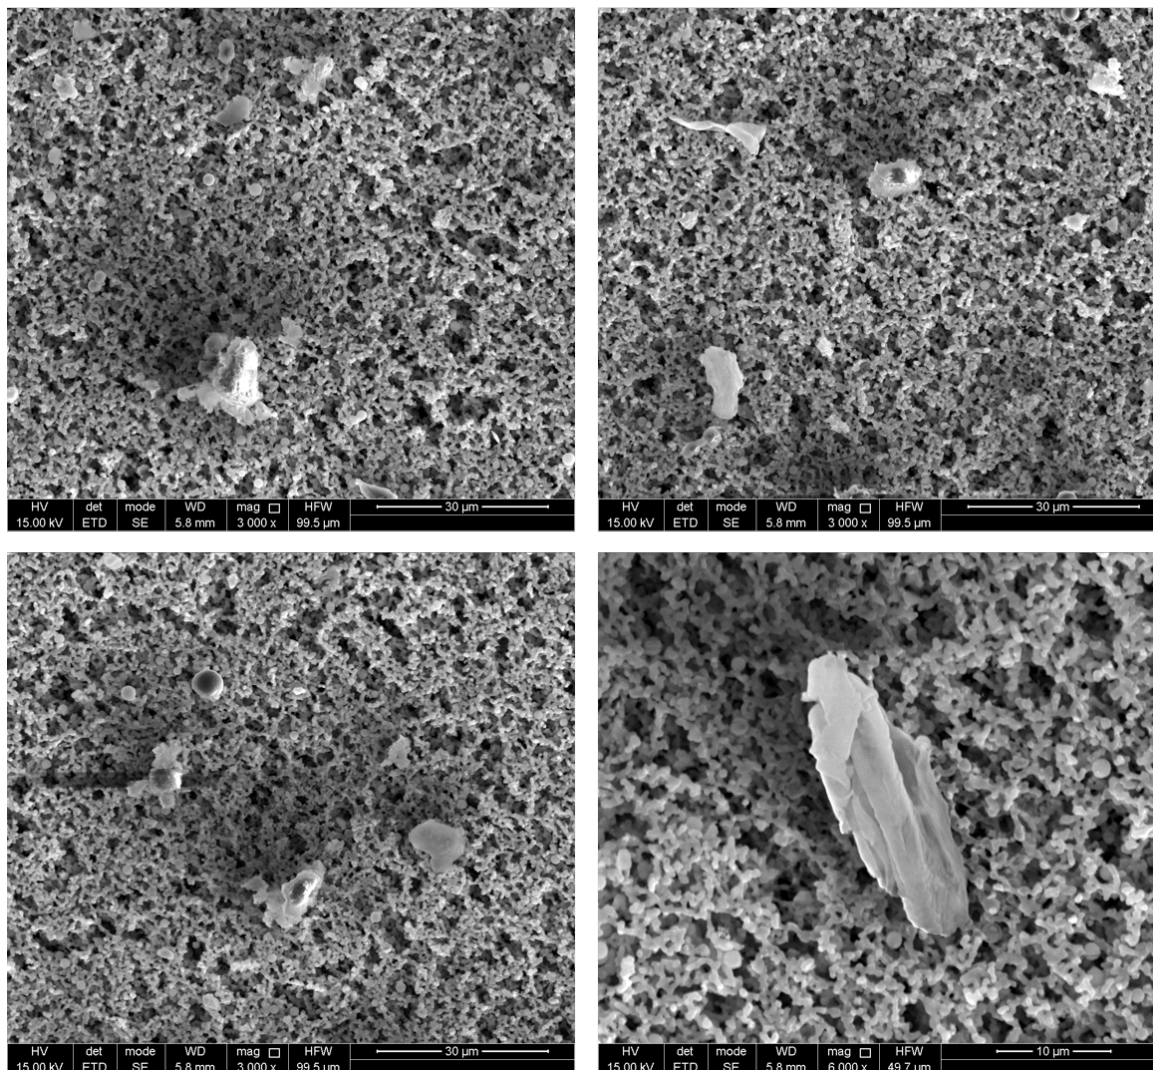
Figure 27. SEM-images with secondary electron detector of the sample “22-02-2020 (0-4)”. The images show the network of the pvc filter using different magnifications with several multiple particles on the surface. The chemical characterization of the particles is shown in Figure 27a.

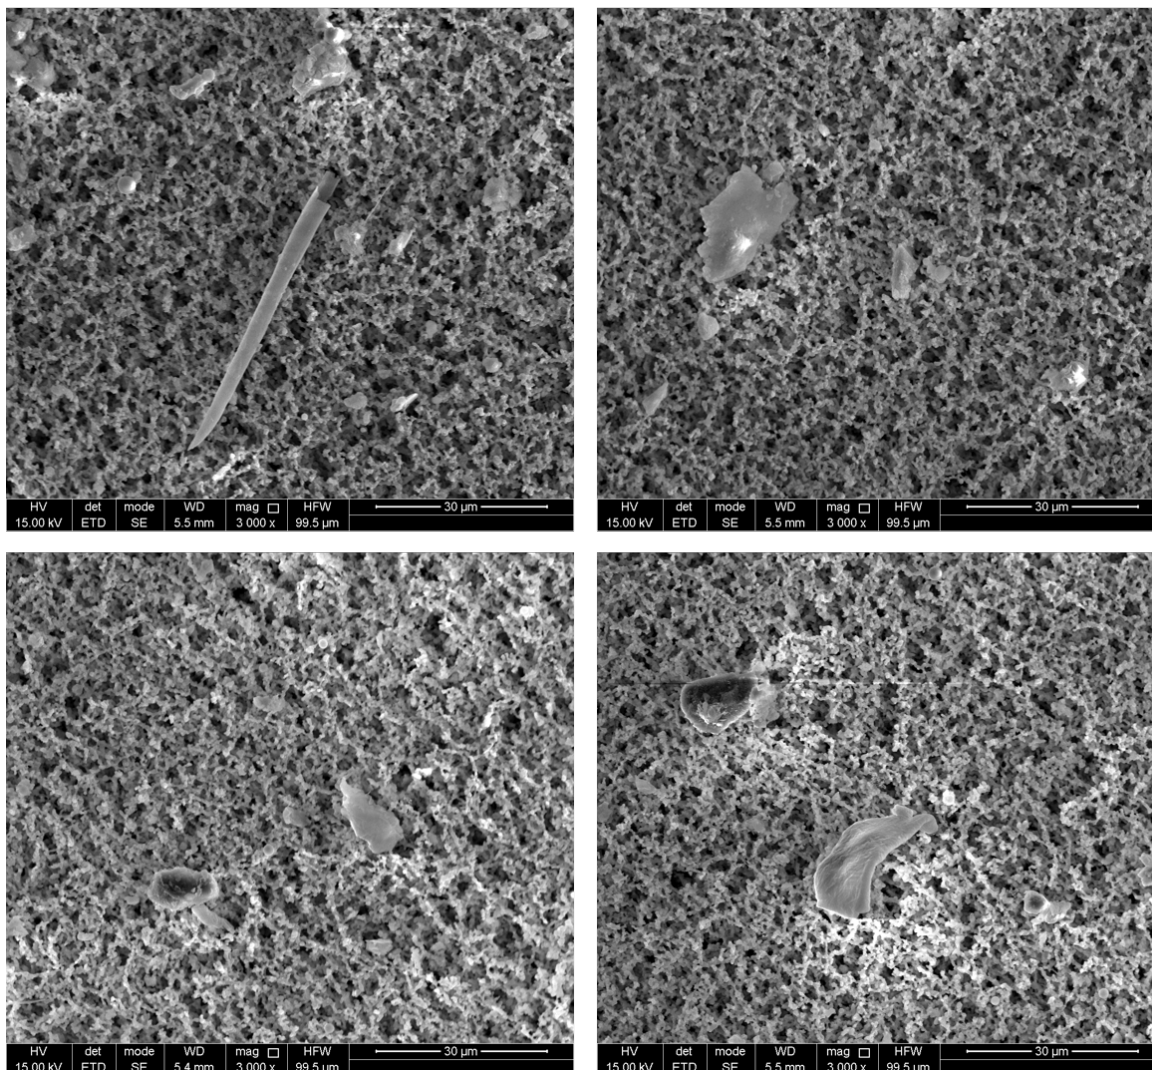
Figure 28. SEM-images with secondary electron detector of the sample “22-02-2020 0-5”. The images show the network of the pvc filter using different magnifications with several multiple particles on the surface. One single fibre structure was observed in this sample but the fibre has no asbestos appearance. The chemical characterization of the particles is shown in Figure 28a.

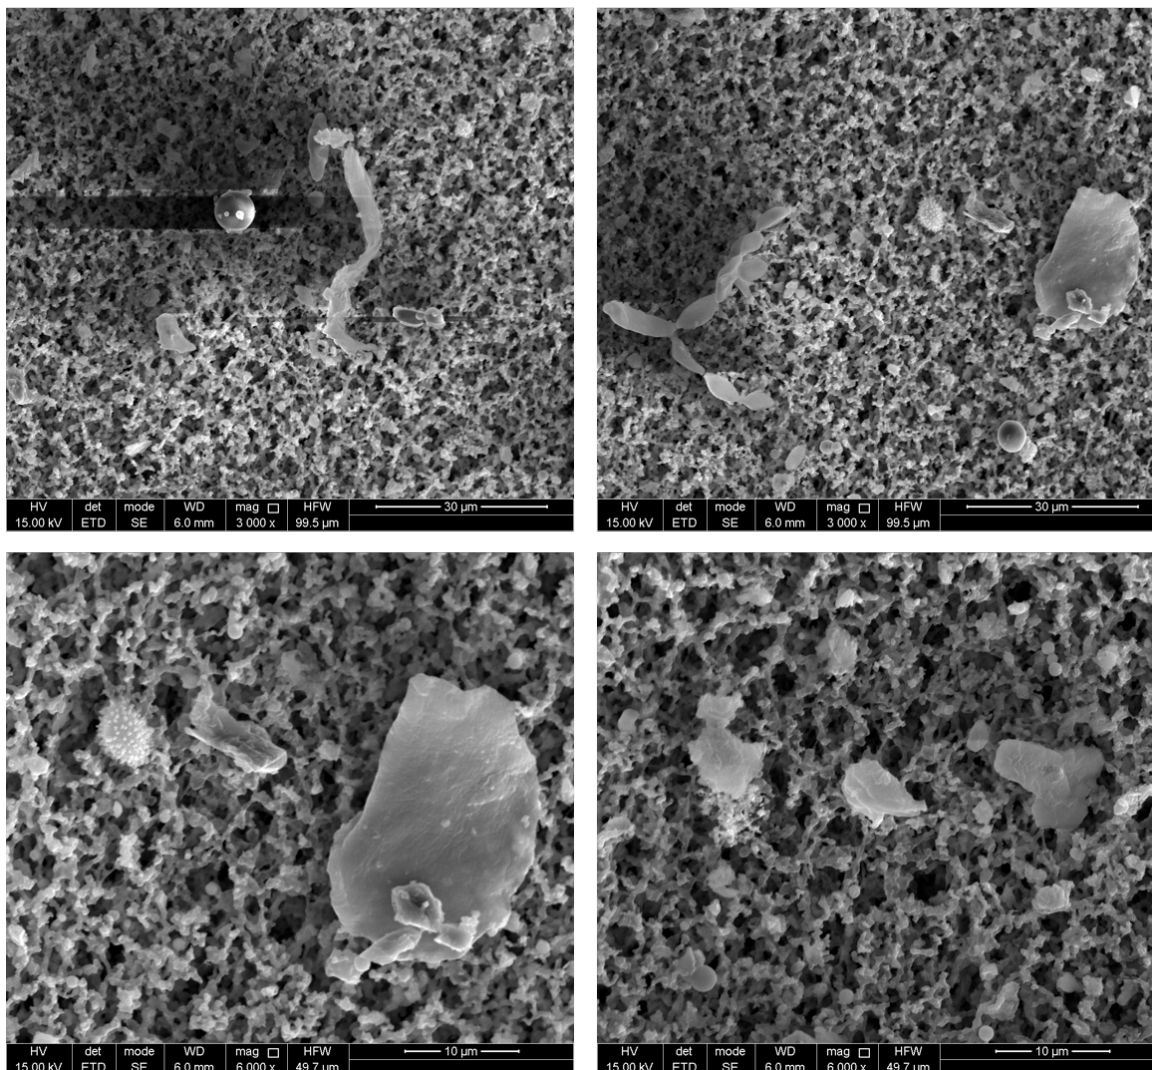
Figure 29. SEM-images with secondary electron detector of the sample “22-02-2020 (N1)”. The images show the network of the pvc filter using different magnifications with several multiple particles on the surface. One single fibre structure was observed in this sample but the fibre has no asbestos appearance. The chemical characterization of the particles is shown in Figure 29a.

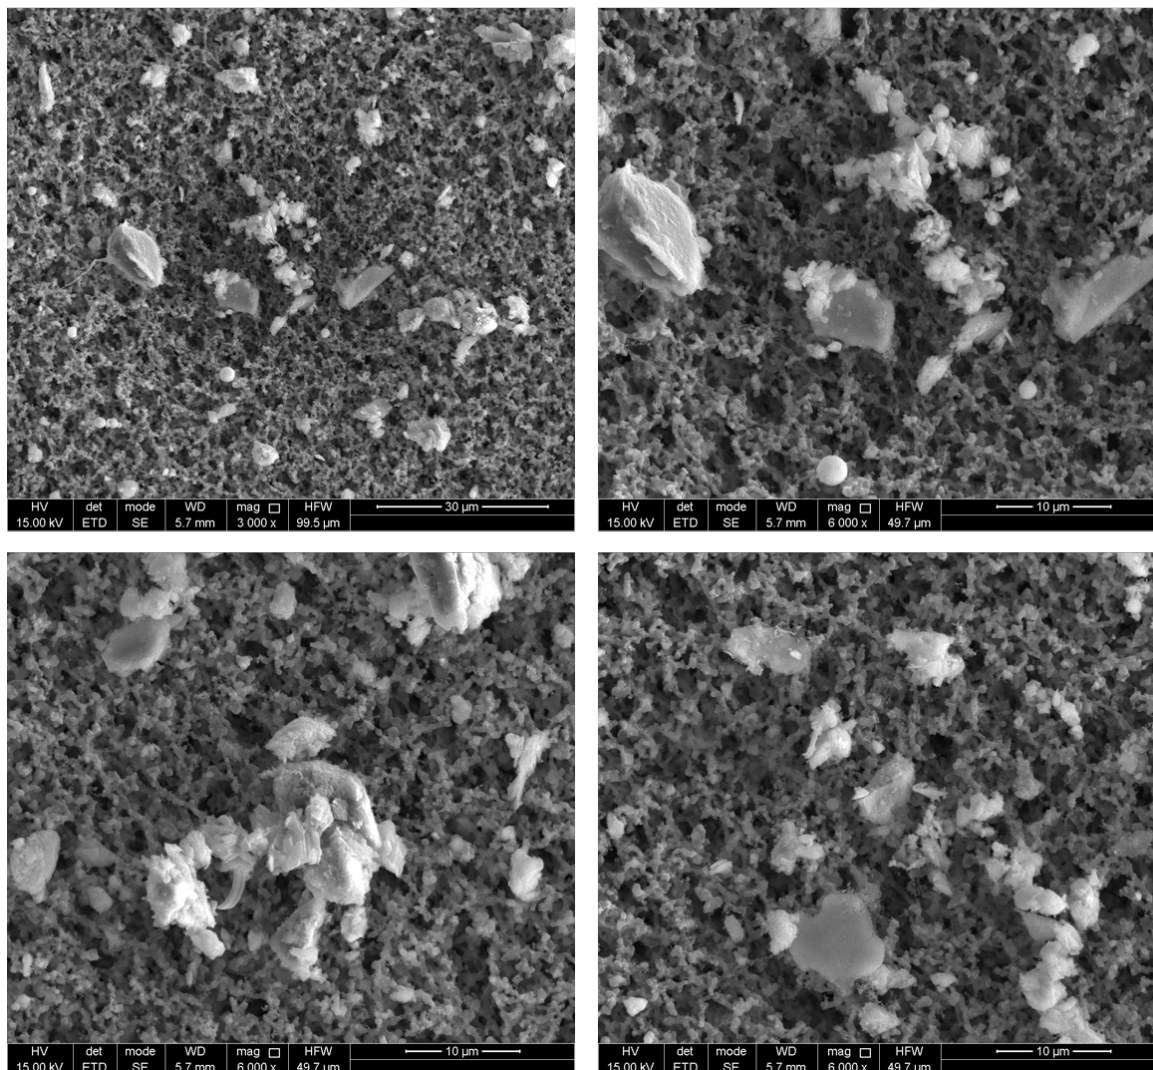
Figure 30. SEM-images with secondary electron detector of the sample “22-02-2020 N1”. The images show the network of the pvc filter using different magnifications with several multiple particles on the surface. The chemical characterization of the particles is shown in Figure 30a.
