Environment Monitoring For an Asbestos Plant in Kymore

Capacity Building and Training

Environics Trust
28-Dec-21

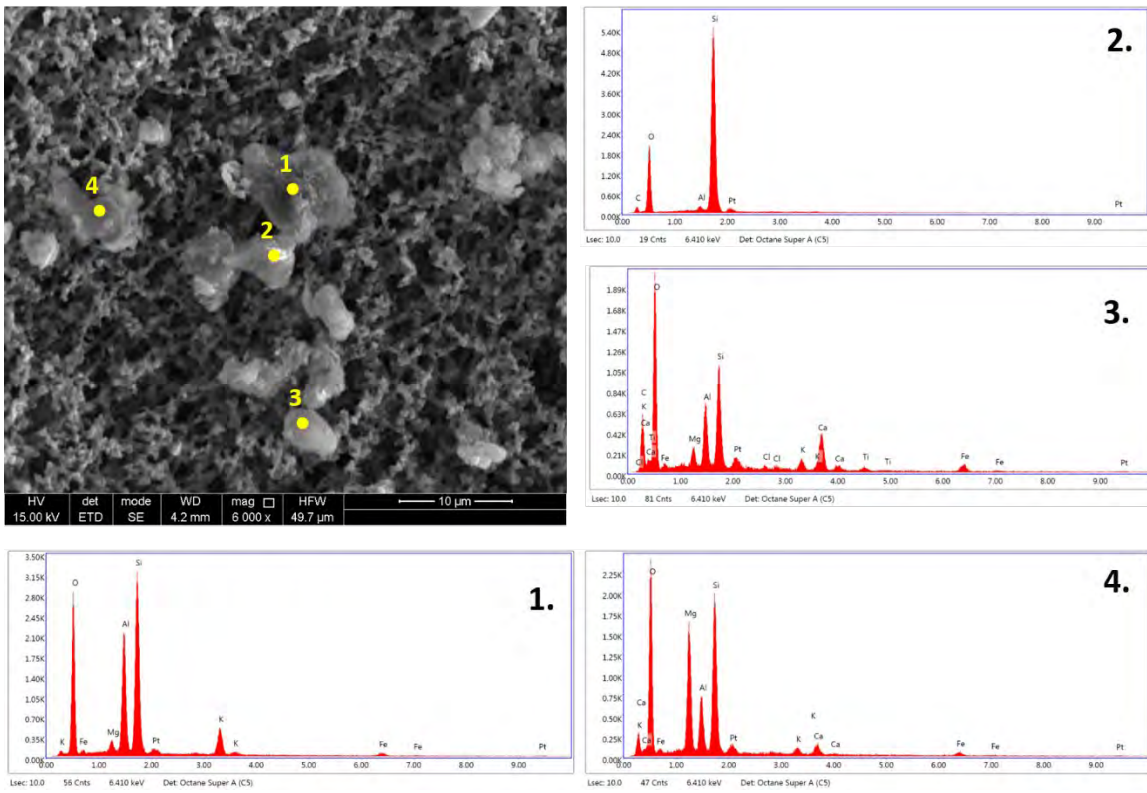
21-WB003 | 18.02.20200-2

Figure 3. SEM-images with secondary electron detector of the sample “21-WB003 | 18.02.20200-2”. The images show the network of the pvc filter using different magnifications with several multiple particles on the surface. No fibre structures were observed. The chemical characterization of the particles is shown in Figure 3a.

Figure 3a. EDX characterization of the particles identified in sample “21-WB003 | 18.02.20200-2”.

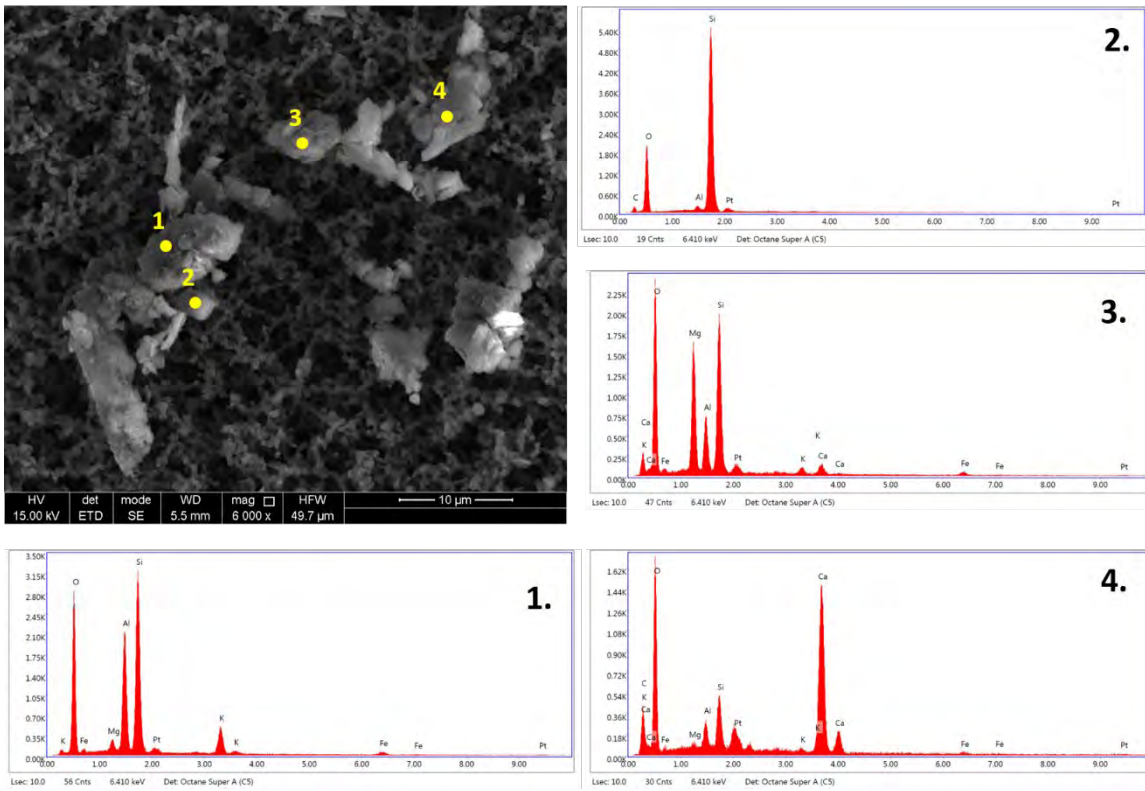
21-WB004 | 19.02.2020-1

Figure 4. SEM-images with secondary electron detector of the sample “21-WB004 | 19.02.2020O-1”. The images show the network of the pvc filter using different magnifications with several multiple particles on the surface. No fibre structures were observed. The chemical characterization of the particles is shown in Figure 4a.

Figure 4a. EDX characterization of the particles identified in sample “21-WB004 | 19.02.2020-1”.

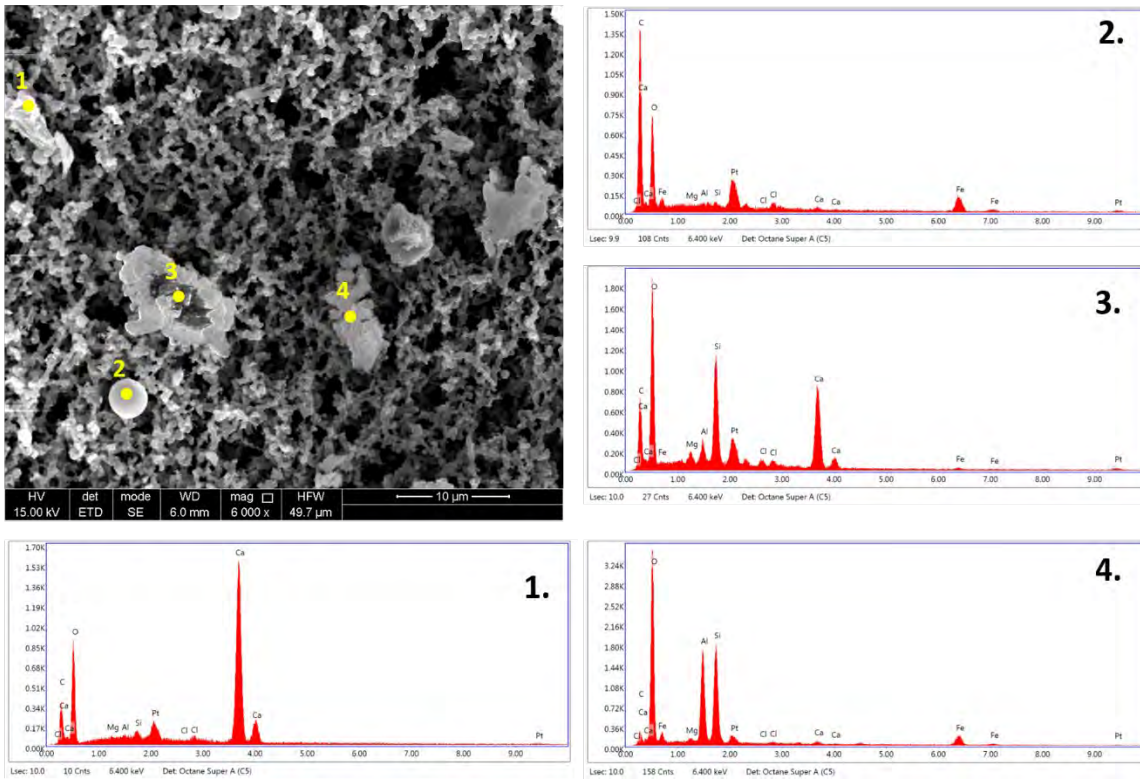
21-WB006 | 19.02.20200-5

Figure 6a. EDX characterization of the particles identified in sample “21-WB006 | 19.02.20200-5”.

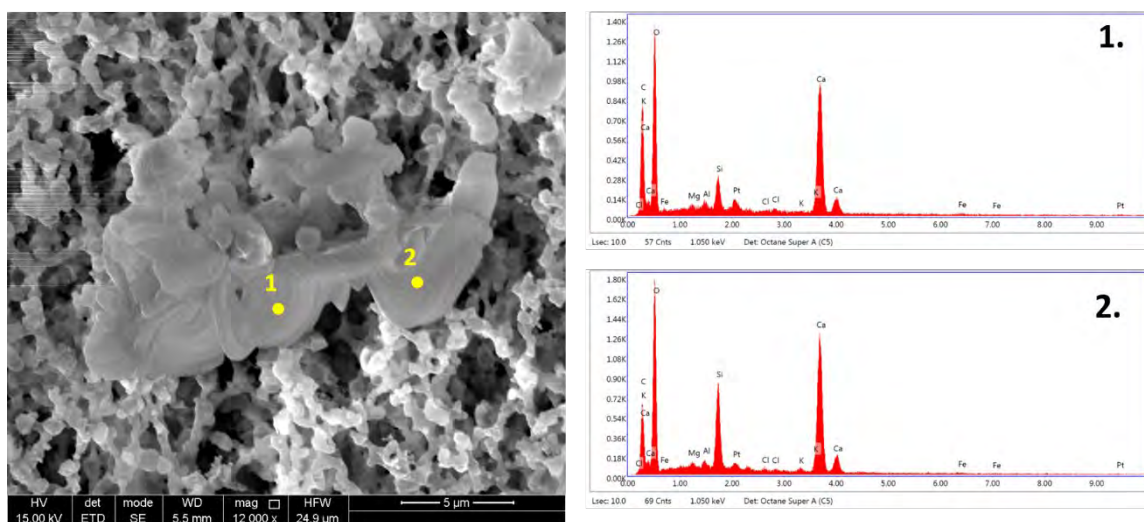
21-WB008 | 19.02.2020N-1

Figure 8a. EDX characterization of the particles identified in sample “21-WB008 | 19.02.2020N-1”.

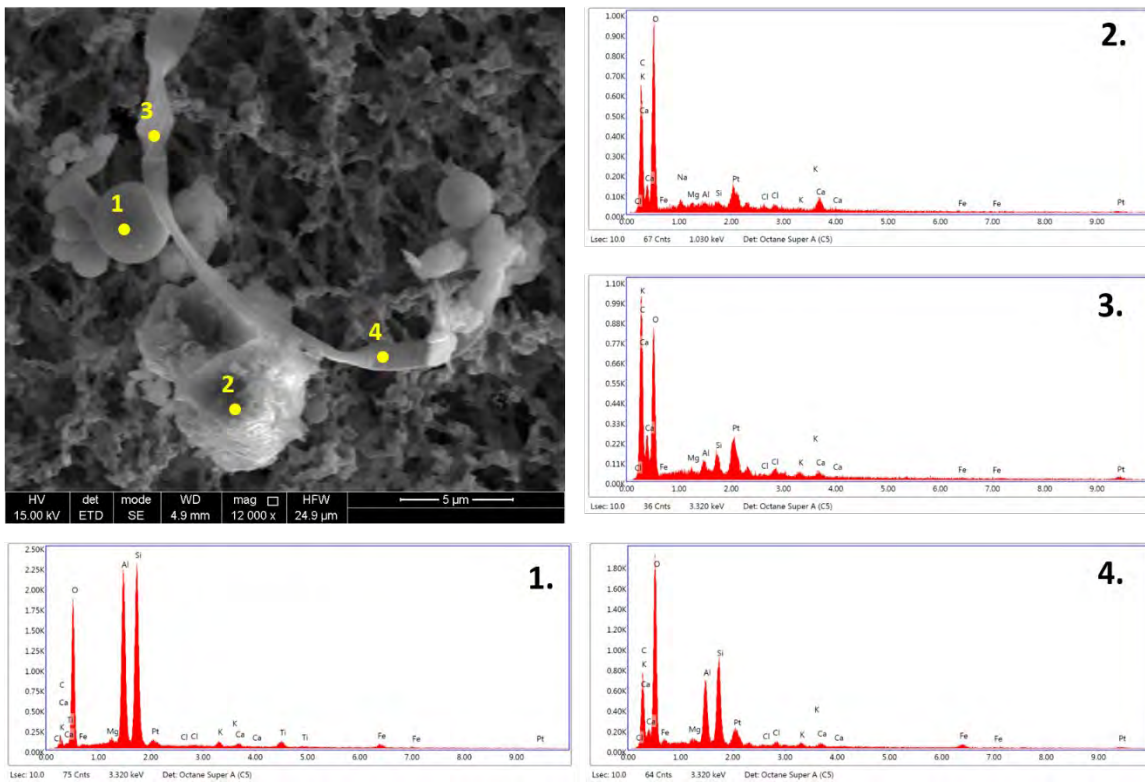
21-WB009 | 19.02.2020N-2

Figure 9. SEM-images with secondary electron detector of the sample “21-WB009 | 19.02.2020N-2”. The images show the network of the pvc filter using different magnifications with several multiple particles on the surface. One single fibre structure was observed in this sample but the fibre has no asbestos appearance. The chemical characterization confirms that it is not an asbestos fibre (see Figure 9a).

Figure 9a. EDX characterization of the particles identified in sample “21-WB009 | 19.02.2020N-2”.

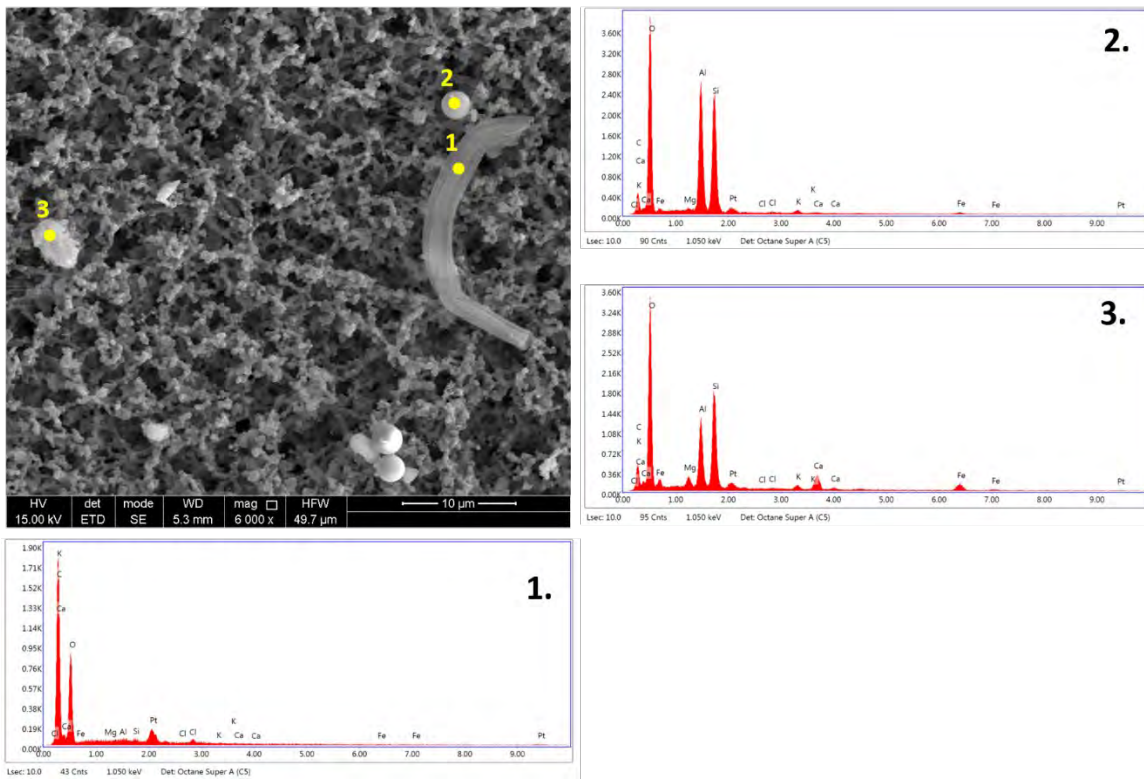
21-WB010 | 20.02.20200-1

Figure 10. SEM-images with secondary electron detector of the sample “21-WB010 | 20.02.20200-1”. The images show the network of the pvc filter using different magnifications with several multiple particles on the surface. One single fibre structure was observed in this sample but the fibre has no asbestos appearance. The chemical characterization confirms that it is not an asbestos fibre (see Figure 10a).

Figure 10a. EDX characterization of the particles identified in sample “21-WB010 | 20.02.20200-1”.

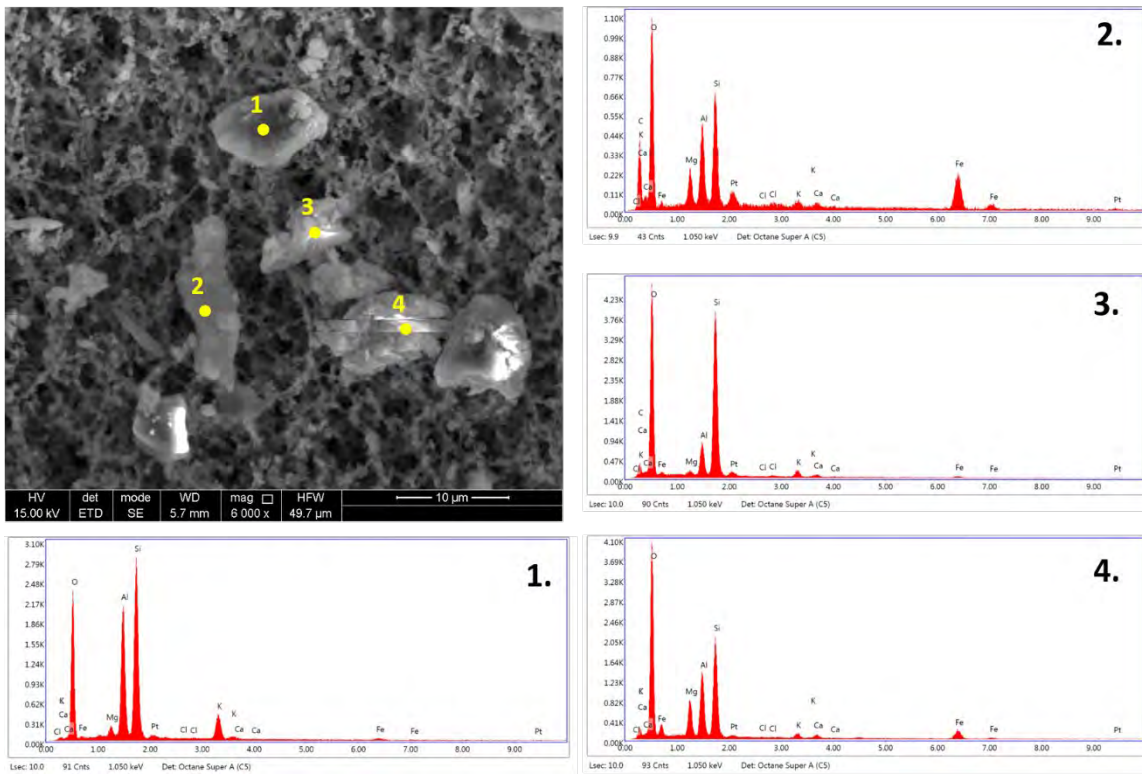
21-WB011 | 20.02.2020O-2

Figure 11a. EDX characterization of the particles identified in sample “21-WB011 | 20.02.2020O-2”.

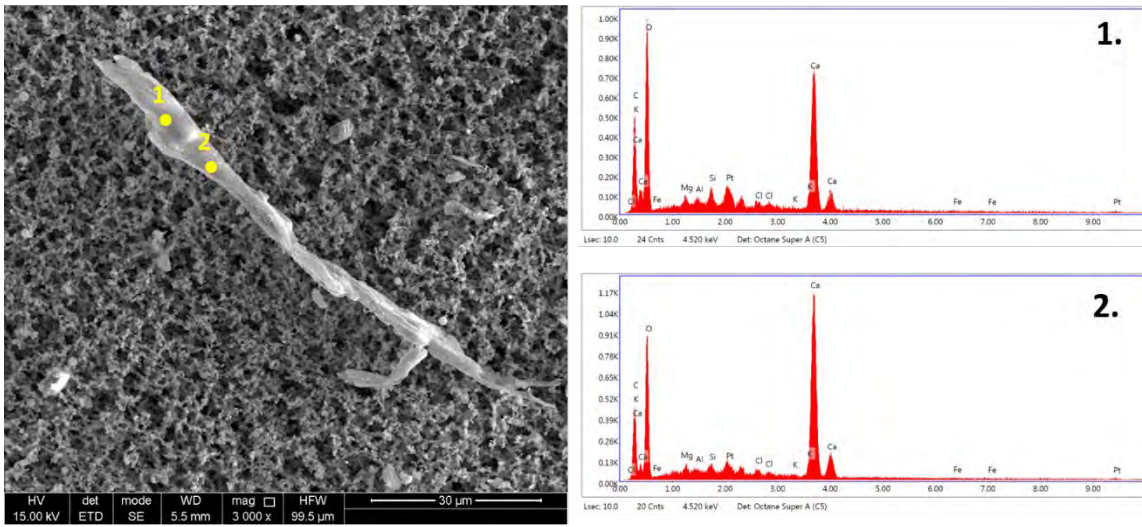
21-WB012 | 20.02.2020-3

Figure 12a. EDX characterization of the particles identified in sample “21-WB012 | 20.02.2020-3”.

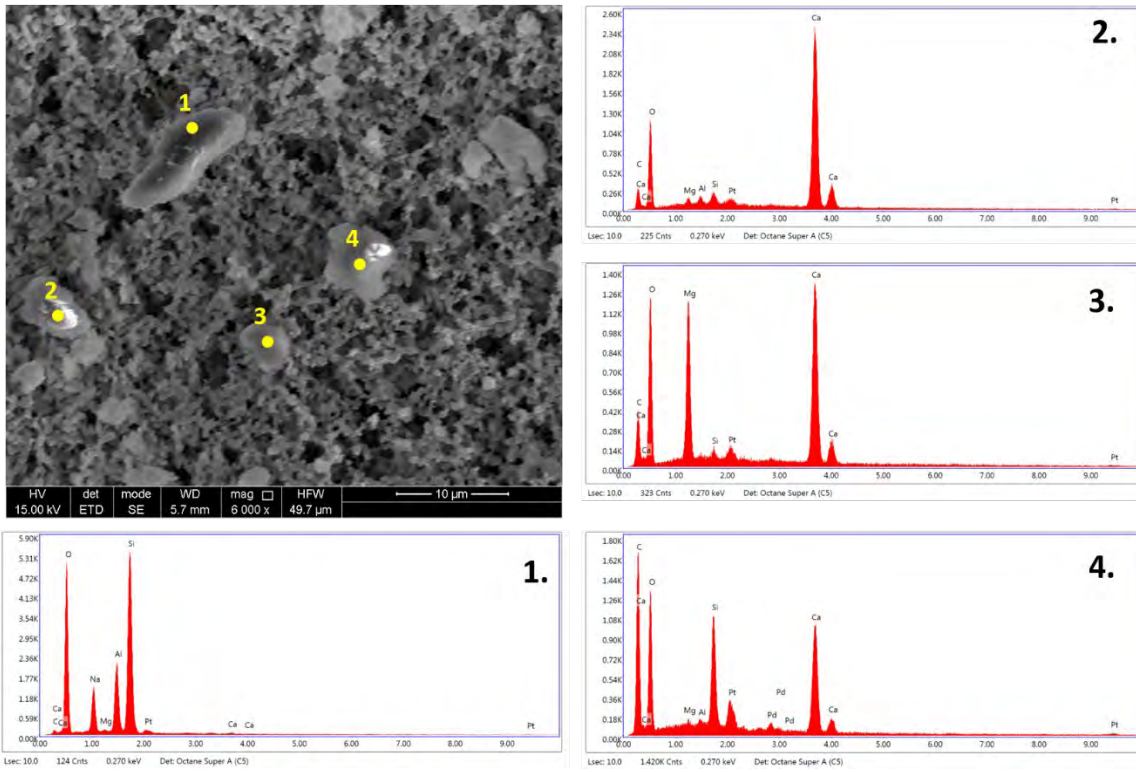
21-WB013 | 20.02.2020-4

Figure 13a. EDX characterization of the particles identified in sample “21-WB013 | 20.02.2020-4”.

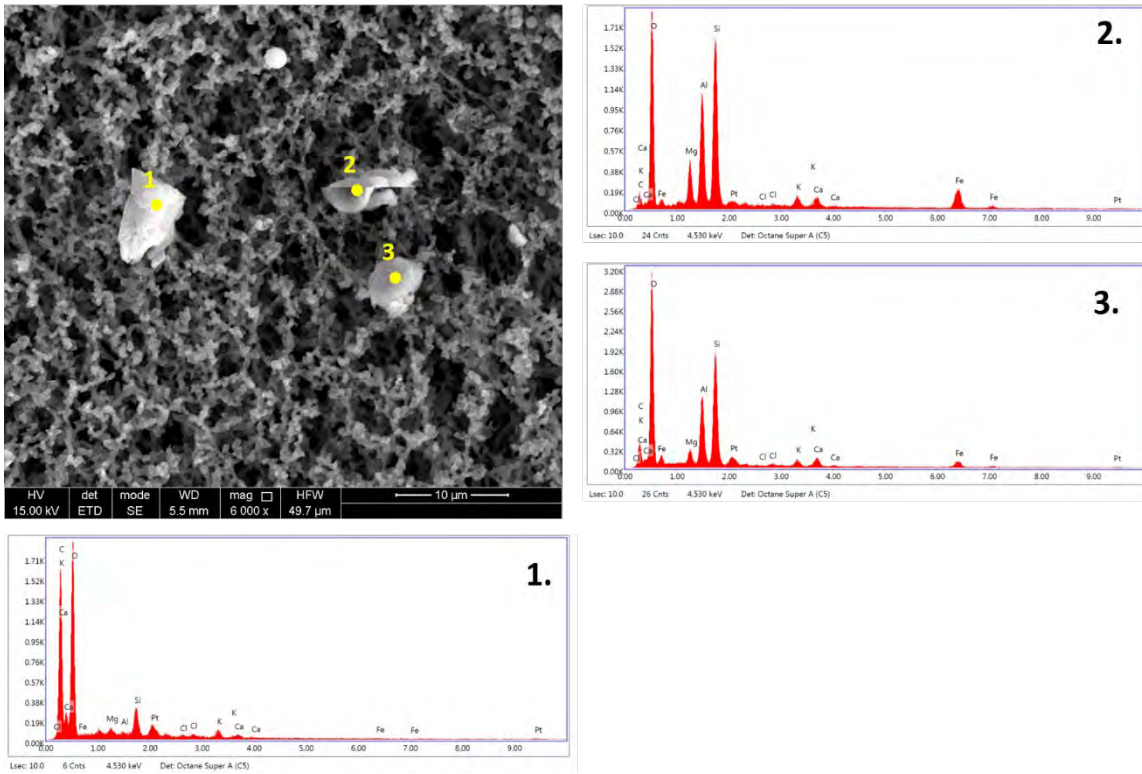
21-WB014 | 20.02.2020O-5

Figure 14. SEM-images with secondary electron detector of the sample “21-WB014 | 20.02.2020O-5”. The images show the network of the pvc filter using different magnifications with several multiple particles on the surface. The chemical characterization of the particles is shown in Figure 14a.

Figure 14a. EDX characterization of the particles identified in sample “21-WB014 | 20.02.2020O-5”.

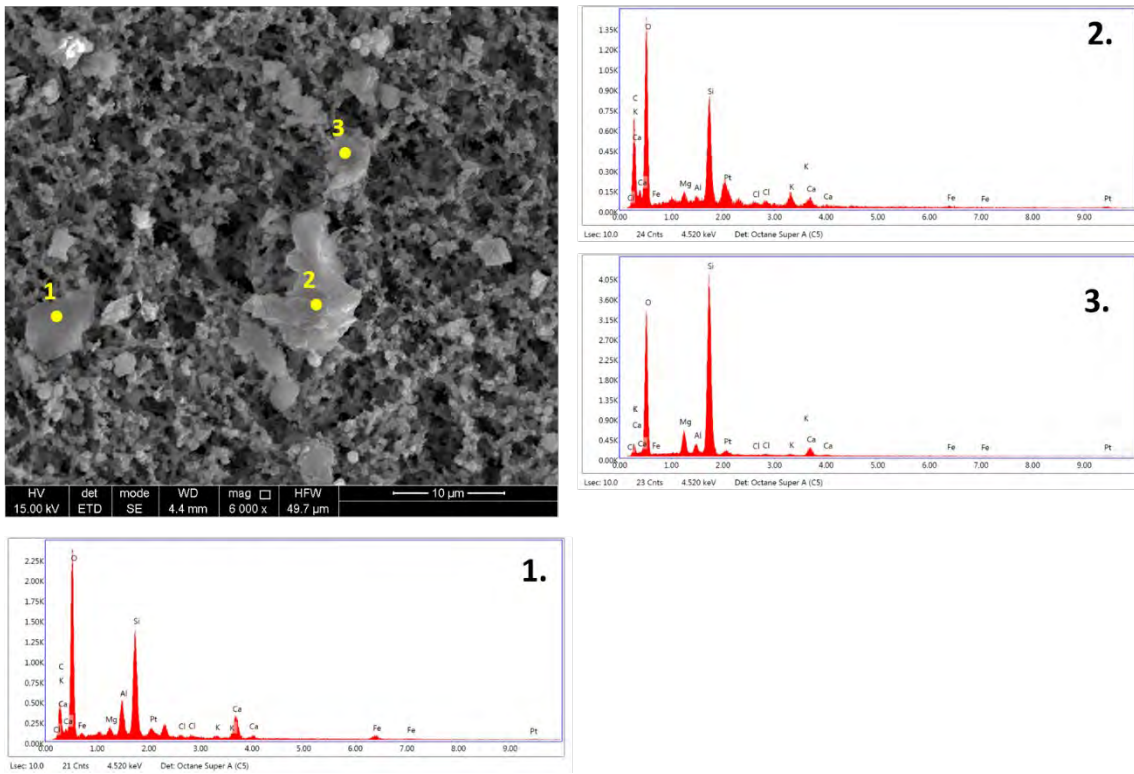
21-WB015 | 20.02.2020N-1

Figure 15. SEM-images with secondary electron detector of the sample “21-WB015 | 20.02.2020N-1”. The images show the network of the pvc filter using different magnifications with several multiple particles on the surface. The chemical characterization of the particles is shown in Figure 15a.

Figure 15a. EDX characterization of the particles identified in sample “21-WB015 | 20.02.2020N-1”.

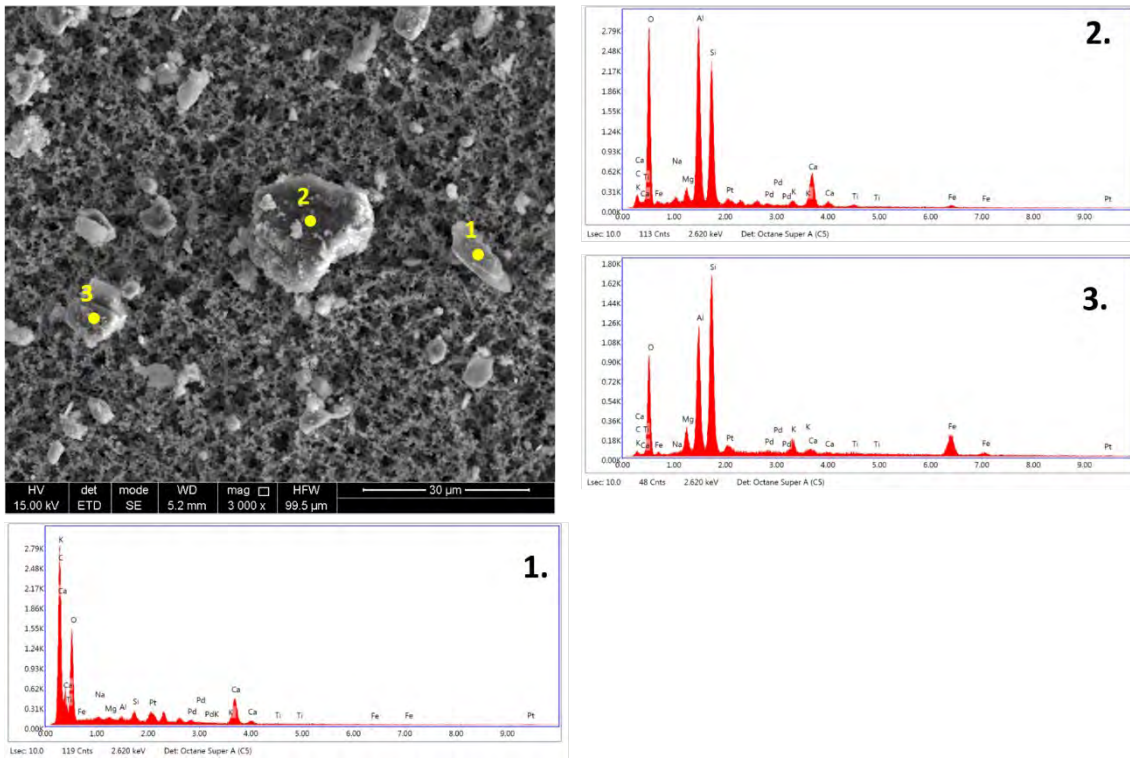
21-WB016 | 20.02.2020N-2

Figure 16. SEM-images with secondary electron detector of the sample “21-WB016 | 20.02.2020N-2”. The images show the network of the pvc filter using different magnifications with several multiple particles on the surface. The chemical characterization of the particles is shown in Figure 16a.

Figure 16a. EDX characterization of the particles identified in sample “21-WB016 | 20.02.2020N-2”.

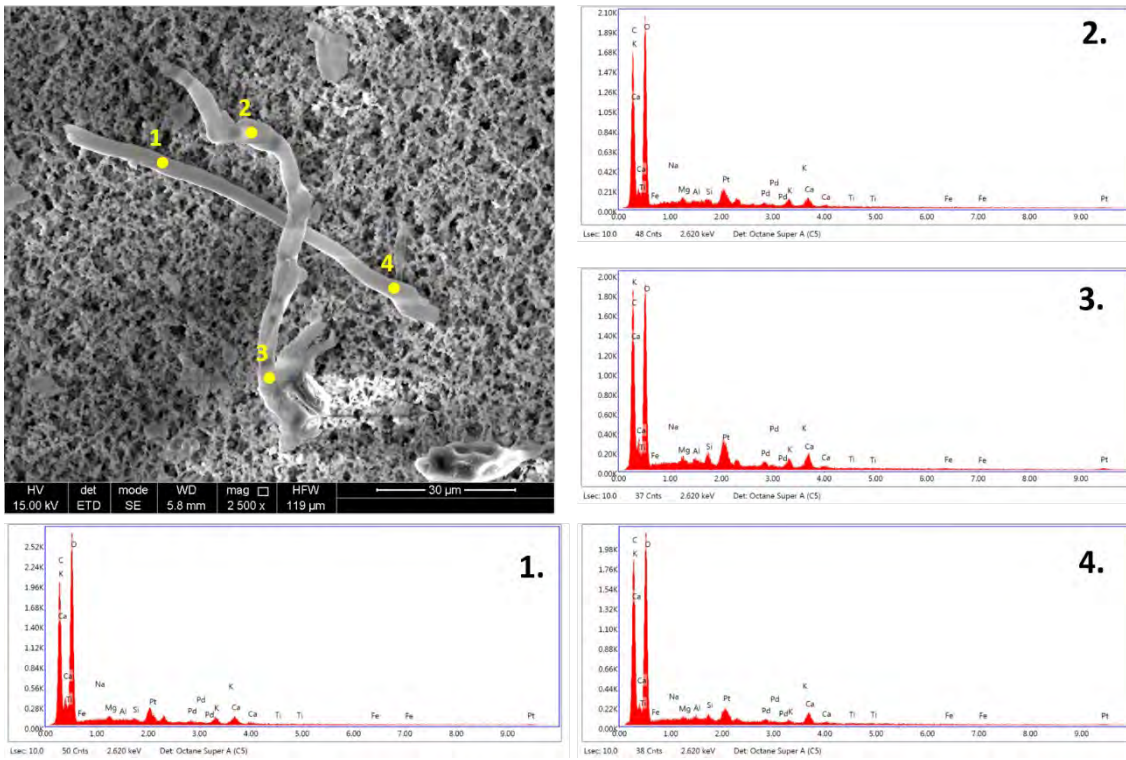
21-WB017 | 21.02.20200-1

Figure 17. SEM-images with secondary electron detector of the sample “21-WB017 | 21.02.2020O-1”. The images show the network of the pvc filter using different magnifications with several multiple particles on the surface. Four single fibre structures were observed in this sample but the fibres have no asbestos appearance. The chemical characterization of the particles is shown in Figure 17a.

Figure 17a. EDX characterization of the particles identified in sample “21-WB017 | 21.02.20200-1”.

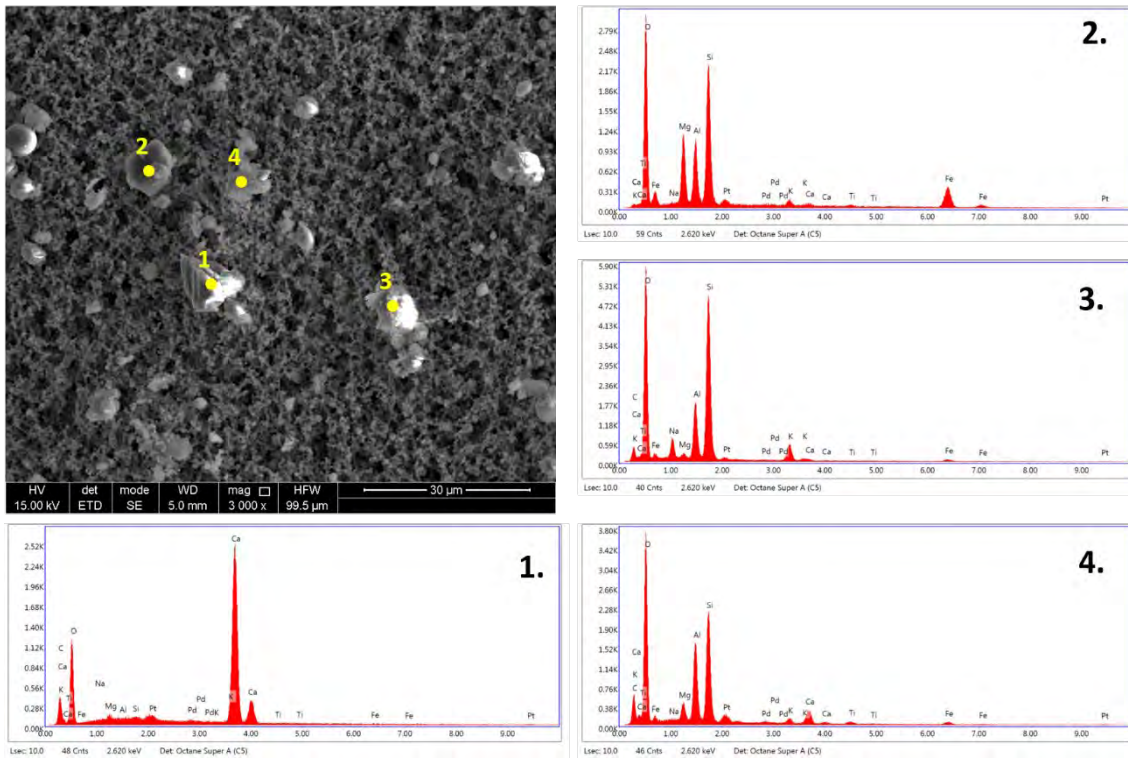
21-WB018 | 21.02.20200-2

Figure 18. SEM-images with secondary electron detector of the sample “21-WB018 | 21.02.2020O-2”. The images show the network of the pvc filter using different magnifications with several multiple particles on the surface. One single fibre structure was observed in this sample but the fibre has no asbestos appearance. The chemical characterization of the particles is shown in Figure 18a.

Figure 18a. EDX characterization of the particles identified in sample “21-WB018 | 21.02.20200-2”.

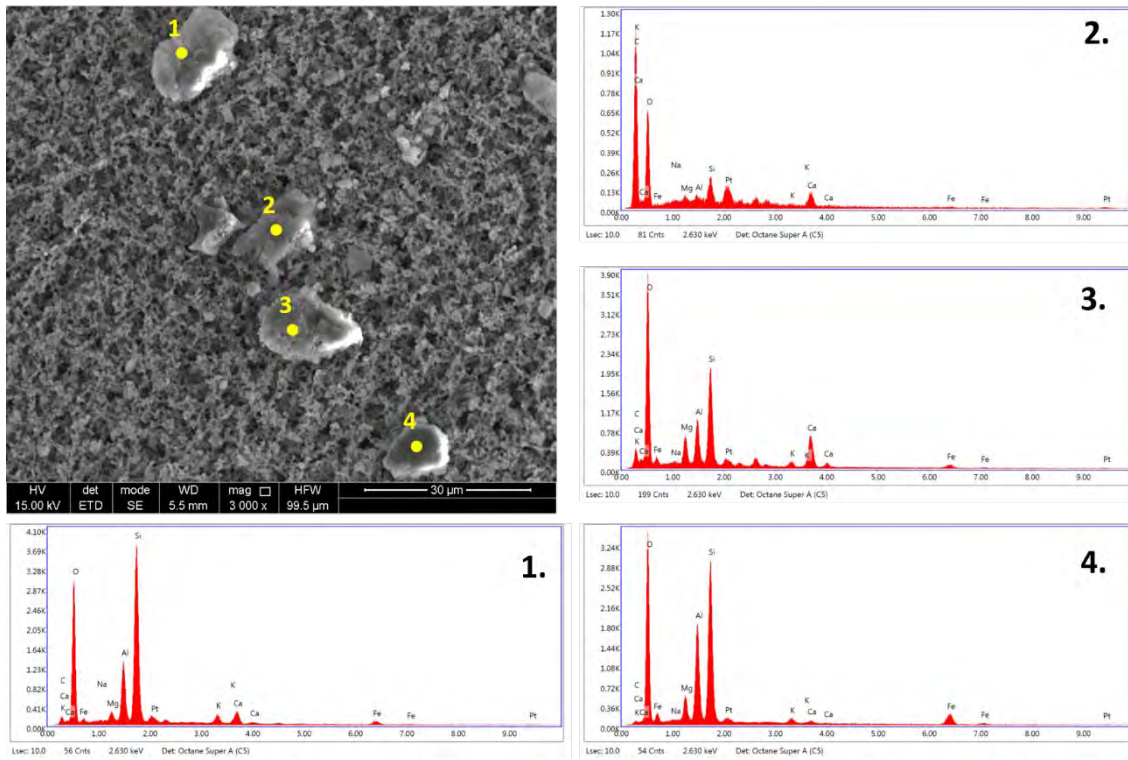
21-WB019 | 21.02.20200-3

Figure 19a. EDX characterization of the particles identified in sample “21-WB019 | 21.02.20200-3”.

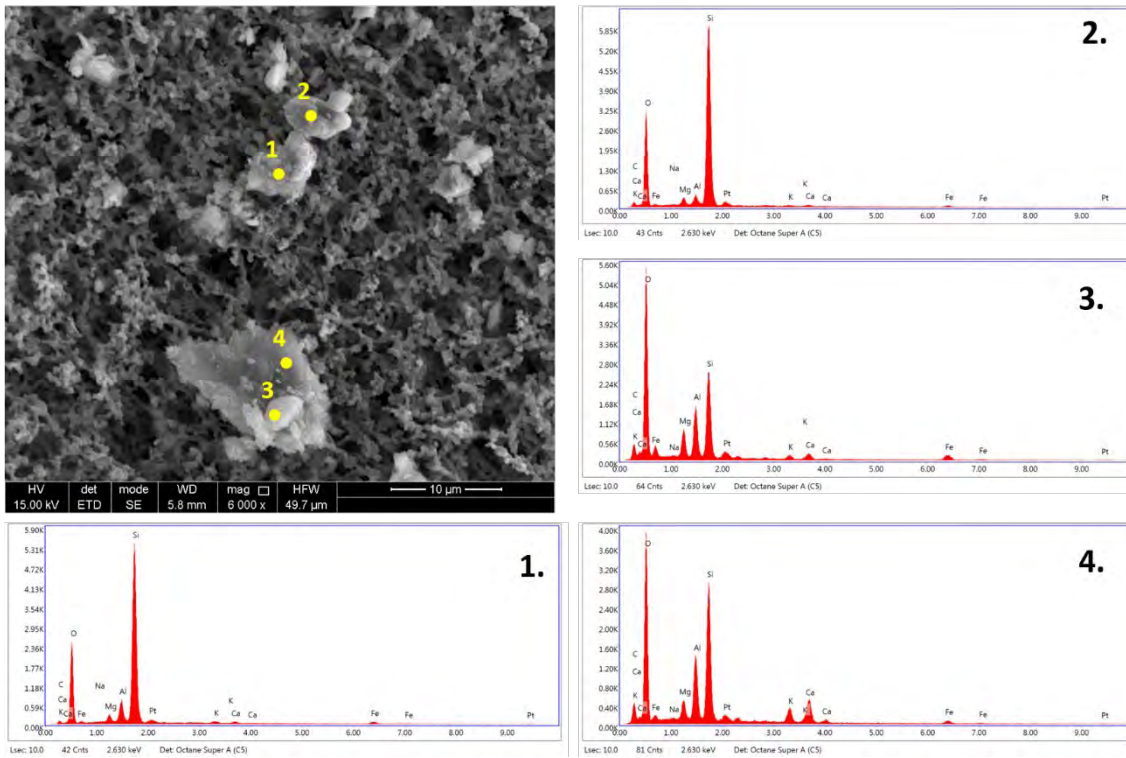
21-WB020 | 21.02.20200-4

Figure 20a. EDX characterization of the particles identified in sample “21-WB020 | 21.02.20200-4”.

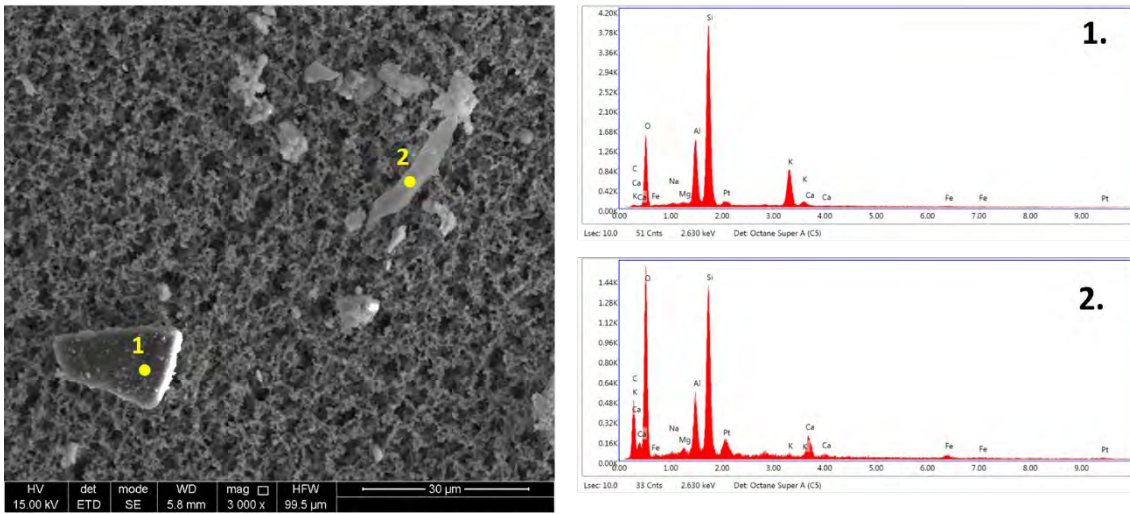
21-WB021 | 21.02.20200-5

Figure 21a. EDX characterization of the particles identified in sample “21-WB021 | 21.02.20200-5”.

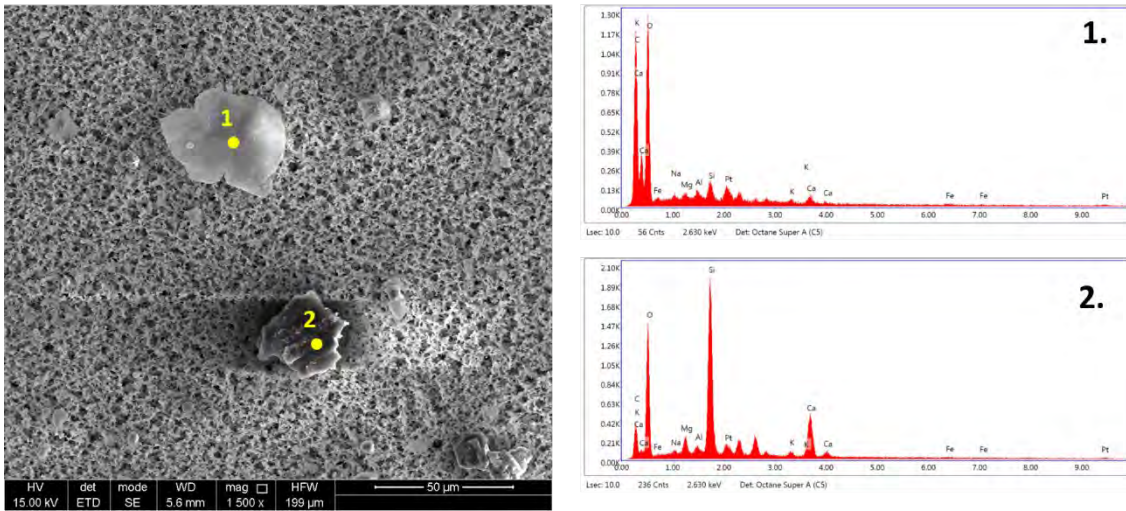
21-WB022 | 21.02.2020N-1

Figure 22a. EDX characterization of the particles identified in sample “21-WB022 | 21.02.2020N-1”.

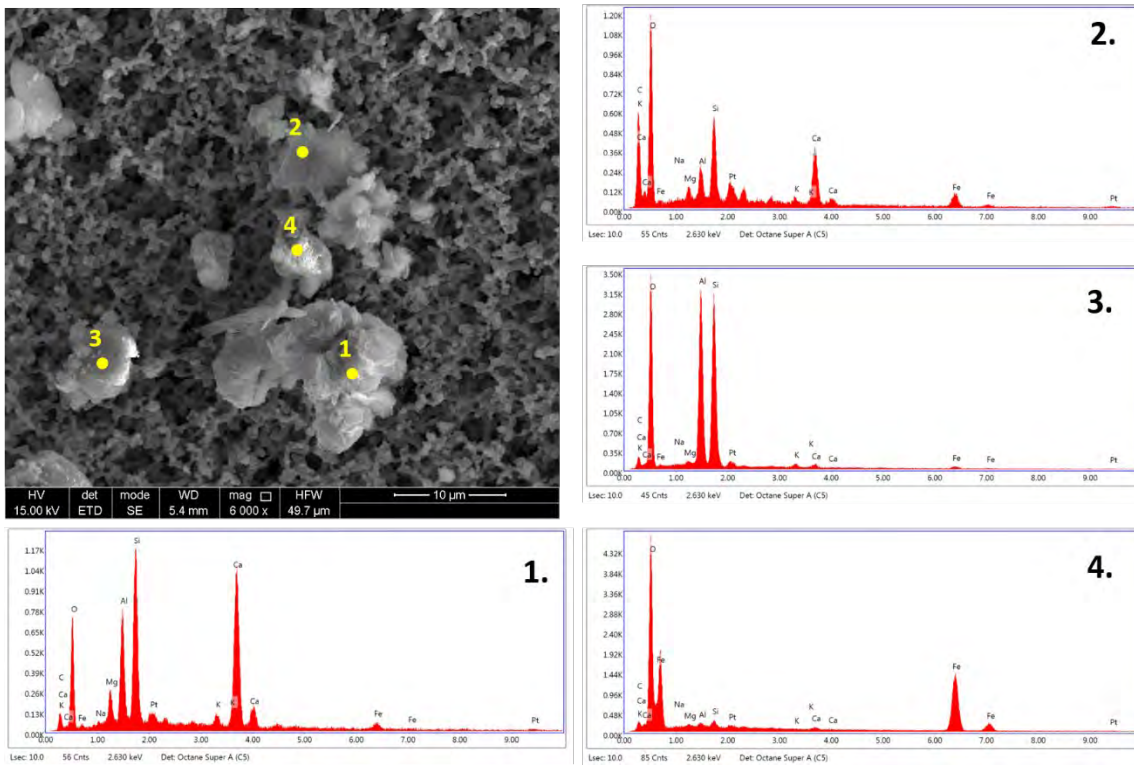
21-WB023 | 21.02.2020N-2

Figure 23a. EDX characterization of the particles identified in sample “21-WB023 | 21.02.2020N-2”.

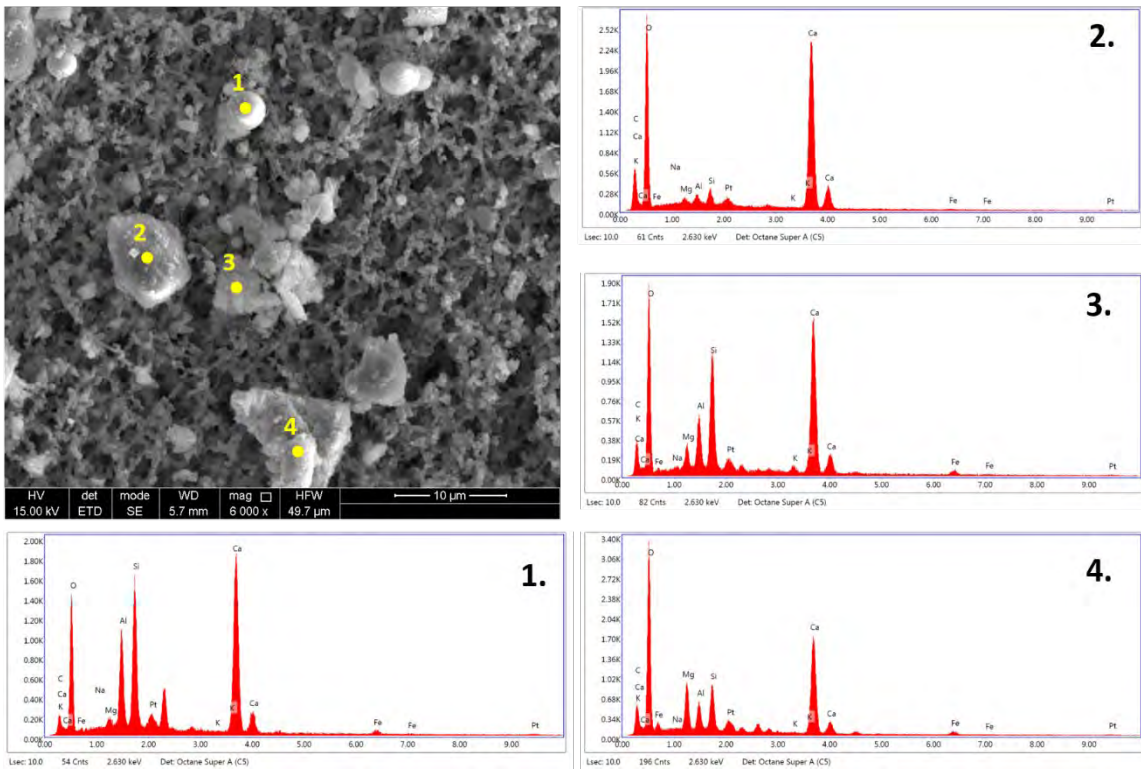
18-02-2020 Portable Day Sampling (N-1)

Figure 24a. EDX characterization of the particles identified in sample “18-02-2020 Portable Day Sampling (N-1)”.

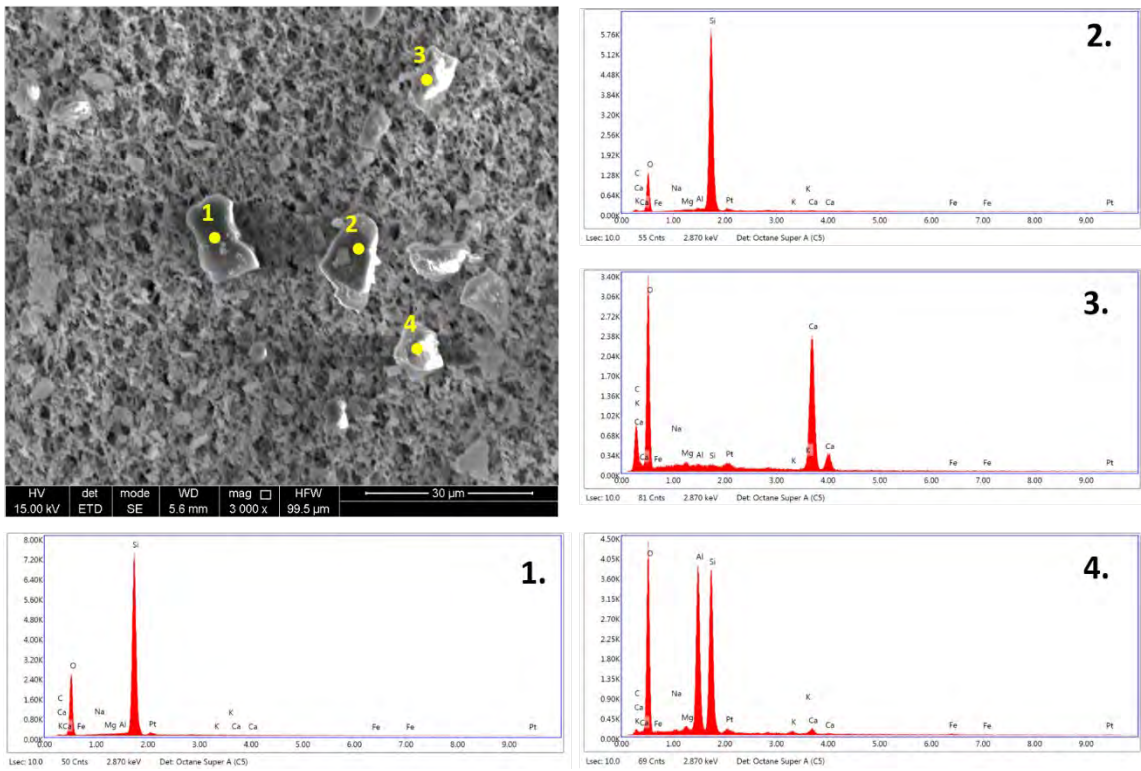
22-02-2020 01

Figure 25a. EDX characterization of the particles identified in sample “22-02-2020 01”.

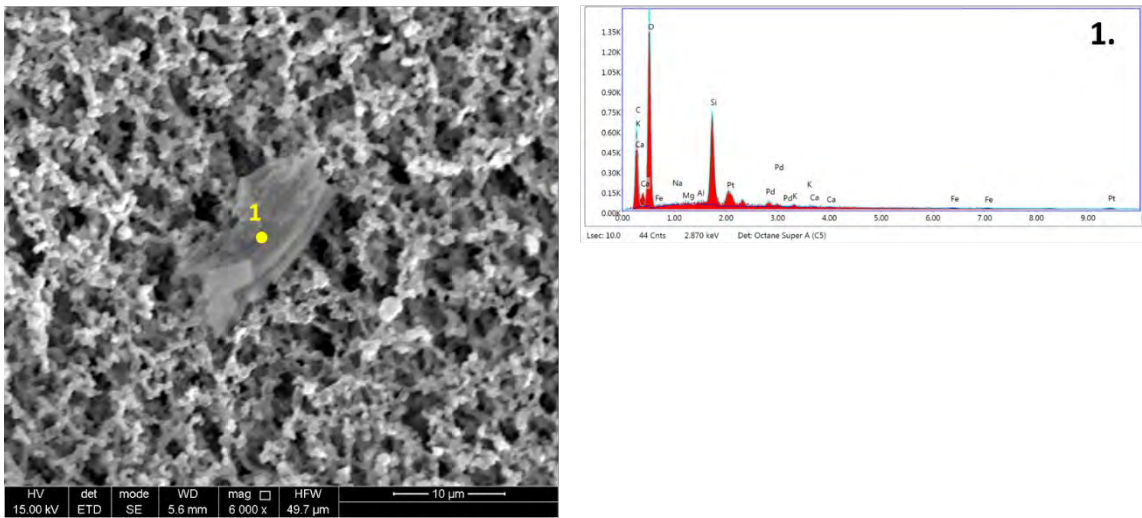
22-02-2020 03

Figure 26a. EDX characterization of the particles identified in sample “22-02-2020 03”.

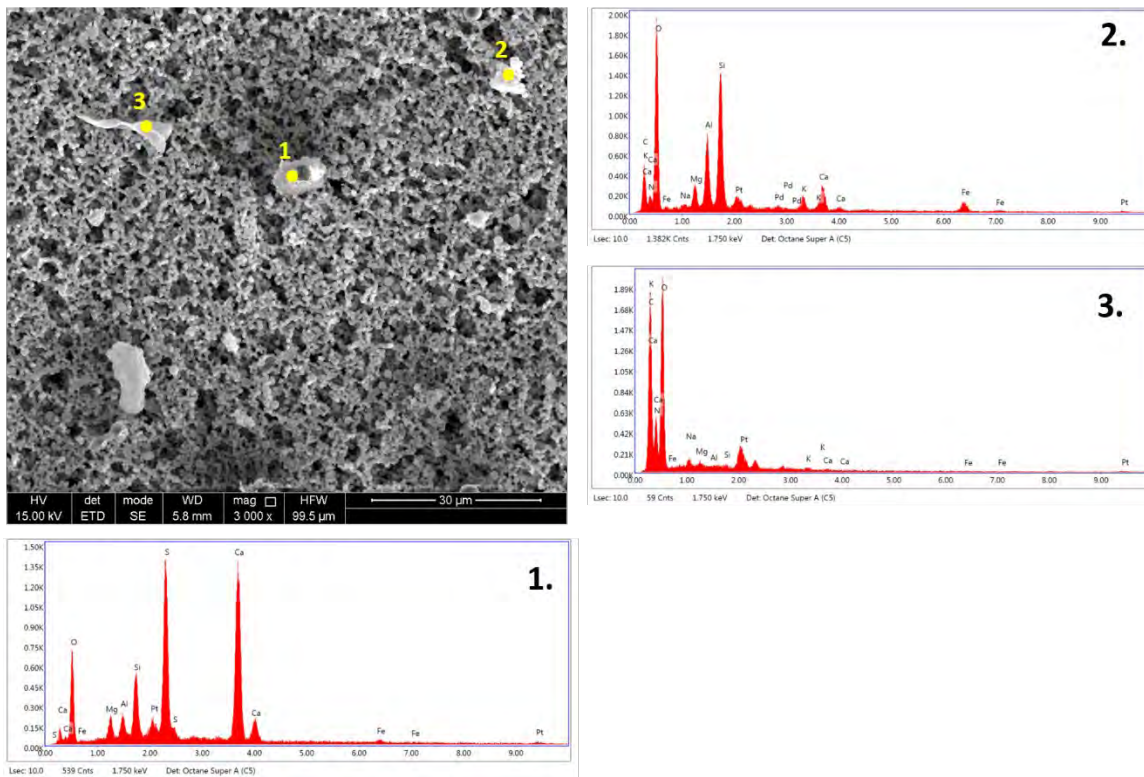
22-02-2020 (0-4)

Figure 27a. EDX characterization of the particles identified in sample “22-02-2020 (0-4)”.

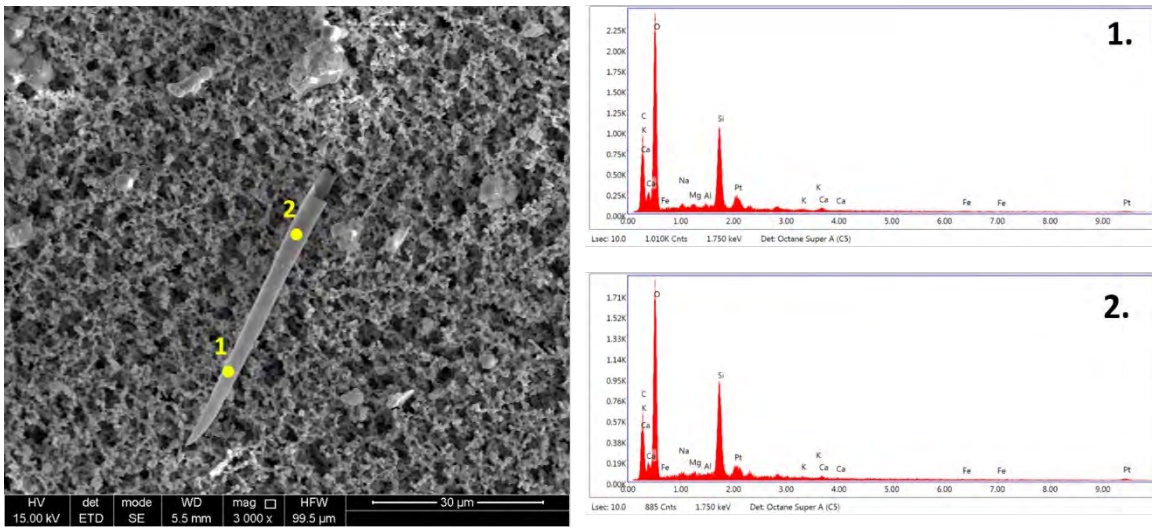
22-02-2020 0-5

Figure 28. SEM-images with secondary electron detector of the sample “22-02-2020 0-5”. The images show the network of the pvc filter using different magnifications with several multiple particles on the surface. One single fibre structure was observed in this sample but the fibre has no asbestos appearance. The chemical characterization of the particles is shown in Figure 28a.

Figure 28a. EDX characterization of the particles identified in sample “22-02-2020 0-5”.

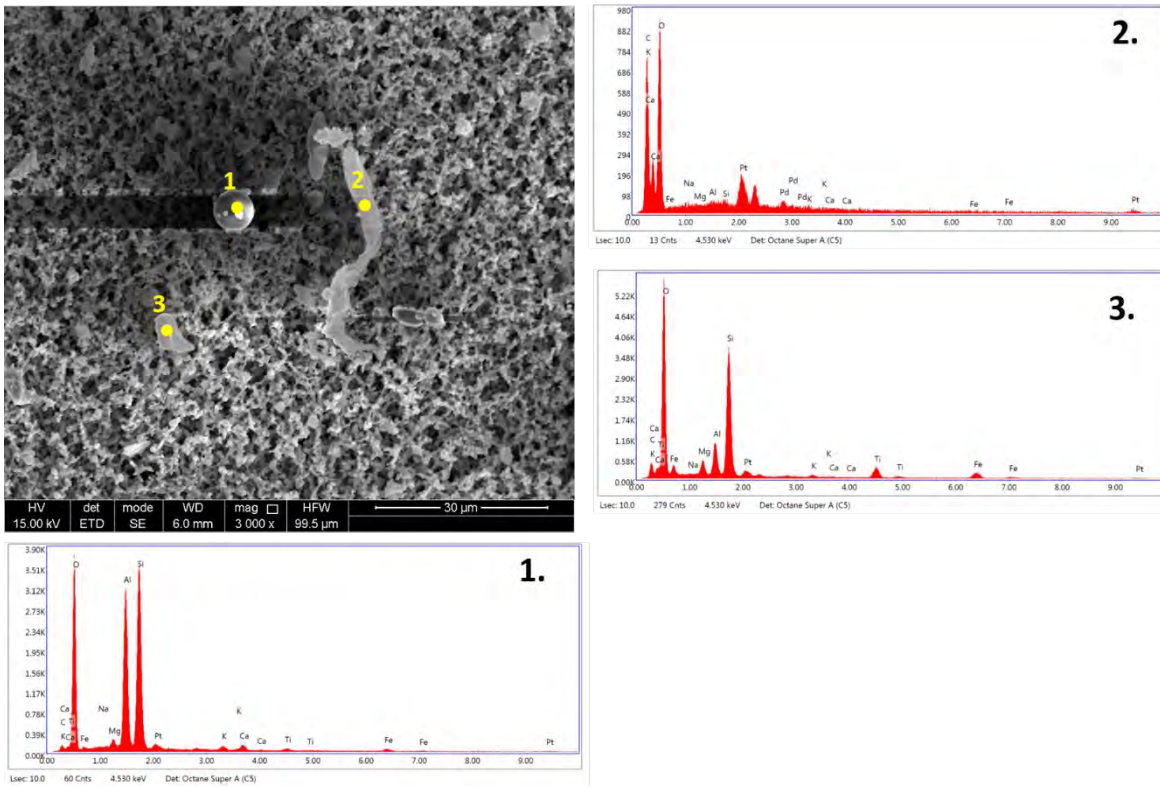
22-02-2020 (N1)

Figure 29. SEM-images with secondary electron detector of the sample “22-02-2020 (N1)”. The images show the network of the pvc filter using different magnifications with several multiple particles on the surface. One single fibre structure was observed in this sample but the fibre has no asbestos appearance. The chemical characterization of the particles is shown in Figure 29a.

Figure 29a. EDX characterization of the particles identified in sample “22-02-2020 (N1)”.
