Environment Monitoring For an Asbestos Plant in Kymore

Capacity Building and Training

Environics Trust
28-Dec-21

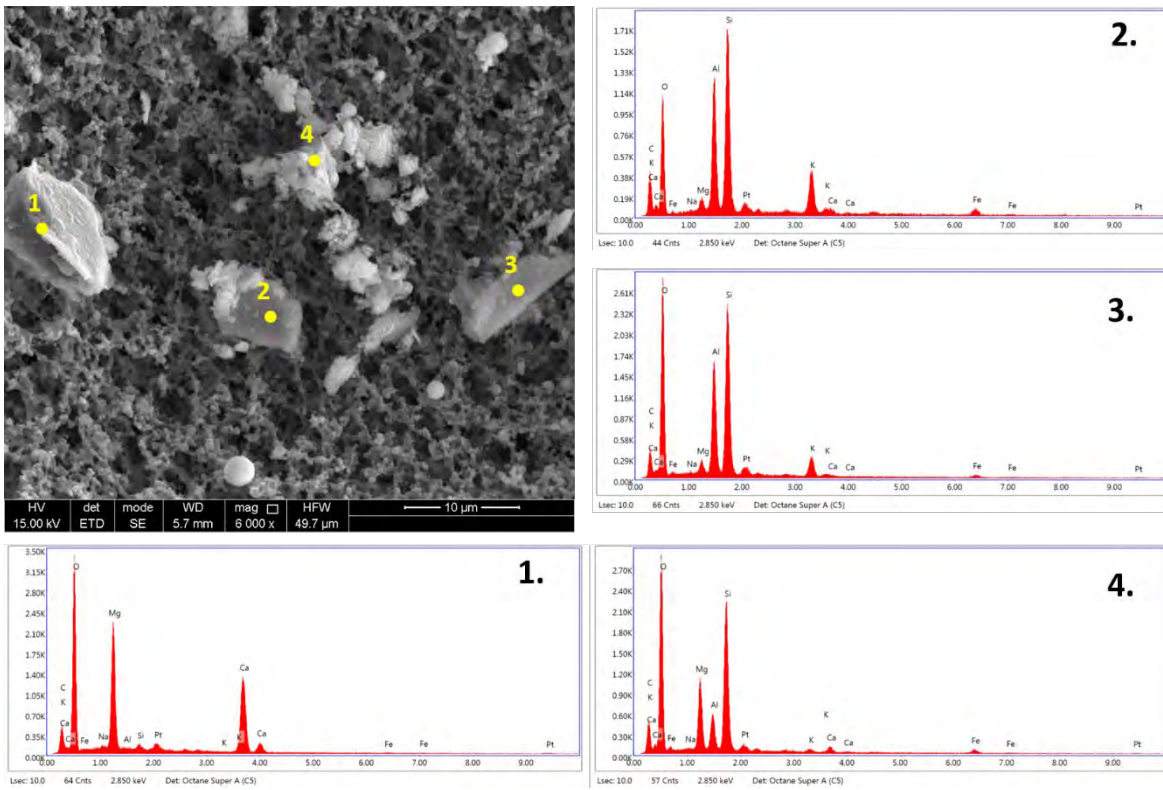
22-02-2020 N1

Figure 30. SEM-images with secondary electron detector of the sample “22-02-2020 N1”. The images show the network of the pvc filter using different magnifications with several multiple particles on the surface. The chemical characterization of the particles is shown in Figure 30a.

Figure 30a. EDX characterization of the particles identified in sample “22-02-2020 N1”.

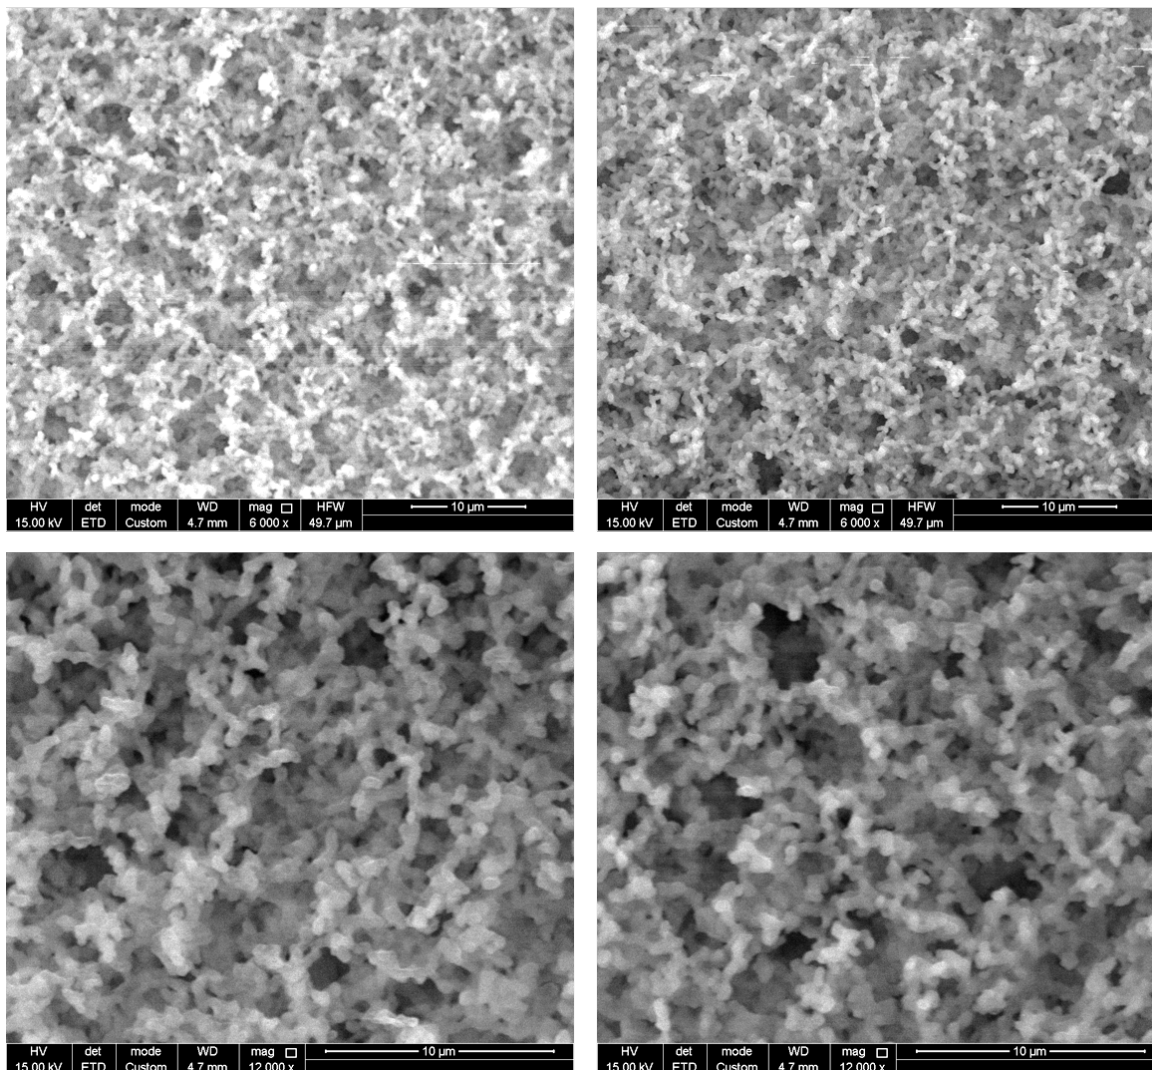
18-02-2020 F Blank

Figure 31. SEM-images with secondary electron detector of the blank sample “18-02-2020 F Blank”. The images show the network of the pvc filter using different magnifications with several multiple particles on the surface.

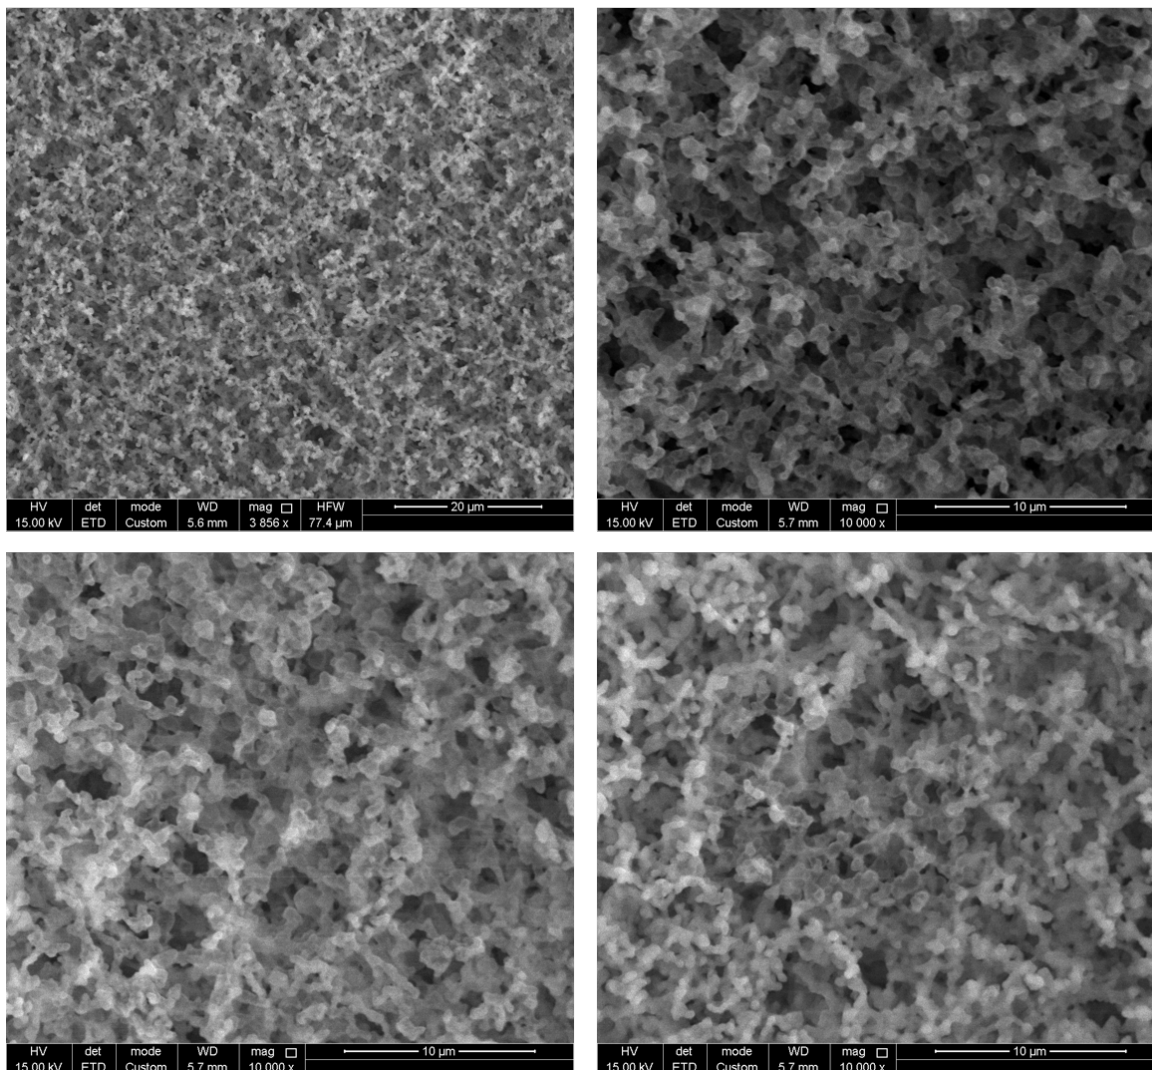
18-02-2020 F Blank (0-1)

Figure 32. SEM-images with secondary electron detector of the blank sample “18-02-2020 F Blank (0-1)”. The images show the network of the pvc filter using different magnifications with several multiple particles on the surface.

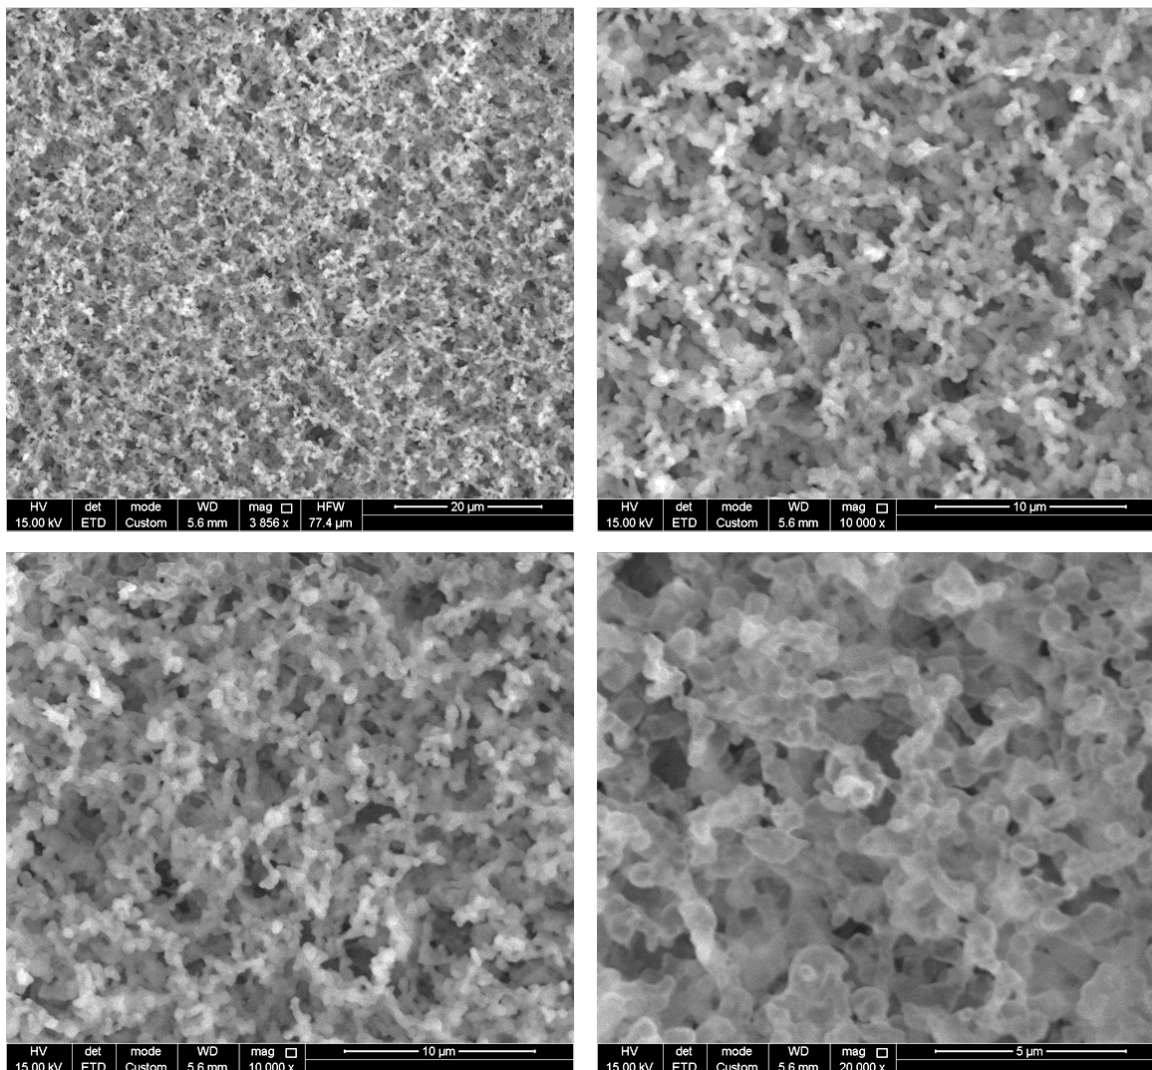
18-02-2020 Calibration Kymore

Figure 33. SEM-images with secondary electron detector of the blank sample “18-02-2020 Calibration Kymore”. The images show the network of the pvc filter using different magnifications with several multiple particles on the surface.

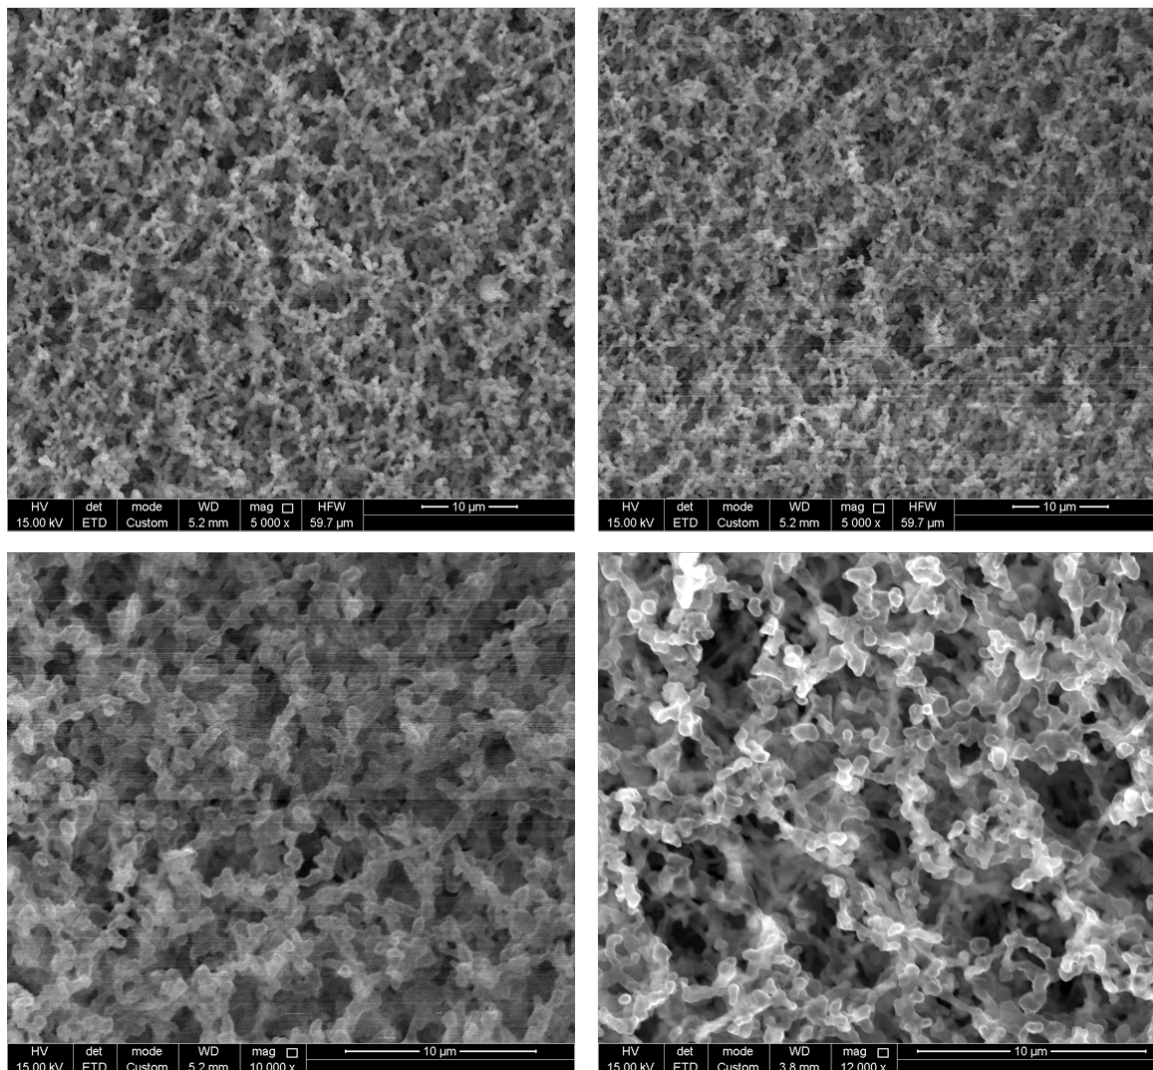
FB-19-2020 Calibration Kymore

Figure 34. SEM-images with secondary electron detector of the blank sample “FB-19-2020 Calibration Kymore”. The images show the network of the pvc filter using different magnifications with several multiple particles on the surface.

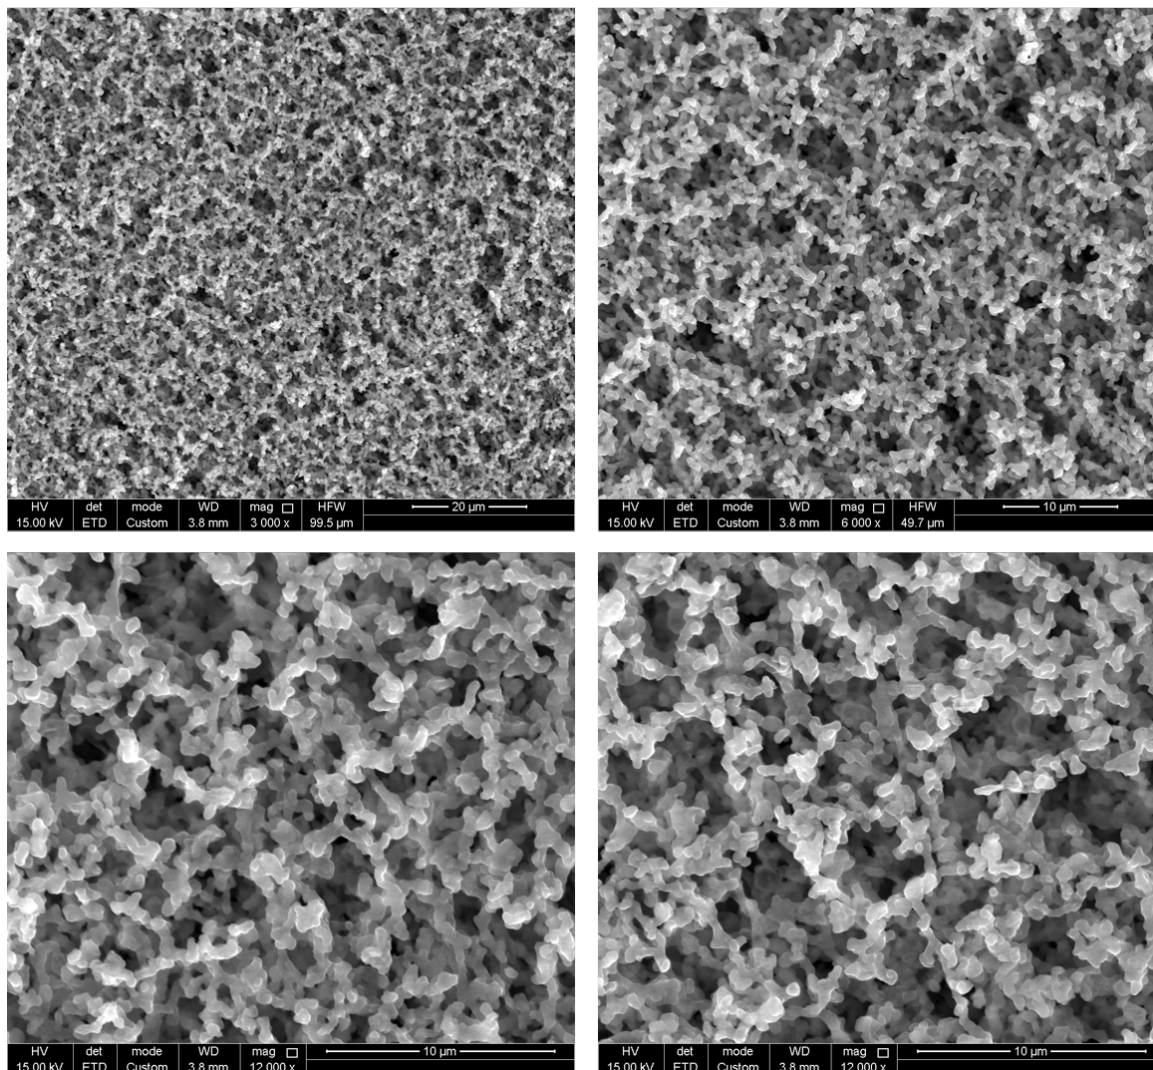
FB-19-02-20

Figure 35. SEM-images with secondary electron detector of the blank sample “FB-19-02-20”. The images show the network of the pvc filter using different magnifications with several multiple particles on the surface.

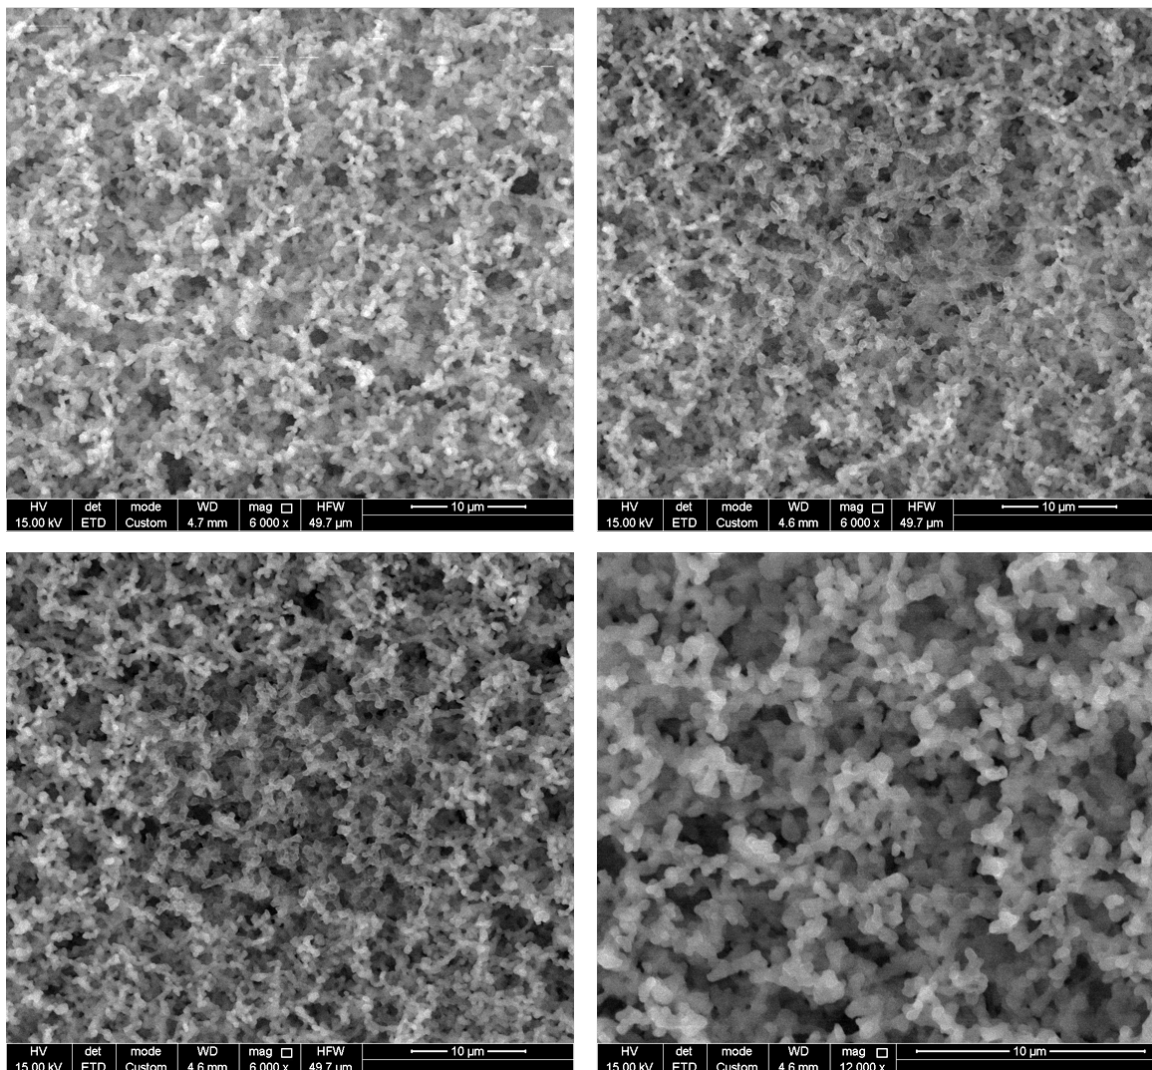
20.02.2020 FB (VIJAYLAL)

Figure 36. SEM-images with secondary electron detector of the blank sample “20.02.2020 FB (VIJAYLAL)”. The images show the network of the pvc filter using different magnifications with several multiple particles on the surface.

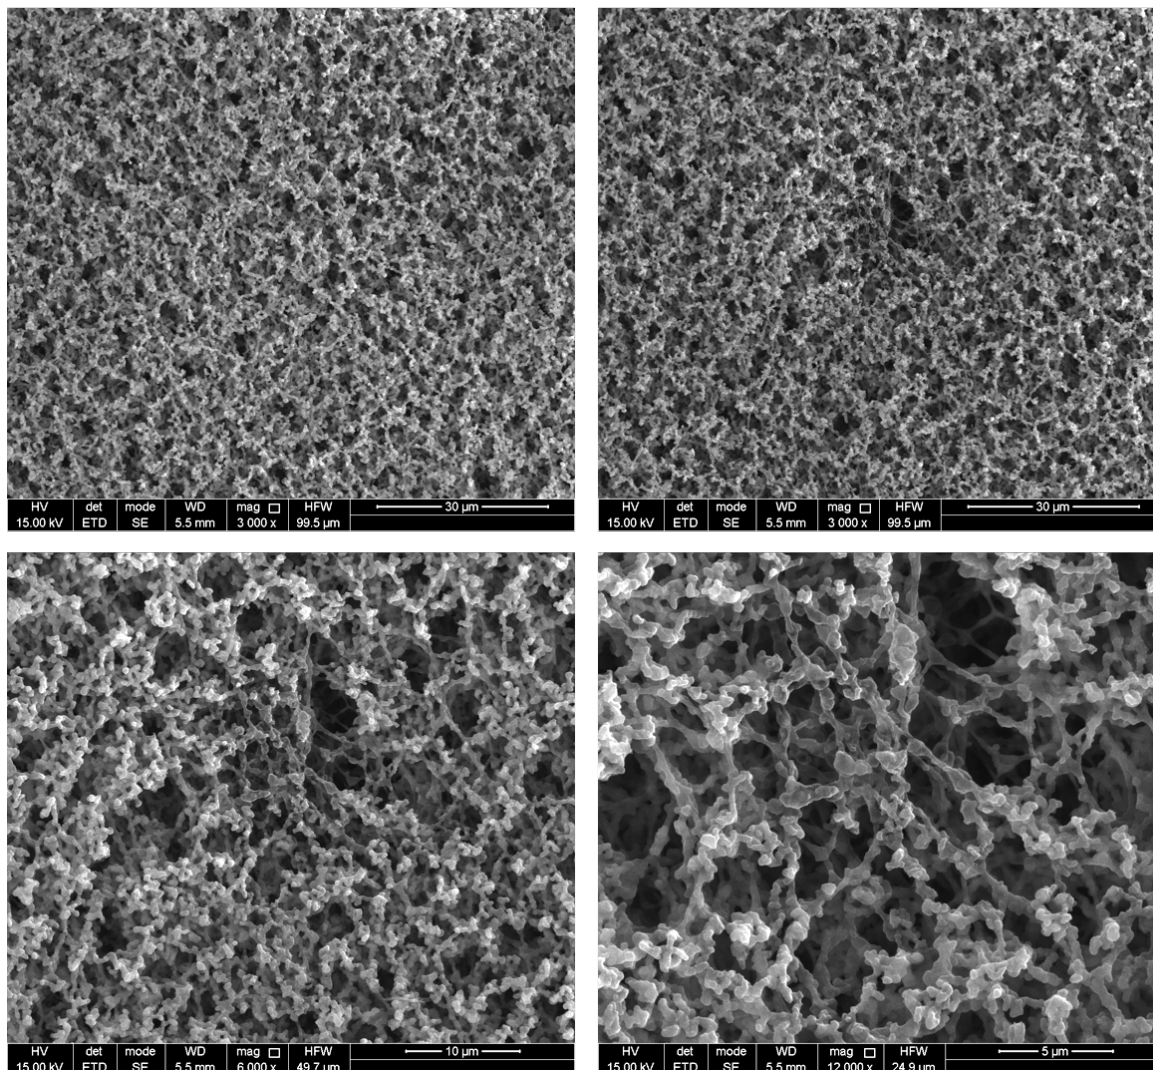
20.02.2020 Cal Kymore

Figure 37. SEM-images with secondary electron detector of the blank sample “20.02.2020 Cal Kymore”. The images show the network of the pvc filter using different magnifications with several multiple particles on the surface.

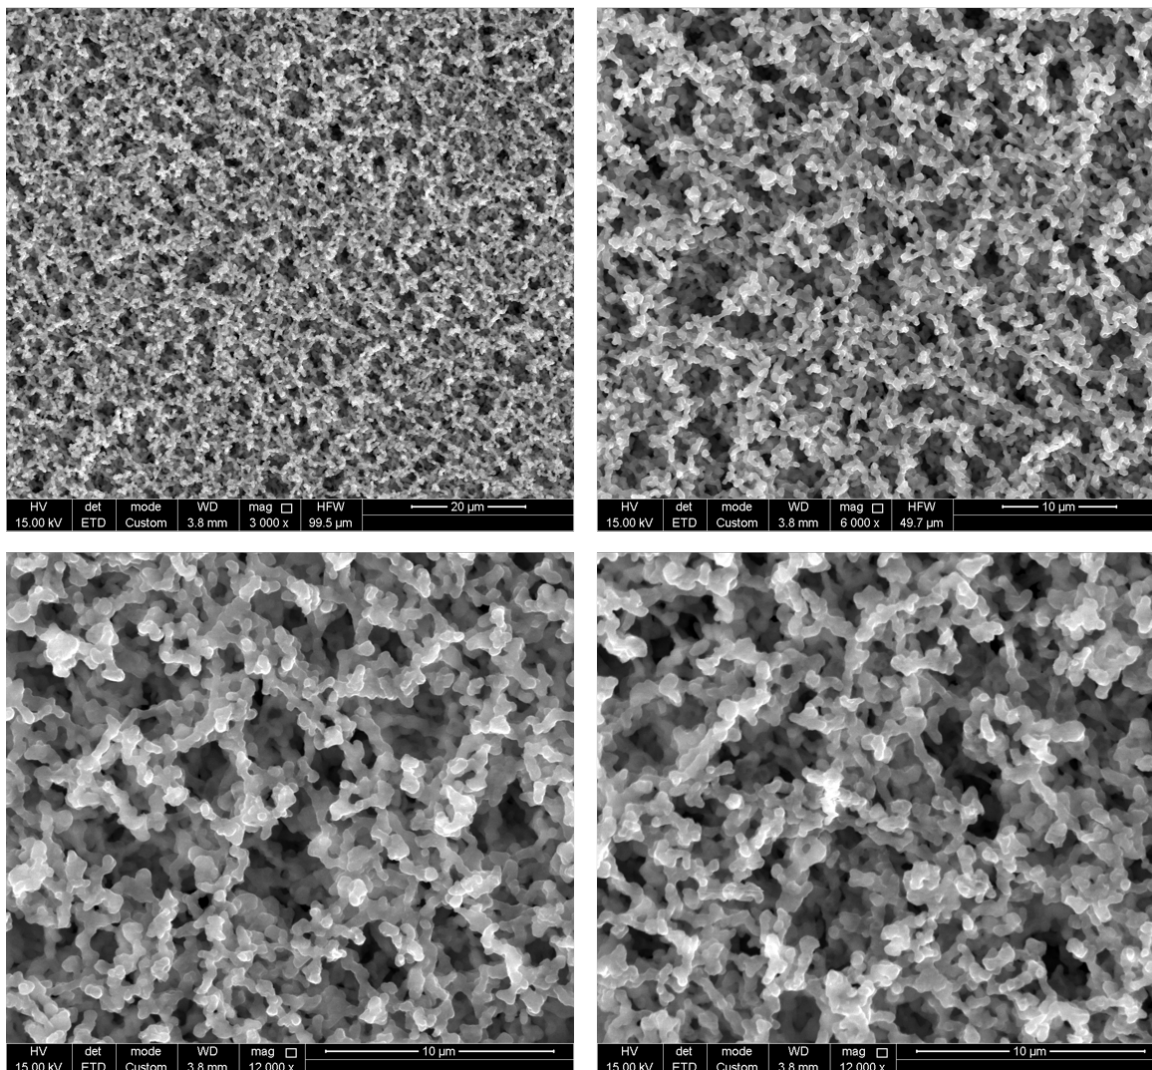
20.02.2020 FB

Figure 38. SEM-images with secondary electron detector of the blank sample “20.02.2020 FB”. The images show the network of the pvc filter using different magnifications with several multiple particles on the surface.

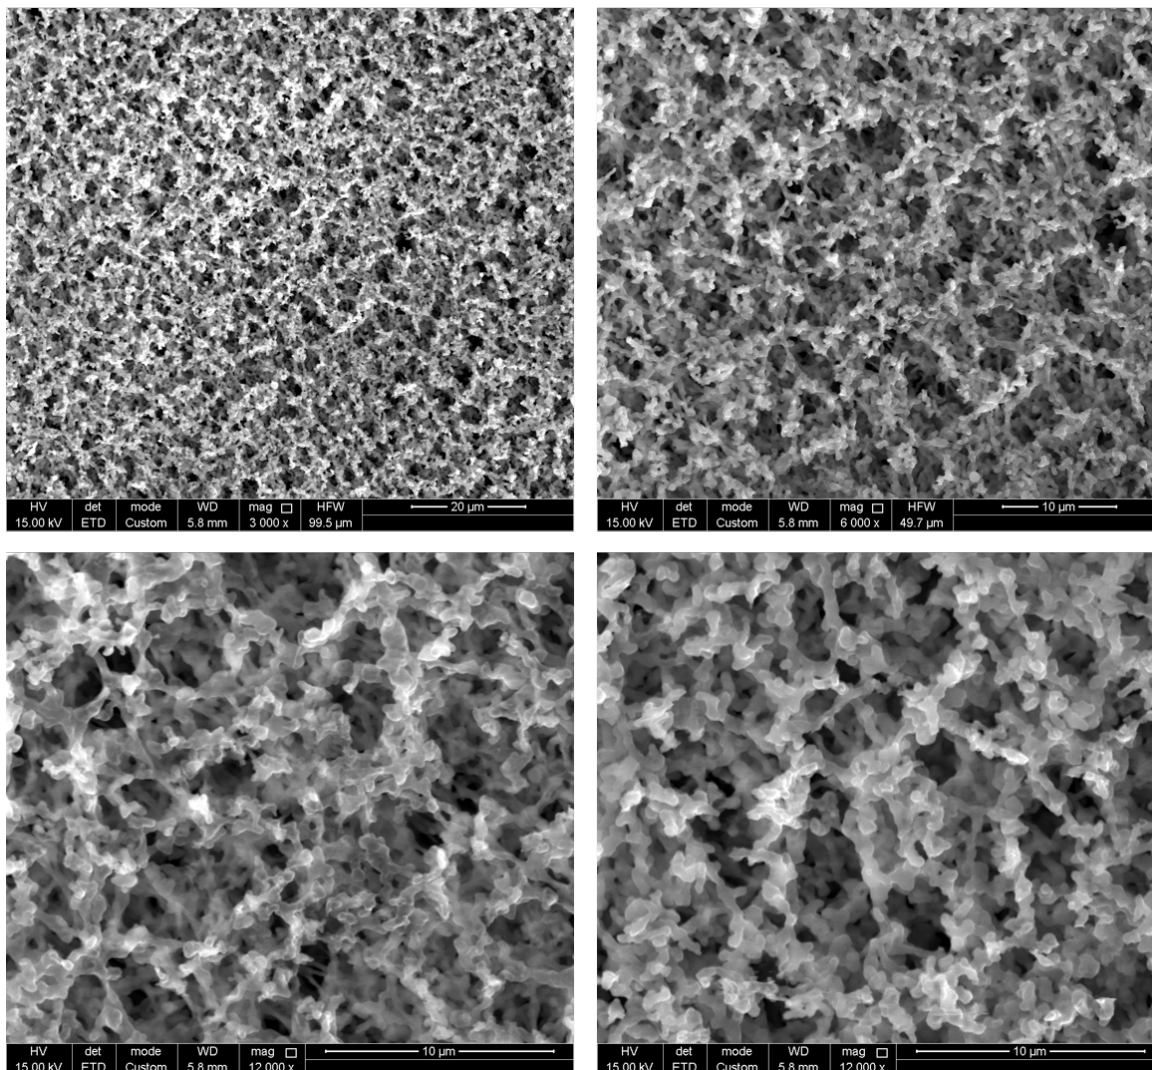
21-02-2020 Cal Kymore

Figure 39. SEM-images with secondary electron detector of the blank sample “21-02-2020 Cal Kymore”. The images show the network of the pvc filter using different magnifications with several multiple particles on the surface.

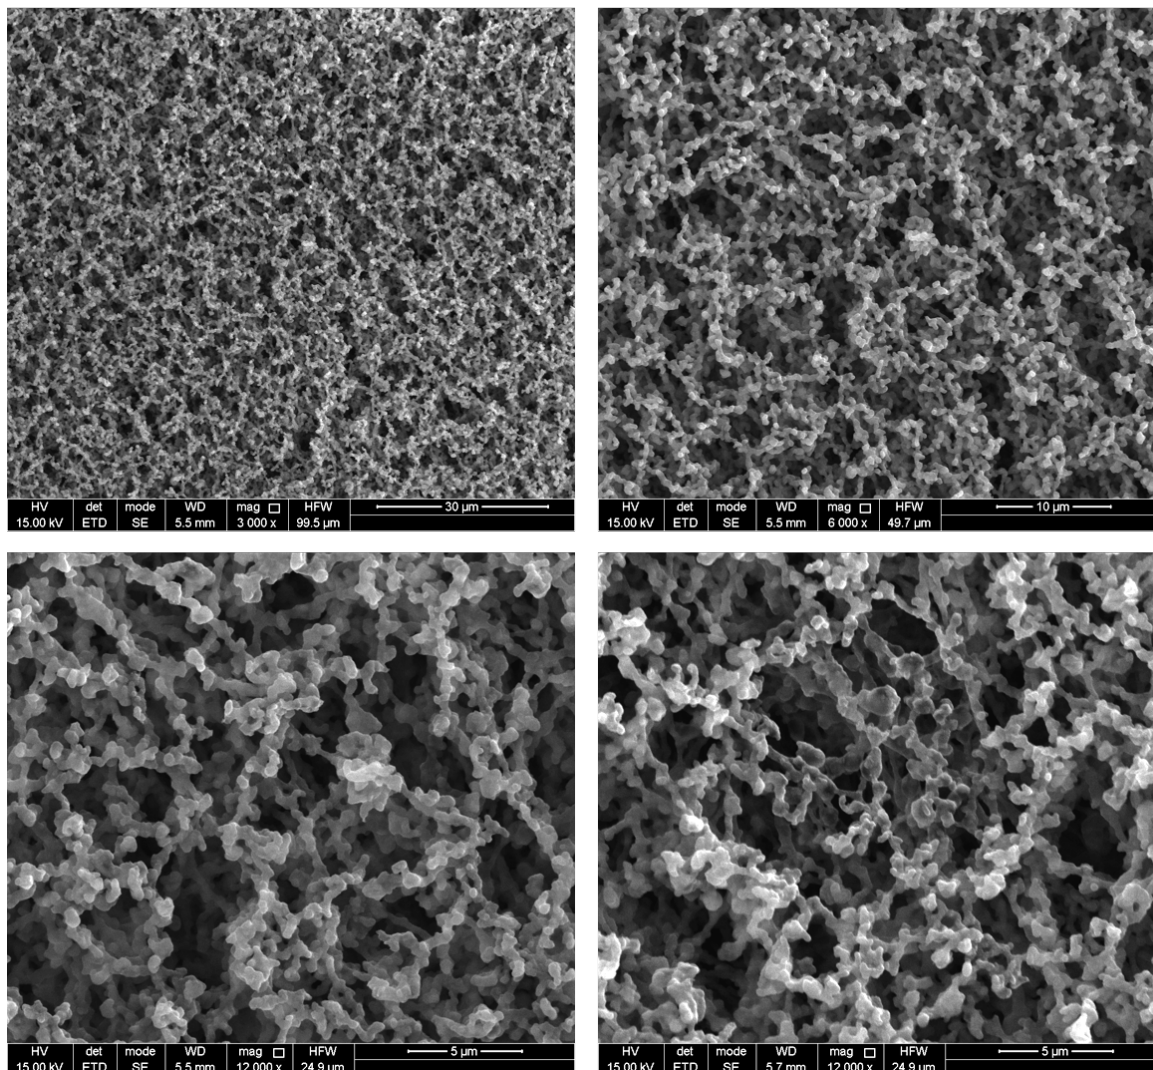
21-02-2020 FB Ravi

Figure 40. SEM-images with secondary electron detector of the blank sample “21-02-2020 FB Ravi”. The images show the network of the pvc filter using different magnifications with several multiple particles on the surface.

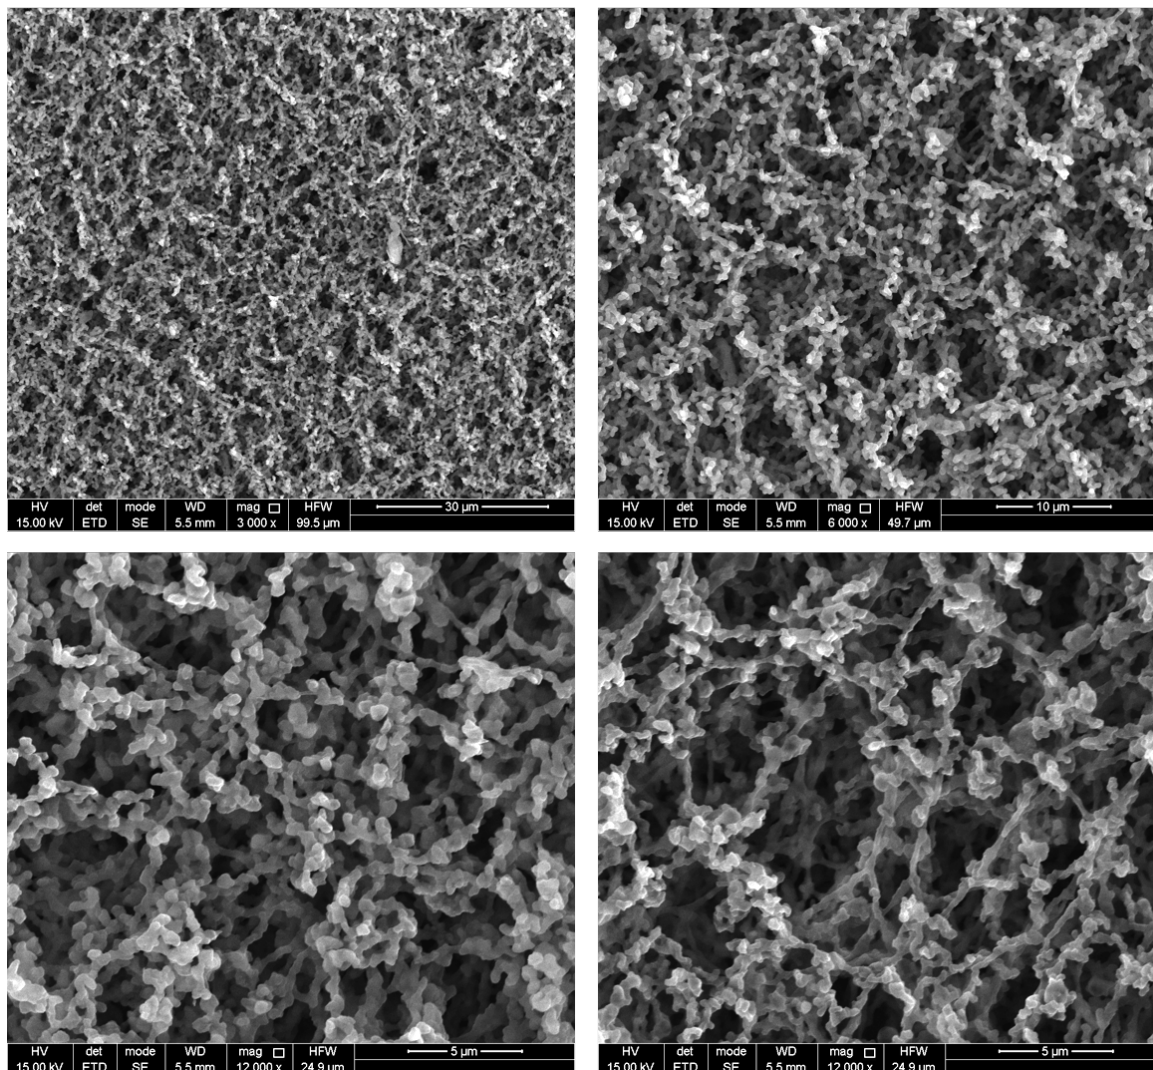
22-02-2020 FB

Figure 41. SEM-images with secondary electron detector of the blank sample “22-02-2020 FB”. The images show the network of the pvc filter using different magnifications with several multiple particles on the surface.

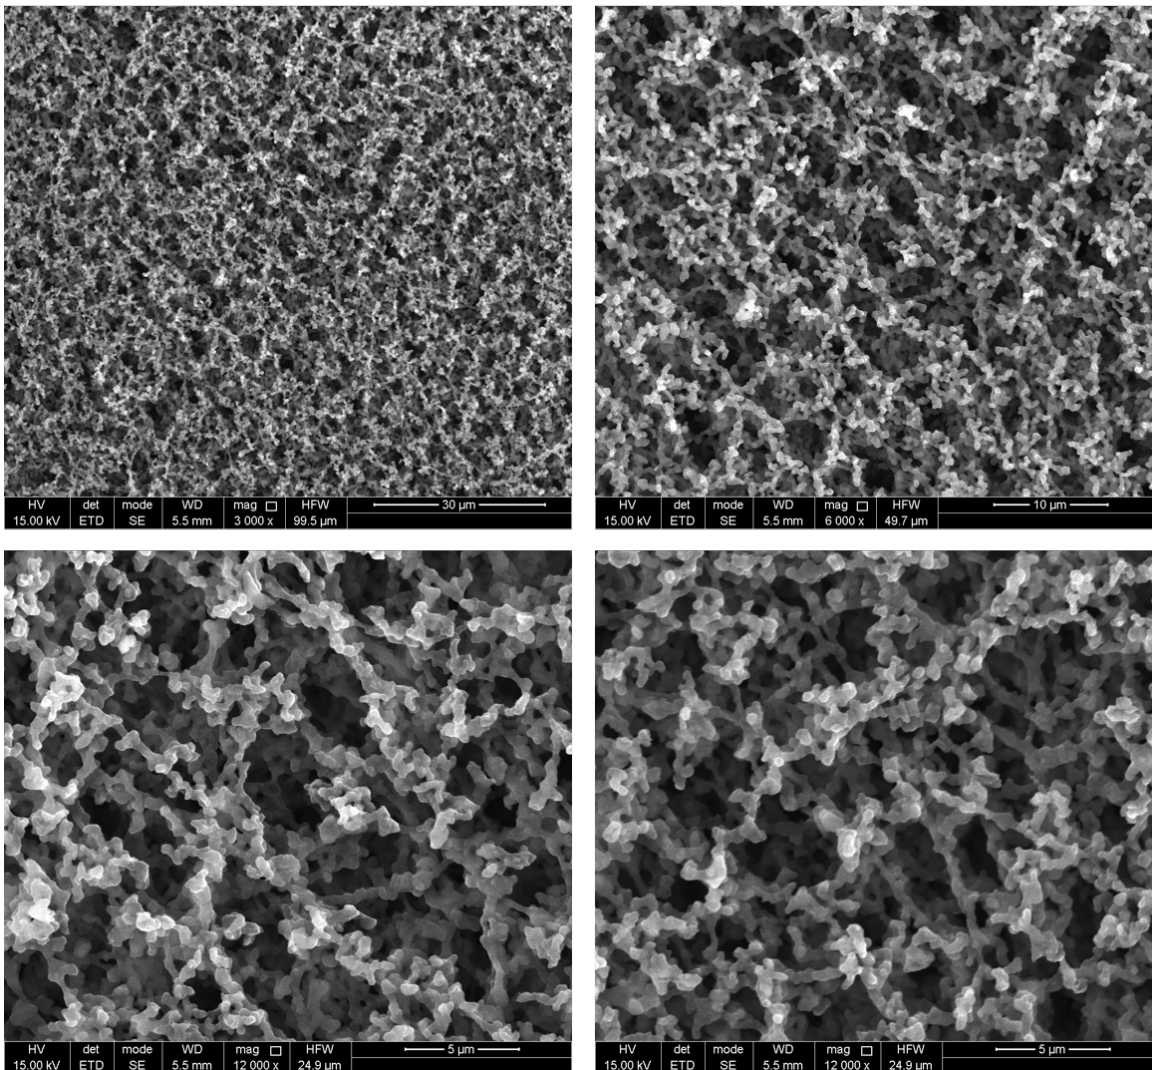
22-02-2020 CLALI Kymore

Figure 42. SEM-images with secondary electron detector of the blank sample “22-02-2020 CLALI Kymore”. The images show the network of the pvc filter using different magnifications with several multiple particles on the surface.
